Multidisciplinary Documentation Using Non-destructive Testing Techniques for the Diagnostic Study of an Ancient Temple

Abstract. In this work, an approach regarding the representation of a monument in combination with building material documentation information (deriving from non-destructive techniques) is presented. Through this approach, data incorporating architectural, surveying and building material documentation information are aggregated with the 3D documentation model, leading to valuable information regarding the preservation state of a monument. The illustration of the Pythian Apollo ancient temple, located in the Ancient Acropolis of Rhodes, Greece, aims to highlight the manner in which the fusion of multilayered information can contribute to the diagnostic study of a monument, ultimately leading to its sustainable protection through time. Information deriving from the three dimensional documentation of the monument is enriched with information deriving from non-destructive techniques (Ground Penetrating Radar, Infrared Thermography, Digital Microscopy) in combination with historical and architectural data and in-situ visual inspection observations. In addition, informa

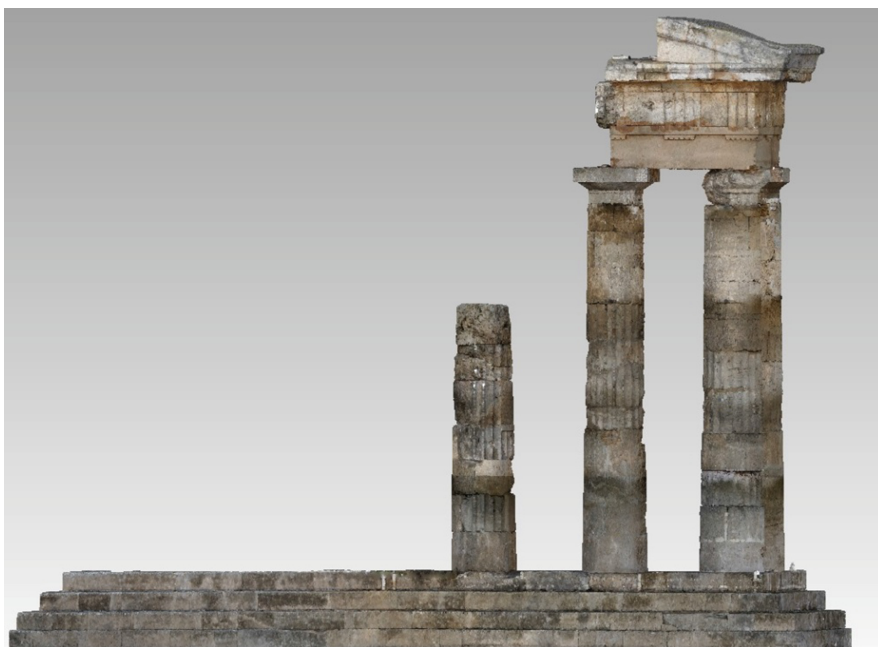
A high resolution three dimensional model of the Temple was produced, including all the voids, cracks and discontinuities that were encountered throughout the process of the 3D modeling (Fig. 4).

Fig. 4. 3D Photorealistic Model of the Pythian Apollo Temple; East Façade.

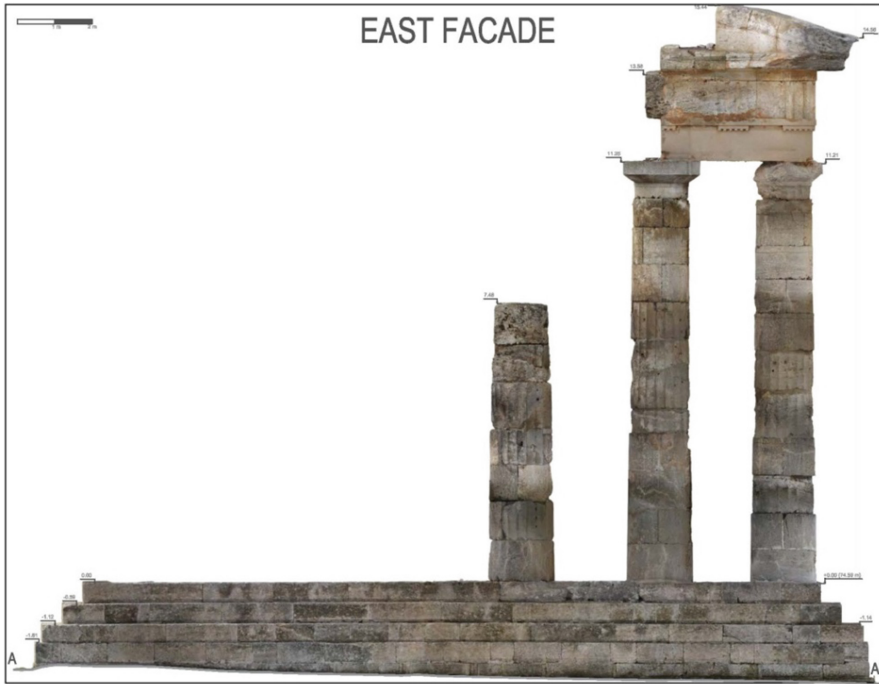
Fig. 5 Orthophoto of the East Façade of the Pythian Apollo Temple.

In the case of the Pythian Apollo Temple, it was very important to obtain a high quality textured products, in order to assess the state of preservation of the restored columns. The variation of the building materials is documented. Cracks and deformations are obtained and can be digitized since the orthoimage can be utilized as a blueprint for further elaboration. The various segments which comprise the Temple can be analyzed, measured in terms of their dimensions with millimeters accuracy. In addition the Temple can be monitored, should structural alterations occur in the future.

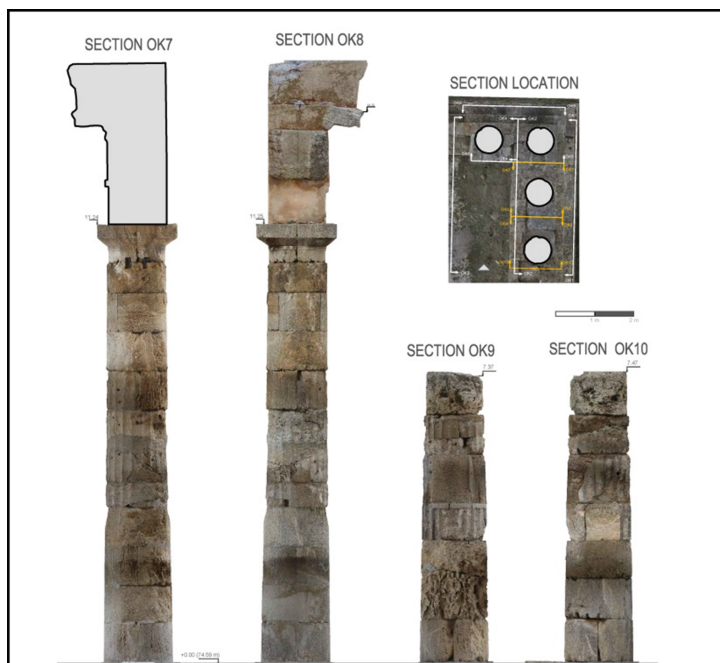
Fig. 6. Sections of the Columns of the Pythian Apollo Temple, north and south facades.

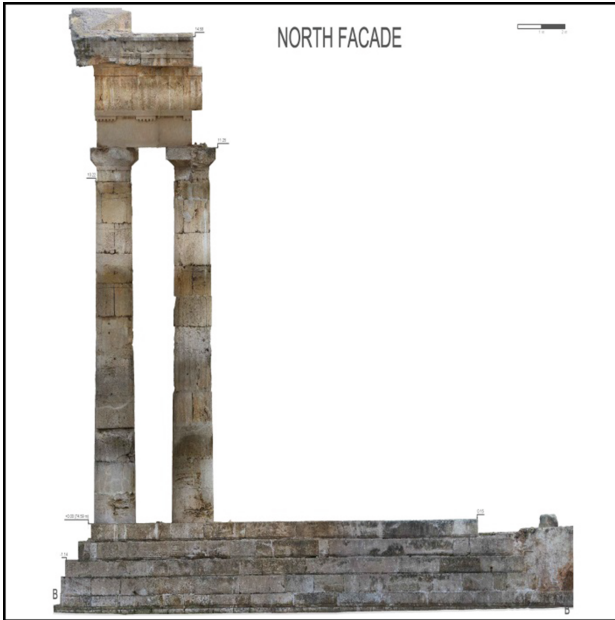
Fig. 7. Orthophoto of the North Façade of the Pythian Apollo Temple.
