Pre-diagnosis Protocol for Large Residential Building Stock. The Case of Barcelona's Vulnerable Areas

C. Cornadó, S. Vima-Grau, and P. Garcia-Almirall

Keywords Refurbishment · Building assessment · Housing refurbishment · Pre-diagnosis protocol

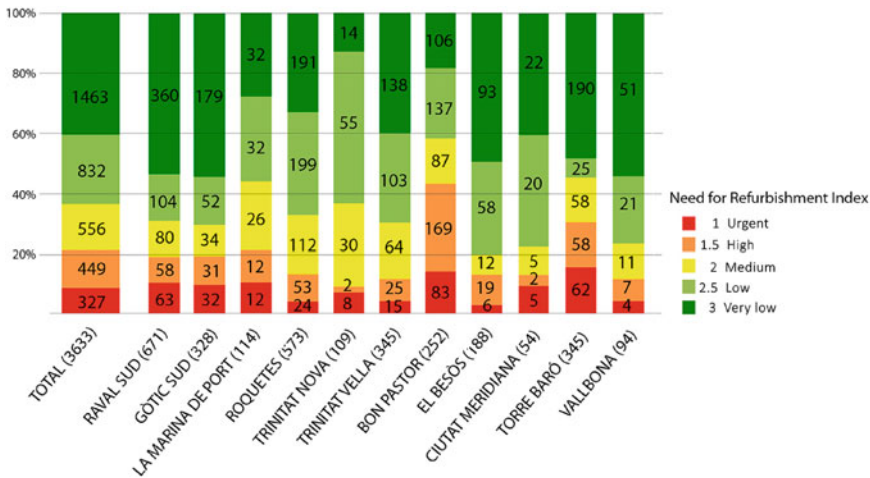
Observation of the state of conservation in the analyzed sample of cases (Fig. 21) shows how the proportion of cases in a reasonably good state (low or very low need of refurbishment) corresponded to 60% of cases. In contrast, the proportion of cases with urgent need of refurbishment (evidence of risk) corresponded to a fifth of the total sample.

However, if we focus on the highest level of urgency, the neighborhoods of El Bon Pastor, Torre Baró, El Raval (southern area), El Barri Gòtic (southern area), La Marina de Port and surprisingly Ciutat Meridiana had a higher percentage of cases, while the neighborhoods of Roquetes, Trinitat Vella, Vallbona and El Besòs had a lower proportion of cases in urgent need of refurbishment.

Taking into account that a quantitatively larger sample was analyzed in El Bon Pastor, Torre Baró and particularly El Raval and El Barri Gòtic, this high proportion of cases with an urgent need of refurbishment translates into a high number of affected buildings in those areas, particularly in El Bon Pastor.

Fig. 21 Need of refurbishment index comparison between neighborhoods

Regarding the state of conservation (Fig. 21), the highest proportion of cases in urgent need of refurbishment correspond to the area of ‘Cases barates’ in El Bon Pastor (Type 1), followed by the neighborhood of Torre Baró (Type 3), and the neighborhoods of the historical center of the city, El Raval and El Barri Gòtic (Type 1).

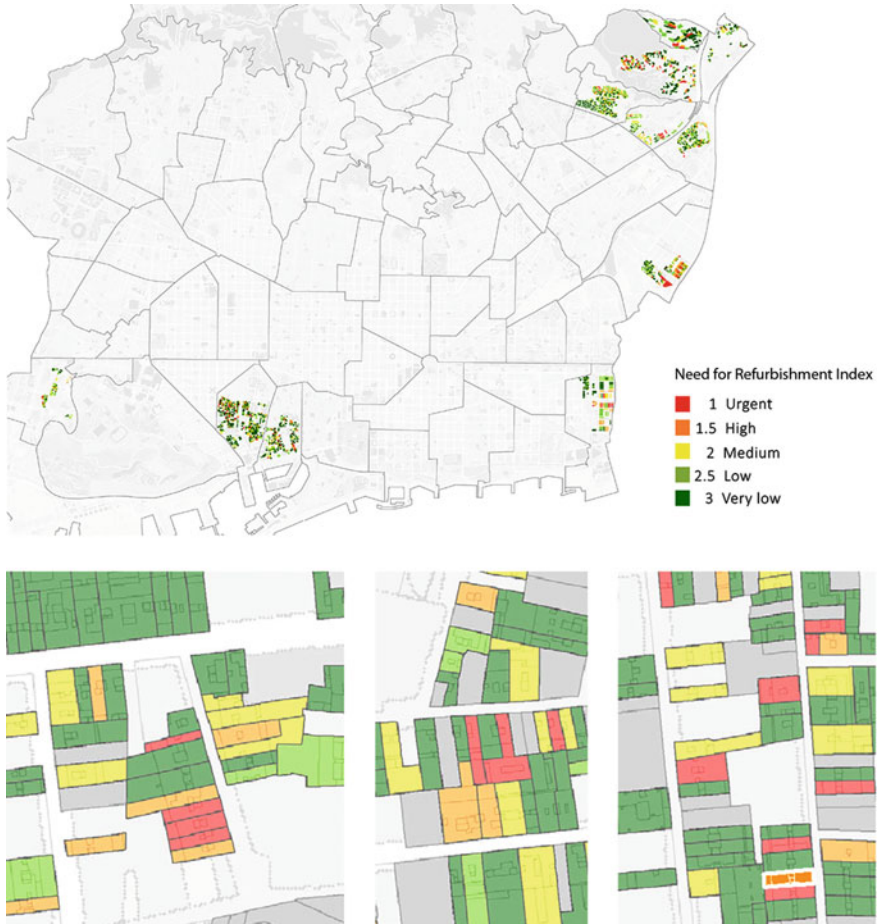
Finally, mapping of refurbishment need results shows how the observed variety in states of conservation within each of the neighborhoods translated into considerable geographic variability of results (Fig. 22). It was impossible to identify areas of a certain scale that were uniformly well-conserved, or areas of a certain scale that were uniformly deprived. In addition, it was common to observe how cases that required urgent refurbishment appeared to be adjacent to cases in a very good state of conservation.

Fig. 22 Need for refurbishment index in the studied areas (top) and close up views in different neighborhoods (bottom)

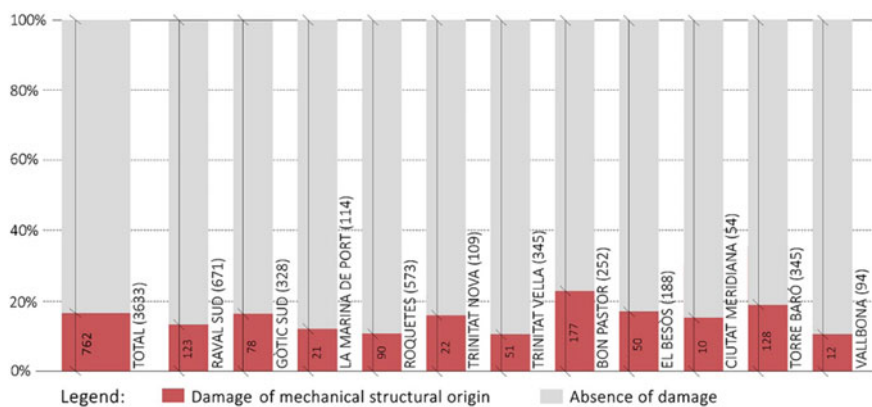
Firstly, mechanical structural damage appeared to be found quite uniformly in the neighborhoods, regardless of the construction building type, in 15–20% of cases (Fig. 23). The highest percentages were in El Bon Pastor, Torre Baró, El Besòs and El Barri Gòtic. In the first case, the observed damage corresponded mainly to cracks in cornices and lintels of mostly abandoned and very poorly maintained buildings (Fig. 24) in the area of ‘Cases Barates’ (economic housing) (Type 1). This repetition of the same kind of damage was generally quite unique to this area, although similar damage was observed in some cases of low Type 1 buildings, such as typologies of suburban growth of the nineteenth century in La Marina de Port.

Fig. 23 Percentage of damage of mechanical structural origin and risk of material detachment within the sample

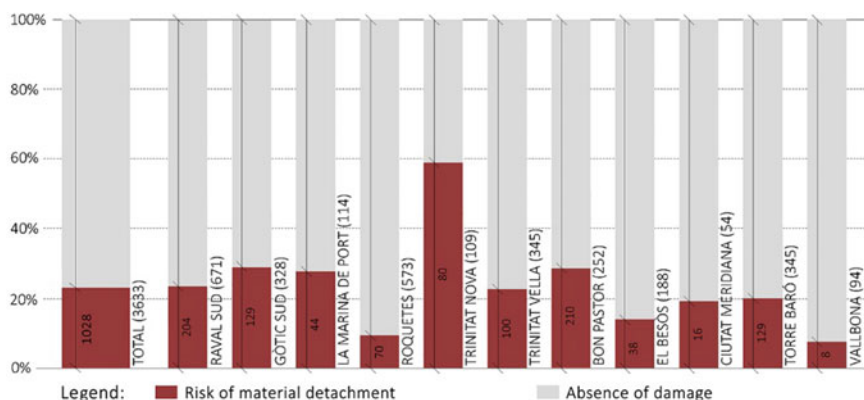
Secondly, unstable elements (Figs. 28 and 29) were observed in much more variable proportions among the neighborhoods (between 20 and 60%). Trinitat Nova was a distinctive case in which there was a very high percentage of buildings with unstable elements in the façade. This damage was greater in neighborhoods where Type 1 and Type 2 are predominant. In the first (Type 1), damage was mainly observed in balconies, cornices and continuous cladding, while in buildings from Type 2, these types of damage mostly appeared in façade plating and other elements besides balconies, and was similar to the observed damage in Trinitat Nova and linear blocks in El Besòs (Type 4). Curiously, in neighborhoods where Type 3 buildings are predominant, the amount of damage was considerably lower (Roquetes, Vallbona, and relatively low in Torre Baró).

Fig. 28 Percentage of risk of material detachment

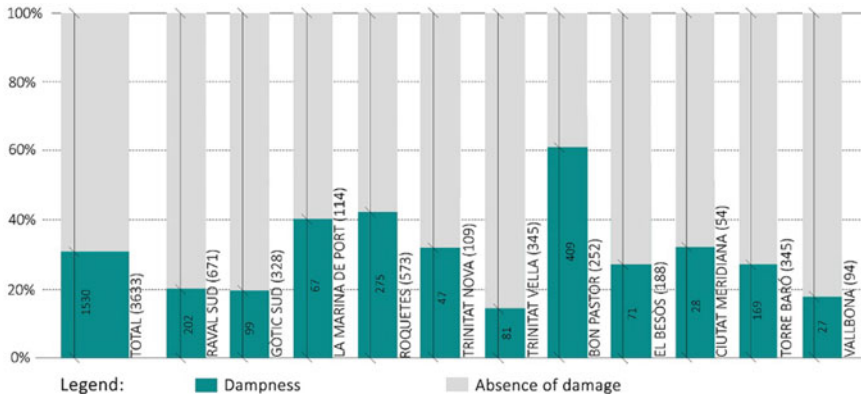
20% in Trinitat Vella, El Raval and El Barri Gòtic, and Vallbona and slightly over 20% in Torre Baró, to around 40% in La Marina de Port, Roquetes, Trinitat Nova, El Besòs and Ciutat Meridiana, and 60% in El Bon Pastor. Since the presence of dampness is associated with other observed types of damage, it is indicative of the general state of maintenance of the façade.

Fig. 30 Percentage of buildings with damage due to dampness

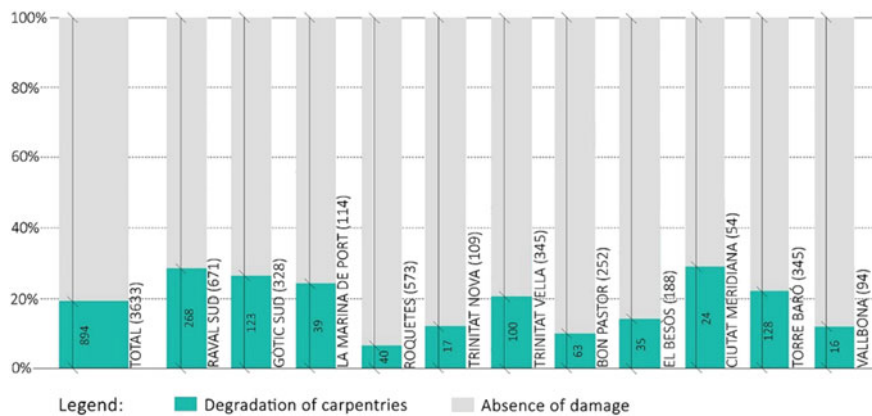
Regarding damage to carpentry and woodwork (Figs. 32 and 33), the percentages were considerably higher in Type 1 buildings (El Raval, El Barri Gòtic and La Marina de Port), mostly due to aging and deformation of woodwork. Percentages were also high in some neighborhoods characterized by Type 2 buildings (Trinitat Vella) and 4 (Ciutat Meridiana), where the carpentry is mostly old aluminum frames, sometimes with deteriorated sliding windows containing single-pane or non-transparent glass.

Fig. 32 Percentage of buildings with damage to carpentry and woodwork

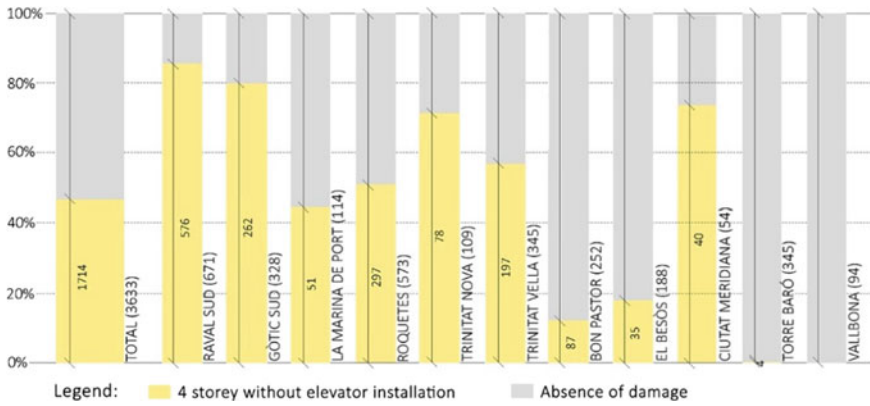
Finally, severe deficiencies in accessibility was the type of damage that varied most widely by neighborhood and was greater in many neighborhoods (Fig. 34). Logically, the variation can be explained by the fact that high buildings with no elevator installation depended strictly on building type and urban morphology.

Fig. 34 Percentage of 4 or more story buildings without elevator

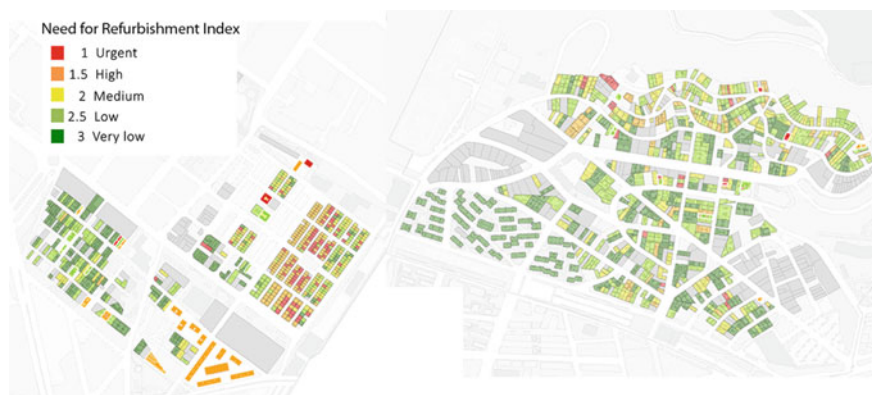
In neighborhoods comprised of clearly differentiated areas in terms of urban form and building types, the mapping showed remarkably different results according to building type. For example, the north-western area of El Besòs, comprised of Type 1 buildings, clearly had a higher concentration of buildings in a very good state, and cases with considerable evidence of risk were nonexistent. Similarly, the area of ‘Cases barates’ in El Bon Pastor (type 1) had the highest concentration of cases with

Fig. 37 Need for refurbishment index in El Bon Pastor (left) and Roquetes (right)

an urgent, high need for refurbishment, and could clearly be distinguished from other areas in El Bon Pastor with 3 and 4 type buildings. Finally, the south-western area of Roquetes, comprised of linear blocks and tower blocks built between the 1950s and 1970s (Type 4) was uniformly in a very good state of conservation according to the exterior inspection, while the northern part of the neighborhood comprised of an originally marginal urbanization of mostly self-constructed buildings had the highest concentration of buildings that need refurbishment with some degree of urgency, and the highest number of cases with evidence of risk in the neighborhood. Figure 37 shows the need of refurbishment index in El Bon Pastor and Roquetes.

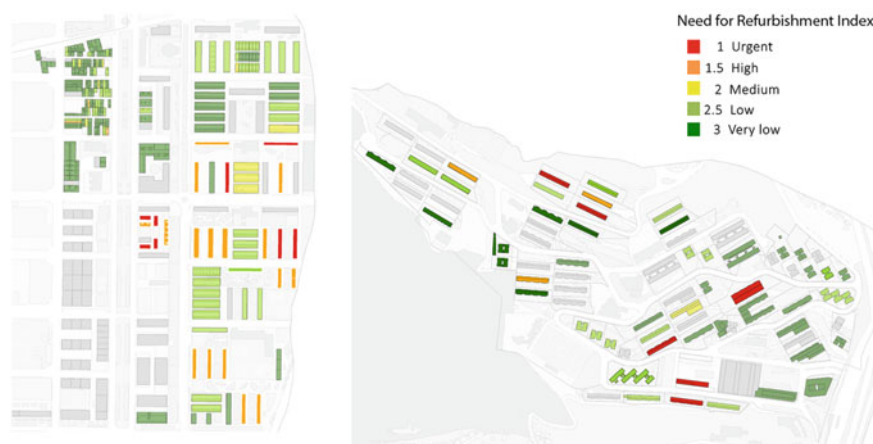
Fig. 38 Need for refurbishment index in El Besòs (left) and Ciutat Meridiana (right)
