# A Case Study of Slope Stability Assessment Thames River, London, Canada

Ron Xia<sup>1</sup>(✉) and Hui Qian<sup>2</sup>

<sup>1</sup> McClymont & Rak Engineers, Inc., Maple, Vaughan, ON, Canada

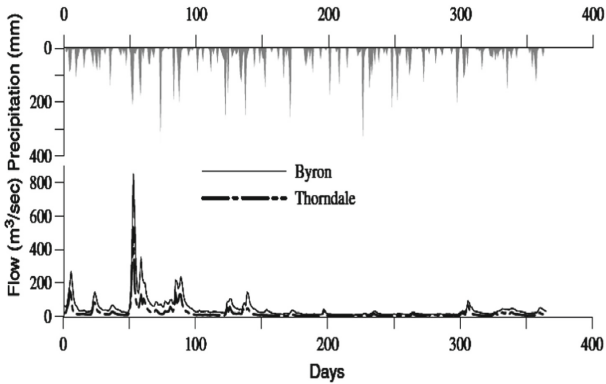
Peak flow is closely related to precipitations during a year and can be explained by a series of historical observations. We adopt the historical hydrological process in 1997, recorded in two hydrologic observation stations at London area, as an example. Plotting the observed total precipitation (rainfall and snowfall) versus river discharge measurements to illustrate the actual trend of peak flows during the year of 1997 (Fig. 4).

The differences in peak flows between Thorndale and Byron, when plotted on Fig. 4, show a similar pattern over the year. Discharge response to total precipitation occurred during the entire year of 1997.

**Fig. 4.** Observed 1997 hydrographs at Byron and Thorndale and total precipitation at London, Ontario -- from Nirupama and Simonovic (2006).

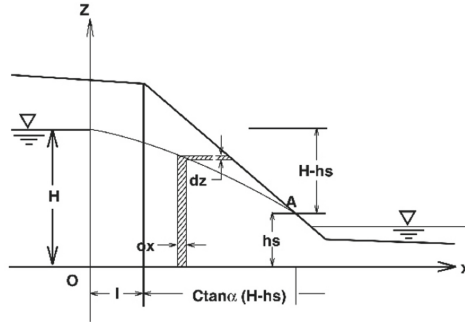
The exchange between groundwater and river water is relatively complex. Generally, river water is mainly recharged by groundwater at the study area. Water table/phreatic line, at the slope section, can be estimated by using Darcey’s Law under fully saturated conditions (Fig. 6).

**Fig. 6.** Profile of a natural slope showing phreatic line computation and seepage zone (Xia et al. 2002).

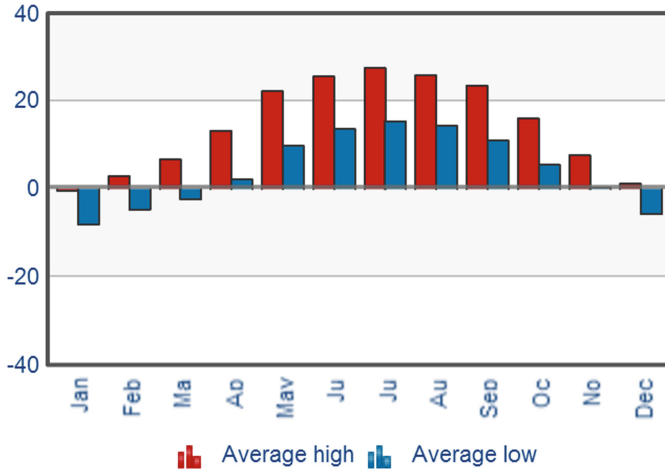
Monthly average high temperature is 27.5 °C in July and monthly average low is – 8.1 °C in January. Three months from December to February monthly mean temperature is sub-zero. Ground freezing start in December and thawing start at early March. Three higher total monthly precipitations 111, 90 and 88 mm happened in June, December, and January – see Figs. 9 and 10.

**Fig. 9.** Statistic overview of monthly average temperature at Delaware, Ontario, Canada (Statistics D. O. 2015)

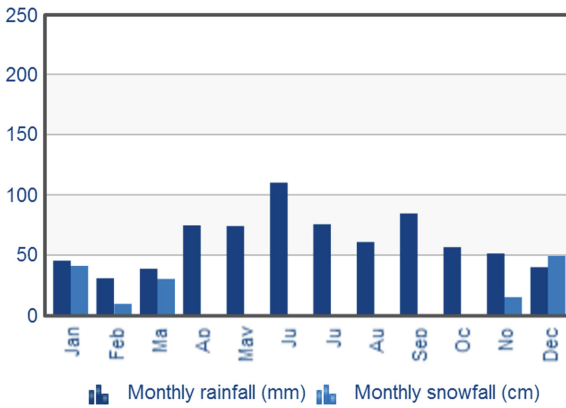
**Fig. 10.** Statistic overview of monthly average precipitation at Delaware, Ontario, Canada (Statistics D. O. 2015)

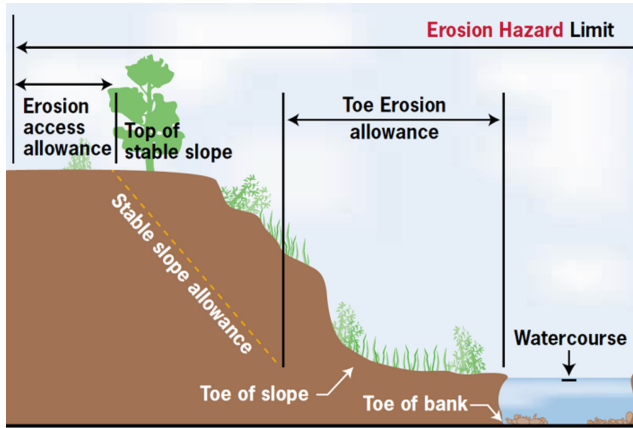
Three types of allowance of erosion hazard limit, described in the Guideline of Ontario Ministry of Natural Resources (OMNR), are of reliable for engineering planning, designing and interest to conservation authorities' review. They are simply summarized as 1) toe erosion allowance, 2) stable slope allowance, and 3) erosion access allowance (OMNR 2002). These three elements are schematically illustrated on Fig. 12.

**Fig. 12.** Confined System, Erosion hazard limit where toe of valley slope is located less than 15 m from the watercourse (OMNR 2002).

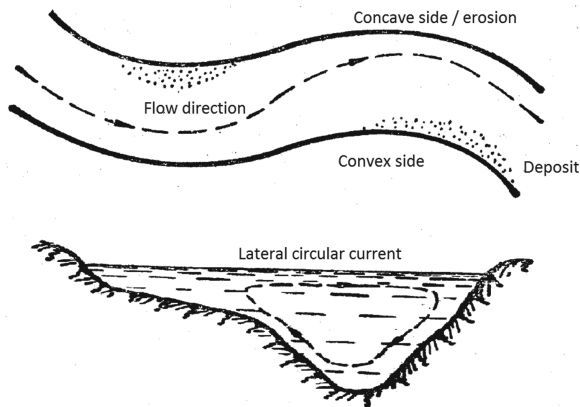
Slope is less of protection, no trees, no grasses, and no vegetation cover on the bank nearby the stream water. Plus the project site is located at the concave side of the tortuous-meanders river section. Current of lateral circular flow, from surface of water to bottom of riverbed, takes soil from the bank of concave side as sediment flow and makes deposit at convex side (Fig. 15).

**Fig. 15.** Lateral circular current takes soil from concave side and deposits soil at convex side of river bank.
