Lessons and Mitigation Measures Learned from One Deep Excavation Failure Case

Wei Xiang, Yu-shan Luo^(✉), and Zhi-rong Liang

Shanghai ShenYuan Geotechnical Co. Ltd., Shanghai 200011, China

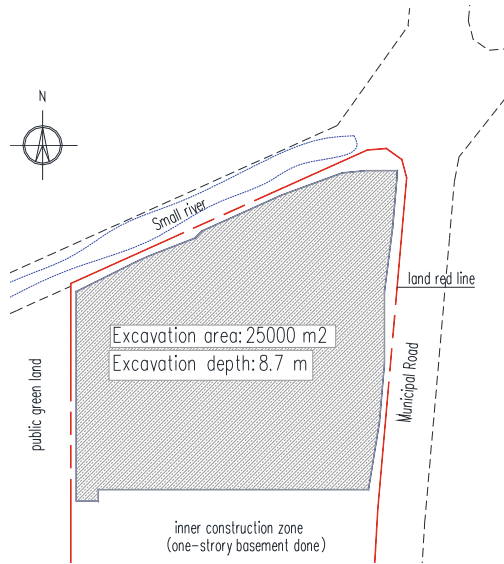
Fig. 1. Sketch of the surroundings around excavations

Figure 1 shows the layout and surrounding environment of the failed project. The environment was not quite complex, surrounded by a small river (about 6 m–10 m in width and 0.4 m–0.9 m in depth) to the north, a 28 m-wide municipal road to the east, a public green land to the west and internal construction site (the construction work of the south 1-story basement was finished, up to ground level) to the south. The main protection objects around the project were the municipal road and underground pipelines in the East.
