Restoration of Architectural Stone Heritage Damaged by 2011 Great East Japan Earthquake

Abstract. The Great East Japan Earthquake of 2011 caused serious damage to a number of architectural heritages. Fukushima Photo Museum (Former Laboratory of Electrics Ministry of Communications), constructed in 1922 and designated as the local governmental important cultural property, was damaged. This heritage structure was categorized into an unreinforced stone structure with local tuff stones. The strong ground motion caused cracks in the stone walls, tilting of the pediment, and falling of the stucco ceiling in the rooms. The multi-disciplinary expert committee for the restoration project was established. In order to discuss the seismic reinforcement of this damaged stone building, structural survey was performed at the first stage of the restoration project. The construction material was the local tuff stone characterized by its rather low specific gravity of 1.2. While the joints were made of cement with insufficient bonding strength, the friction coefficient of the joints was evaluated to be as high as 1.5. Finally, the committee proposed the seismic reinforcement by employing prestressi

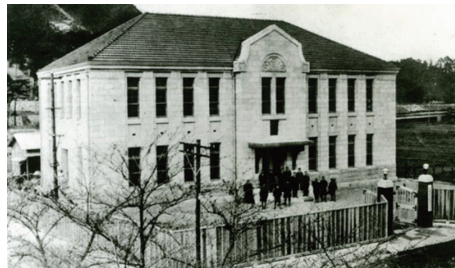
Fig. 1. Appearance of building in 1930's

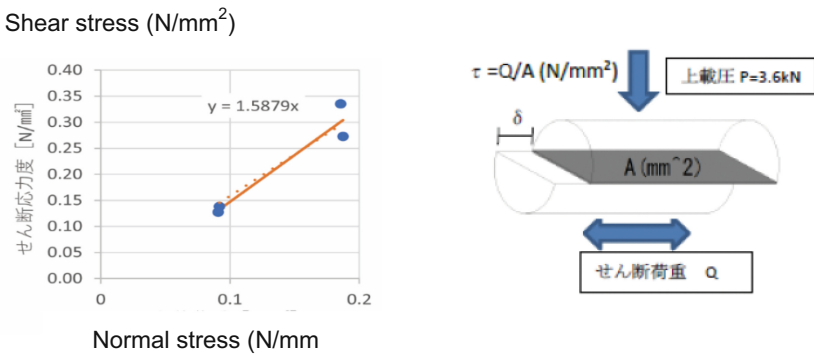
Fig. 3. Shear tests of joint

cement was already used widely in Japan during this period of the construction, it was believed that the cement was used for the joint materials. However, the bonding effect of the joints was too small to evaluate the strength, as shown in Fig. 3. On the other hand, the friction coefficient was evaluated to be approximately 1.5, because the surface of the stone that touched the joints was rather rough.

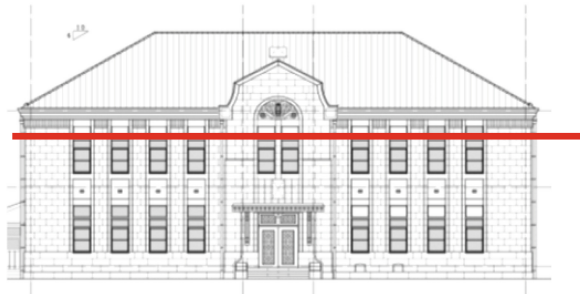
Fig. 10. Section where peak normal stress shown in Fig. 11

In order to verify the effectiveness of the prestressing force, the normal stress induced at the section of the walls was described. Figure 10 shows the section level where the peak stress is compared between before and after the reinforcement. The peak normal stress generated by the strongest earthquake ground motion by Japan Building Code is presented in Fig. 11 comparing before and after the reinforcement. It can be recognized in this figure that the reinforcement employing prestressing method is effective in reducing the tensile stress generated during the most severe earthquake. The peak tensile stress induced during the strongest ground motion was evaluated to be 155 N/mm^2 , which was enough smaller than the tensile strength of the high strength steel bar of 1080 kN/mm^2 .
