Numerical Modelling and Structural Health Monitoring for Built Heritage Management: The Case of the Church of Santa Croce in Ravenna

Francesca Ferretti^(III), Chiara Monteferrante, and Claudio Mazzotti

DICAM Department, University of Bologna, Viale Risorgimento 2, 40136 Bologna, Italy francesca.ferretti10@unibo.it

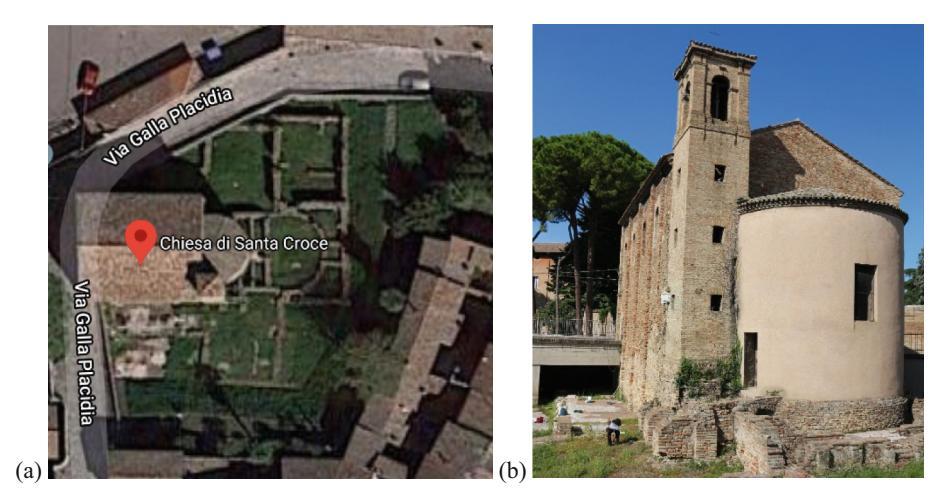
The Church of Santa Croce is located in the city center of Ravenna (Italy) within an archeological site inscribed as UNESCO cultural property since 1996 (Fig. 1). The area in which the Church is located is characterized by subsidence phenomena which, together with the conformation of the site itself, determines the constant presence of water. The area is therefore prone to sudden flood, especially in case of heavy rainfall, which have become increasingly frequent due to climate change. Currently, a drainage system allows the site to be maintained in a dry condition.

Fig. 1. Church of Santa Croce: (a) plan view from Google Maps, (b) south-east view.

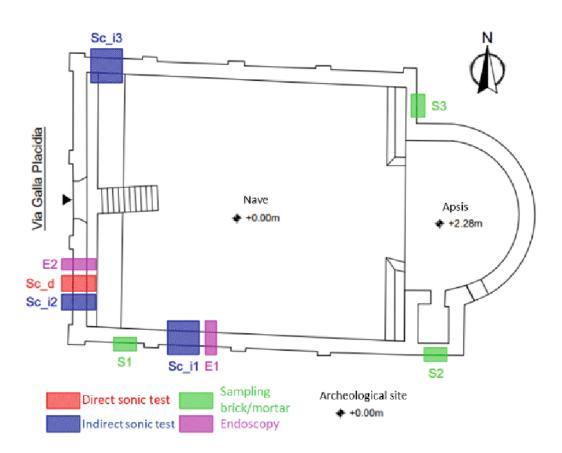
On-Site Experimental Campaign. Given the historical character of the Church of Santa Croce, non-destructive and minor-destructive on-site tests were conducted with the objective of identifying the structural details and evaluate material properties to be used in the numerical simulations. In more details, the following investigations were carried out: (i) endoscopies to detect the wall stratigraphy, (ii) sonic tests to evaluate the homogeneity of the masonry walls and the presence of cracks/defects, and (iii) sampling of bricks and mortar for the determination of their compressive strength. The test locations are reported in Fig. 4.

Fig. 4. Plan view with indication about the test locations.

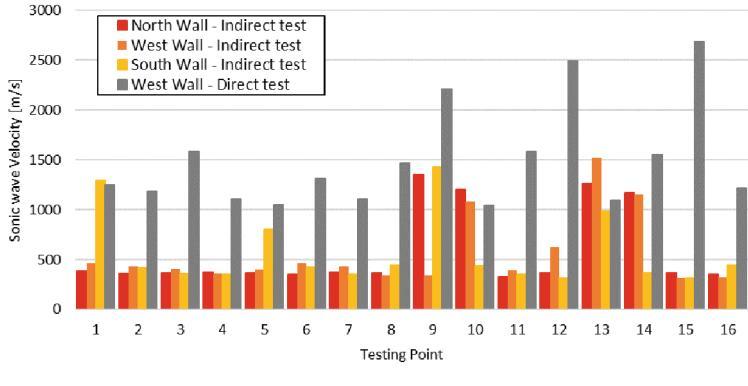
time the sonic waves take to travel, and the distance within the probes, it was possible to evaluate the wave velocity, that can be directly related to the material quality. The results of an indirect sonic test are presented in Fig. 5b, where the velocity contour plot was obtained by interpolating the results obtained at the different testing points. In Fig. 6, the comparison between the sonic wave velocities obtained for all the tests is presented. It is possible to observe that lower values of the wave velocities were obtained for the indirect sonic tests and this can be explained by the irregularities detectable on the wall surfaces, mainly due to damages and degradation of the mortar joints.

Fig. 6. Sonic test results.

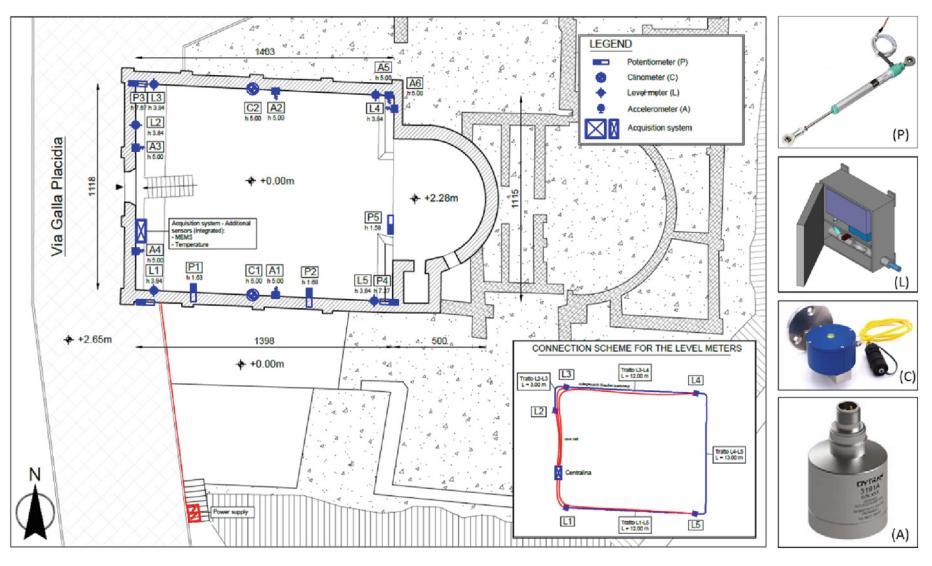
On the basis of the knowledge acquired about the state of conservation of the Church of Santa Croce, a proper design of the monitoring system was carried out by first identifying the typologies of the sensors to be adopted. Considering the subsidence problems and the pre-existing cracks detected through the damage survey, the following sensors were chosen: (i) 5 linear potentiometers, with a gauge length of 50 mm, to measure the opening of main cracks, (ii) 2 biaxial clinometers (measurement range of $\pm 5^{\circ}$, resolution equal to 0.001°) to measure rotations of the longitudinal walls, (iii) 5 level meters (measurement range of ± 40 mm, sensitivity equal to 0.01 mm) to monitor vertical displacements of the walls, and (iv) 6 uniaxial accelerometers for the dynamic identification. They were all installed inside the Church in the positions reported in the plan view of Fig. 7. A web dashboard was also developed for the real-time visualization of the data registered by the acquisition system. The data were transmitted to the web platform through wireless protocols.

Fig. 7. Monitoring system: type and positions of the sensors.

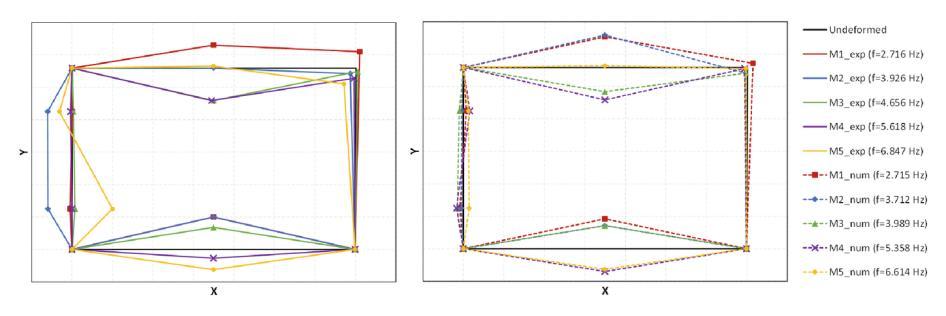
In Fig. 10, a comparison between the experimental and numerical first vibration modes is presented. Values of the displacements were taken from the FE model considering the points where the real accelerometers were placed during the dynamic testing, then normalized and amplified. As it can be seen, a quite good agreement was obtained between the experimental results and those from the calibrated model, demonstrating the reliability of the model itself.

Fig. 10. Comparison between numerical and experimental mode shapes.
