# Application of the Electrical Resistivity Tomography Technique in the Assessment of Historical Buildings in the State of Aguascalientes, Mexico

**Abstract.** Diagnosis of historic buildings is relevant because it contributes to their preservation in adequate and safe conditions; in the present work, the Electrical Resistivity Tomography (ERT) technique is applied on horizontal and vertical planes to study aspects of humidity, to recognize the internal geometry of elements, and to detect resistivity anomalies in two old buildings in the state of Aguascalientes, Mexico; these buildings are the Temple of the Inmaculada Concepción and Terán House. In the first, the electrical profiles obtained from the subsoil show a zone of low resistivity associated with a saturated layer that damages the wall due to rising dampness. On the second, the resistivity images obtained from measurements on two walls with humidity problems show the source and define some flow patterns. It could be concluded that using the obtained results ERT technique generates valuable information for the preservation of built heritage and, therefore, is viable for the diagnosis of historical buildings, mainly in the s

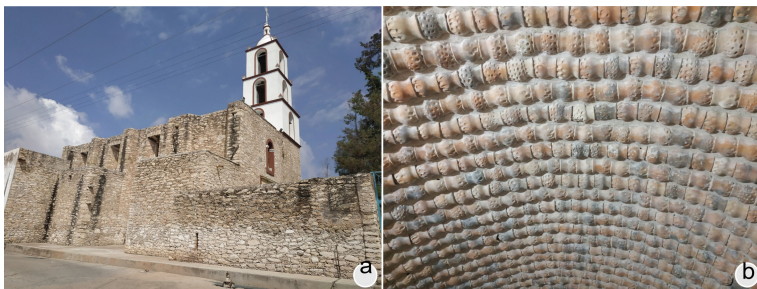
**Fig. 1.** a) Lateral View of the Temple Inmaculada Concepción. b) *Cantaritos* vault.

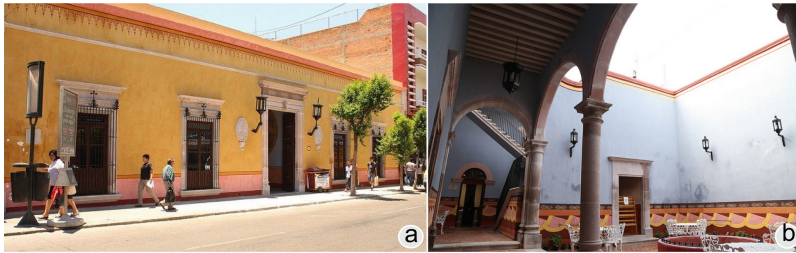
**Case 2. Terán House.** It is located downtown in the city of Aguascalientes, Mexico. Nowadays is used as Cultural Animation Center; it is considered one of the most important historical buildings in the state due to its history and architectonic richness (Fig. 2). It was built from 1775 to 1986, using mud walls and ceilings. It has an architectonic style called “Neo-style”; it is a transition period from baroque to classic. The architectonic scheme is on yards surrounded by rooms [15]. Nowadays, this building presents humidity problems on walls and vaults that gradually deteriorate it.

**Fig. 2.** a) Terán House façade. b) Terán House indoor

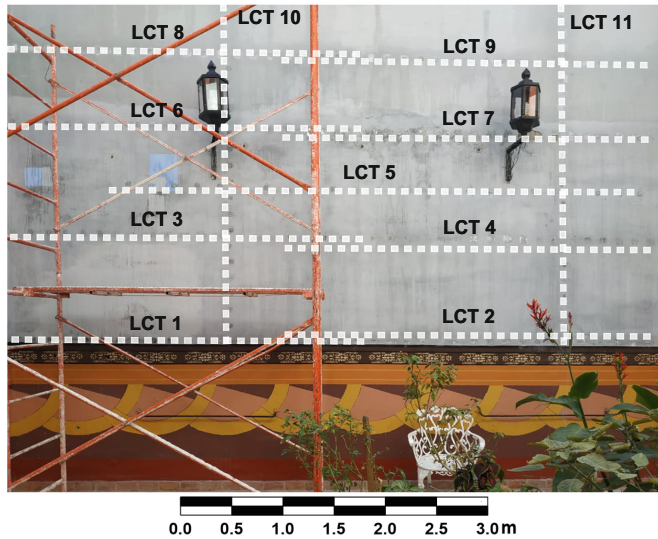
Longitudinal measurements on the wall were conducted from left to right from a height of 1.42, 2.4, 2.85, 3.4, and 4.12 m from the floor. Vertical measurements start on 1.42 m in height and end at 4.87 m from the floor. In four different heights, two continuous and longitudinal, with an overlap between lines of eight electrodes, were continuous models that covered the length of the wall (Fig. 5). The vertical lines were on the interested zones with low resistivities that resulted from the horizontal models.

**Fig. 5.** Location of the electrical lines on the wall of Terán House
