Monitoring the Combined Effects of Induced Earthquakes and Climate Change on a Heritage Building in Groningen

Abstract. Heritage buildings are often subjected to loading conditions that they were not exposed to in their earlier life span. Induced earthquakes in non-seismic regions caused by energy exploitation activities, or strains in the ground that are caused by the climate changes, are new phenomena that alter the usual loading situations for historical buildings.

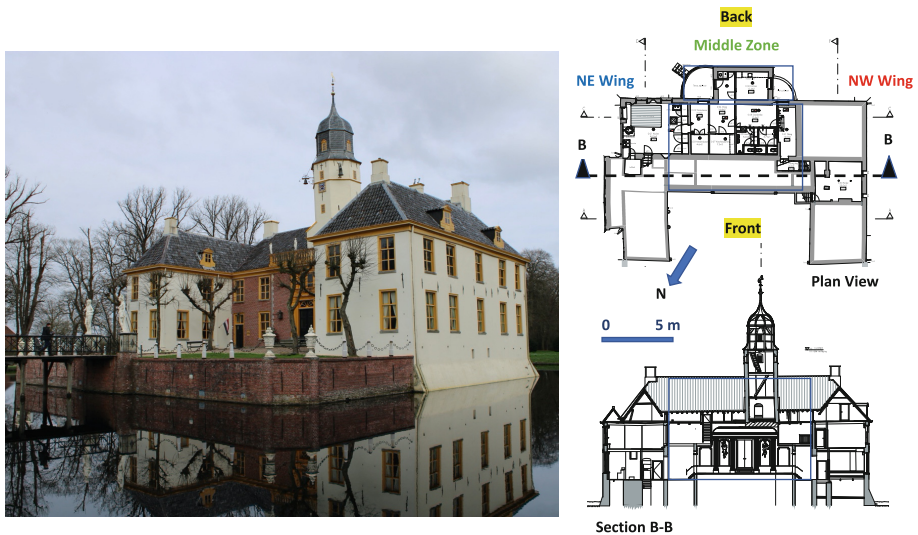
Fraylemaborg is surrounded by a manmade lake with a water depth of approximately 1.5 m. The main structure has a U-shaped plan consisting of a partial basement, two floors, roof attic and a clock tower (Fig. 1). The construction material of the load bearing walls is clay brick with additions of stones in the corners, and metal ties and timber elements in the roof. The brick-walls are solid and of varying thickness (40 to 80 cm) in different parts of the structure and the bricks are laid in English bond pattern. Six bricks, retrieved during the previous restoration works, were subjected to compression tests.

Fig. 1. Fraeylemaborg (left) and its plan views (right).
