Problems Associated with the Use of Pyritiferous Fill at Ballymun Youth Facility, Dublin

A. Brian Hawkins and Matthew Stevens

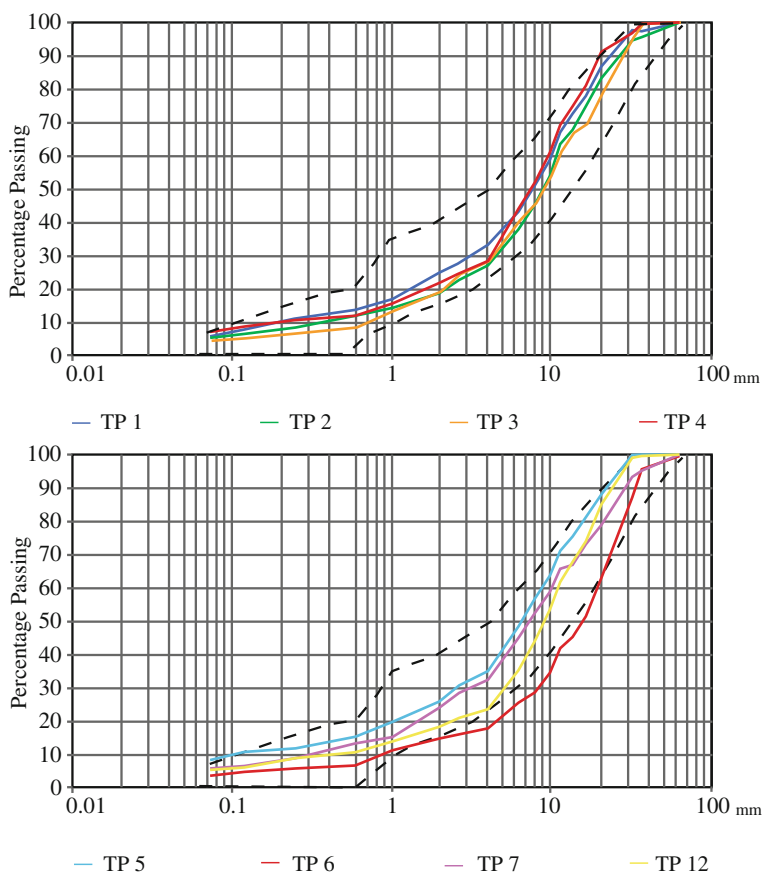
2. The particle size analysis (Fig. 21) indicated that the material generally fell within the grading envelope required for Clause 804 as specified, but that Samples 4 and 5 had slightly more fines (<0.063 mm) than stipulated. However, such a small increase in the fraction may well be a consequence of the placement/compaction processes and would not necessarily have a significant influence on the behavior of the fill if it was inert. As seen in Fig. 21, the middle fraction of Sample 6 (between 2 and 11 mm) was slightly coarser than detailed in Clause 804. Again this would not be considered problematic.

Fig. 21 Particle size of fill from TPs 1–7 and TP 12 relative to the Clause 804 grading envelope

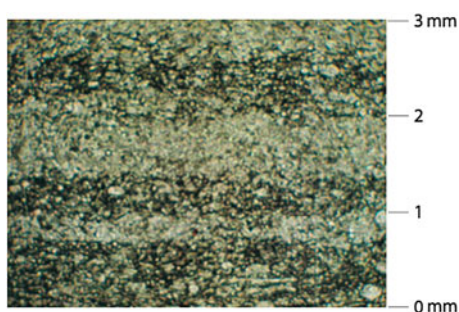
- (c) Some of the very calcareous mudstones/argillaceous limestones were laminated with clear bedding partings (shales) and many of the “more massive” calcareous mudstones contained layering/sedimentary banding where the clay-rich horizons were only some 1 mm apart (Fig. 22). These bands were also notably darker in colour and would be expected to be weaker than the general material.

Fig. 22 Layers of clay-rich material in a calcareous mudstone

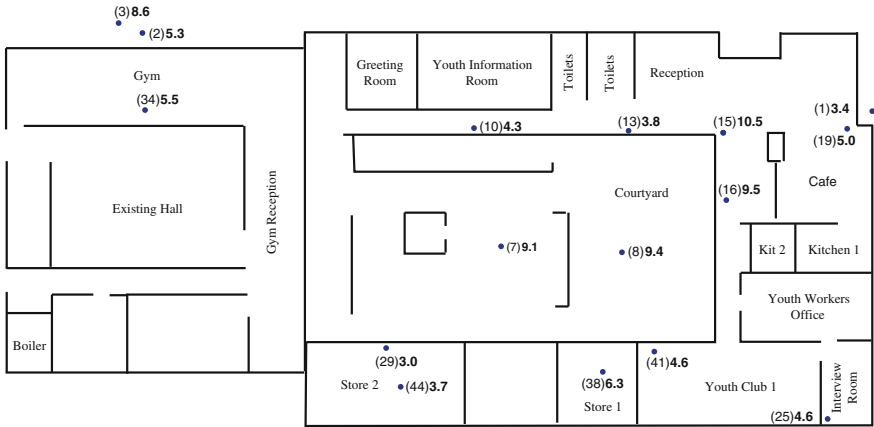
Between 11th March 2008 and 14th April 2009 sixteen readings were taken at the 45 monitoring points and the two datum points. Unfortunately, at some locations the points were damaged such that a total of 11 were only read for part of the 13 month period. Rather than provide all the detailed data here, Table 6 gives an indication of the more significant changes over this period. It should be noted that this is in addition to the rise which had already occurred prior to Mar 2008. The points which had risen by more than 3 mm between March 2008 and April 2009 are shown in Fig. 25.

Fig. 25 Levelling points showing a rise of >3 mm between March 2008 and April 2009

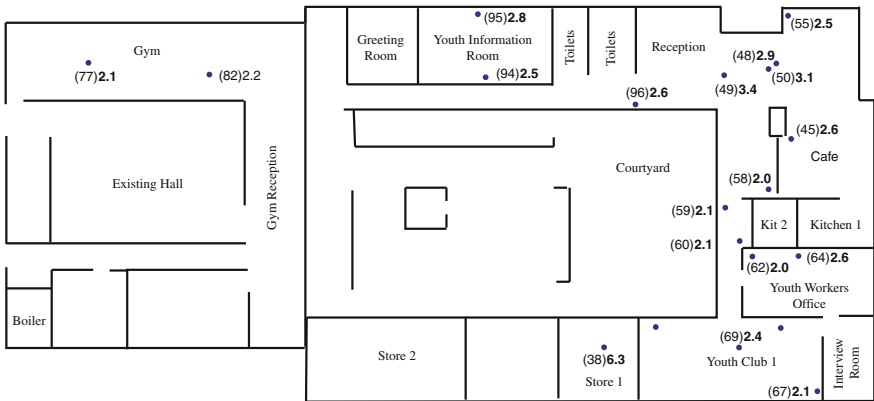
In view of the results obtained in the first six months when five showed a rise of more than 4 mm, a further 57 monitoring points were installed and read between 17th November 2008 and 14th April 2009. At nine points the floor rose by at least 2.5 mm over this 143-day period (Fig. 26). The maximum rise of 3.4 mm (L 49) was in the Reception area where there were also rises of 2.6 and 2.9 mm (L 48 and 96). In the café, at L 45, 50 and 55, the rise was 2.6, 3.1 and 2.5 mm respectively while in the Youth Workers' Office (L 64), there was a rise of 2.6 mm and in the Youth Information Room (L 94 and 95) the rise was 2.5 and 2.8 mm.

Fig. 26 Points showing a rise of >2 mm between November 2008 and April 2009

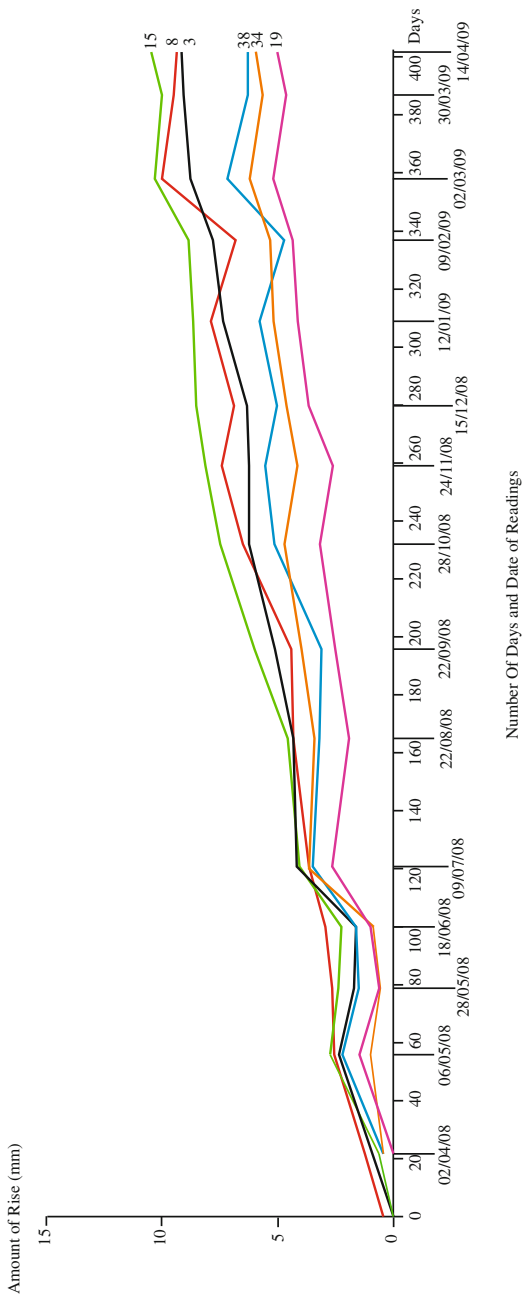
A time versus rise graph has been prepared for the six points which rose by more than 5 mm in 402 days (Fig. 27). Even allowing for possible inaccuracies related to the surveying, it is clear that the relative heave was not consistent.

- (b) Between 9th July and 22nd September 2008, the rise was not generally as fast as the overall average.
- (c) There was an apparent drop at two internal and two external locations between 12th January and 2nd March 2009. The records shows that on 9th February 2009 there was an apparent drop of 1.1 mm in Store 1 (Location 38) and 1.6 mm in the Gym (Location 34) while in the courtyard (Locations 7 and 8) apparent drops of 1.4 and 1.1 mm were recorded.

The accuracy of the survey is believed to be within 0.8 mm hence minor “blips” may be associated with the survey techniques. The sudden rise in June/ July 2008 would appear to be a consequence of quicker expansion, possibly related to a period of warmer weather. The reason for the apparent drops has not been established. Without further evidence it is considered likely to be related to the survey techniques, possibly a change in staff and/or instrumentation.

Fig. 27 Six monitoring points which rose by >5 mm over 402 days

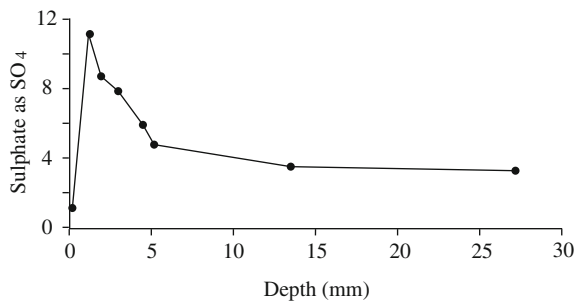
- (a) Patches of gypsum up to $>50 \mu\text{m}$ thick were present, coating part of the outer surface of the concrete (Fig. 29);
- (b) Ettringite extended up to 8 mm into the top of the ground beam (Fig. 30);
- (c) In core 6, ettringite was present in voids. As seen in Fig. 31, there was 10.6 % SO_4 at 1 mm and 7 % SO_4 at 3 mm into the core;
- (d) Thaumasite was present to a depth of 2.8 mm in the top of the ground beam and in cracks up to 1.8 mm into the concrete (Fig. 32);

Fig. 32 Fibrous thaumasite in crack around quartz particles, note crack in concrete

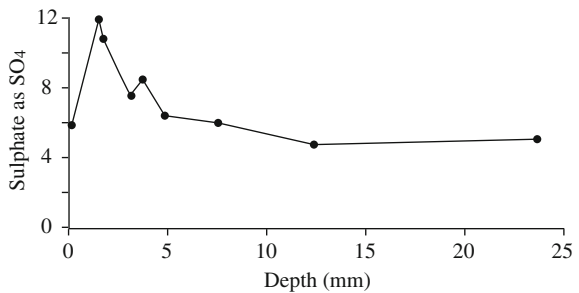
(e) At the top of the mass concrete pier, ettringite penetrated into pores and cracks by up to 5 mm. The sulphate profile from the outer surface indicates up to 11 % SO_4 by mass of cement (Fig. 33) and elevated sulphates up to 3 mm into the pier.

Fig. 33 Relationship between % SO₄ and distance from top of concrete pier
