Post-earthquake Assessment of a Masonry Tower by On-Site Inspection and Operational Modal Testing

Antonella Saisi and Carmelo Gentile

Keywords Diagnosis · Ambient vibration testing · Historic masonry structure

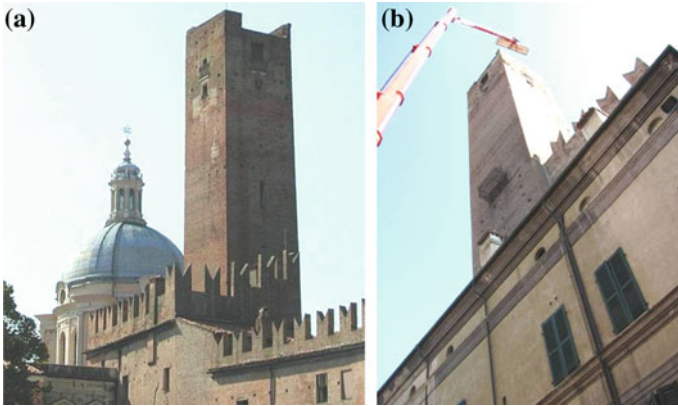
Fig. 1 Views of the Gabbia tower and the surroundings: **a** from East and **b** from South

Excepting the upper part of the tower, visual inspection did not reveal evident structural damage but only superficial decay of the materials (mainly of the mortars, due to the natural ageing and the lack of maintenance). In the lower part of the tower, the corners exhibit rare thin cracks and the masonry section appears of solid bricks and lime mortars. Subsequent pulse sonic tests and double flat jacks confirm the soundness and the compactness of the masonry of such building portion. Results from pulse sonic tests suggest compact solid brick section, with high velocity values, ranging between 1100 and 1600 m/s. Double flat jack test carried out on the N-E side at about 32.8 m from the ground level (Fig. 7) revealed that the Young's modulus is larger than 3.00 GPa. Similar information result from the laboratory tests on sampled bricks and mortars.

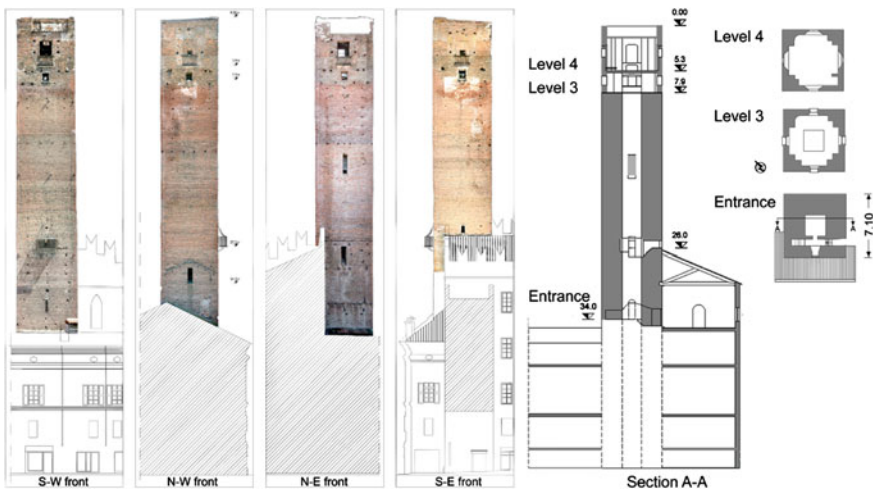
Fig. 3 Fronts and section of the tower

On the contrary, the top of the tower (i.e. the upper portion about 8.0 m high, Fig. 3) shows damage related to the detachment of the several construction phases, worsened by the natural decay (Fig. 4). In fact, settlement of the interventions and of the opening infillings coupled with the highly disordered masonry and mortar erosion causes lack of horizontality of the joints of the crowing and the development of cracks as well (Fig. 8). Critical areas are the infillings between merlons (Figs. 4 and 9), supported only by few courses of thin masonry due to the unusual

It is important to remark the change of the masonry sections and of the plan layout on *top* of the tower (Levels 3 and 4 in Fig. 3), where the continuous side wall of the nearly squared plan turns into corner masonry piers and un-toothed infillings. The decrease of resisting section is especially significant for the piers on North and South corners at level 4. As shown in Fig. 10, the corner pier at South is partially dismantled, showing an embedded pipe at the edge and the merlon shape. The lack of any mortar encrustation in the merlon surface suggests a weak connection in the other piers at the same level, as well.

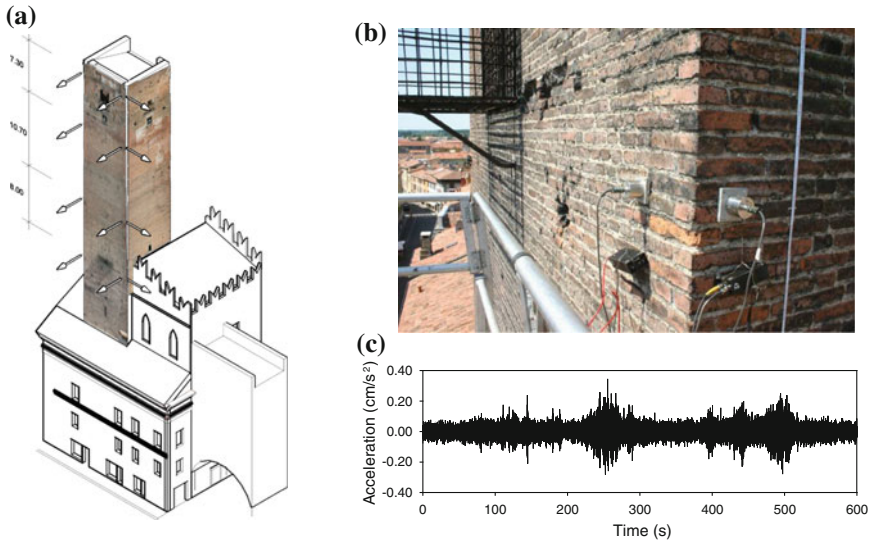
The response of the tower was measured in 12 selected points, belonging to 4 different cross-sections along the height of the building, according to the sensor layout shown in Fig. 11a. Figure 11b shows two accelerometers mounted on the corner of the lower instrumented cross-section, corresponding to the level of the hanging dock on the S-W front (about 28.0 m from the top). It should be noticed that the positioning of the accelerometers at the upper levels was aimed at checking if the change of masonry texture detected in visual inspection (and the thickness decrease of load bearing walls, Fig. 3) affects the dynamic characteristics of the tower. Hence, the upper instrumented sections (Fig. 11a) were at the crowning (about 2.0 m from the top) and just below the change of masonry texture (about 9.3 m from the top).

Fig. 11 **a** Sensor layout adopted in ambient vibration testing of the Gabbia tower (dimensions in m); **b** typical mounting of accelerometers; **c** sample of acceleration recorded at the *top* of the tower

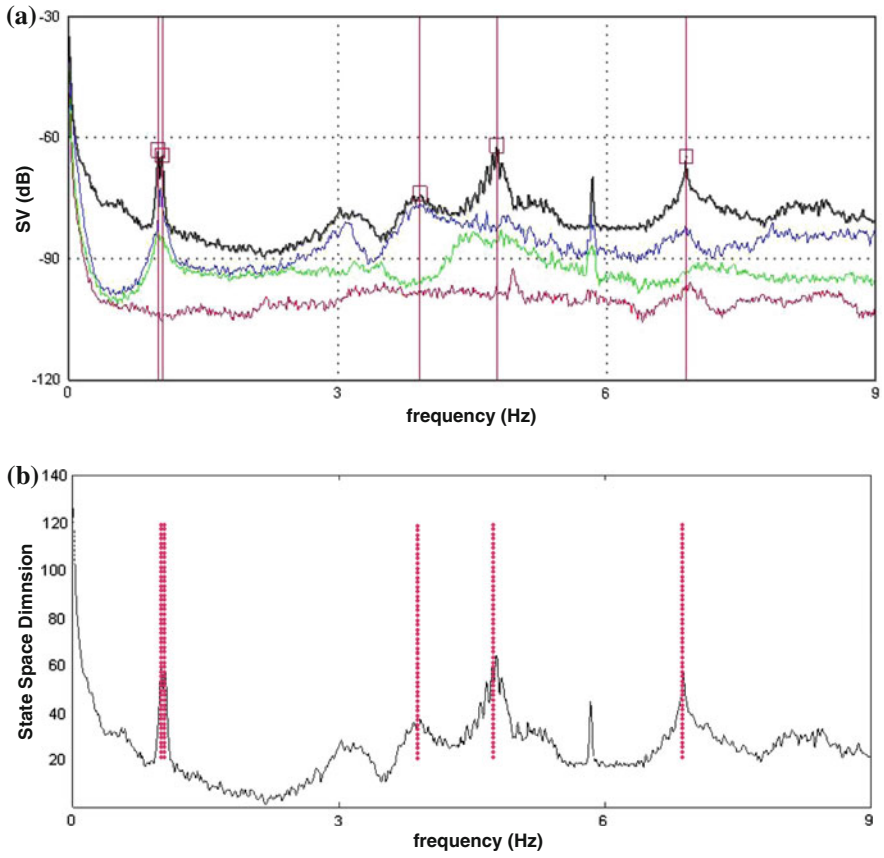
Notwithstanding the very low level of ambient excitation (Fig. 11c) that existed during the tests, the application of both FDD and SSI techniques to all collected data sets generally allowed to identify 5 vibration modes in the frequency range of 0–7 Hz.

- (a) two closely spaced modes were identified around 1.0 Hz. These modes are dominant bending (B) and involve flexure in the two main planes of the tower, respectively: the mode B1 (Fig. 13B1) is dominant bending in the N-E/S-W plane whereas the modal deflections of B2 (Fig. 13B2) belong to the orthogonal N-W/S-E plane;

- (b) the third mode B3 (Fig. 13B3) involves bending in the N-E/S-W plane, with slight (but not negligible) components in the orthogonal plane;
- (c) just one torsion mode (T) was identified (Fig. 13T1) and the corresponding natural frequency was 4.77 Hz (in the examined time window);

- (d) the last identified mode is local (L) and only involves deflections of the upper portion of the tower (Fig. 13L1). The mode shapes seem dominant bending, with significant components along the two main planes of the tower. The presence (and generalized detection) of a local vibration mode provides further evidence of the structural effect of the change in the masonry quality and morphology (including un-toothed opening infillings and discontinuities) observed on top of the tower during the preliminary visual inspection. On the other hand, both visual inspection and OMA confirm the concerns about the seismic vulnerability of the buildings and explains the fall of small masonry pieces from the upper part of the tower, reported during the earthquake of May 29th 2013.

Fig. 12 Dataset recorded on July 31st 2013, 16:00–17:00: **a** singular value (SV) lines and identification of natural frequencies (FDD); **b** stabilization diagram (SSI)

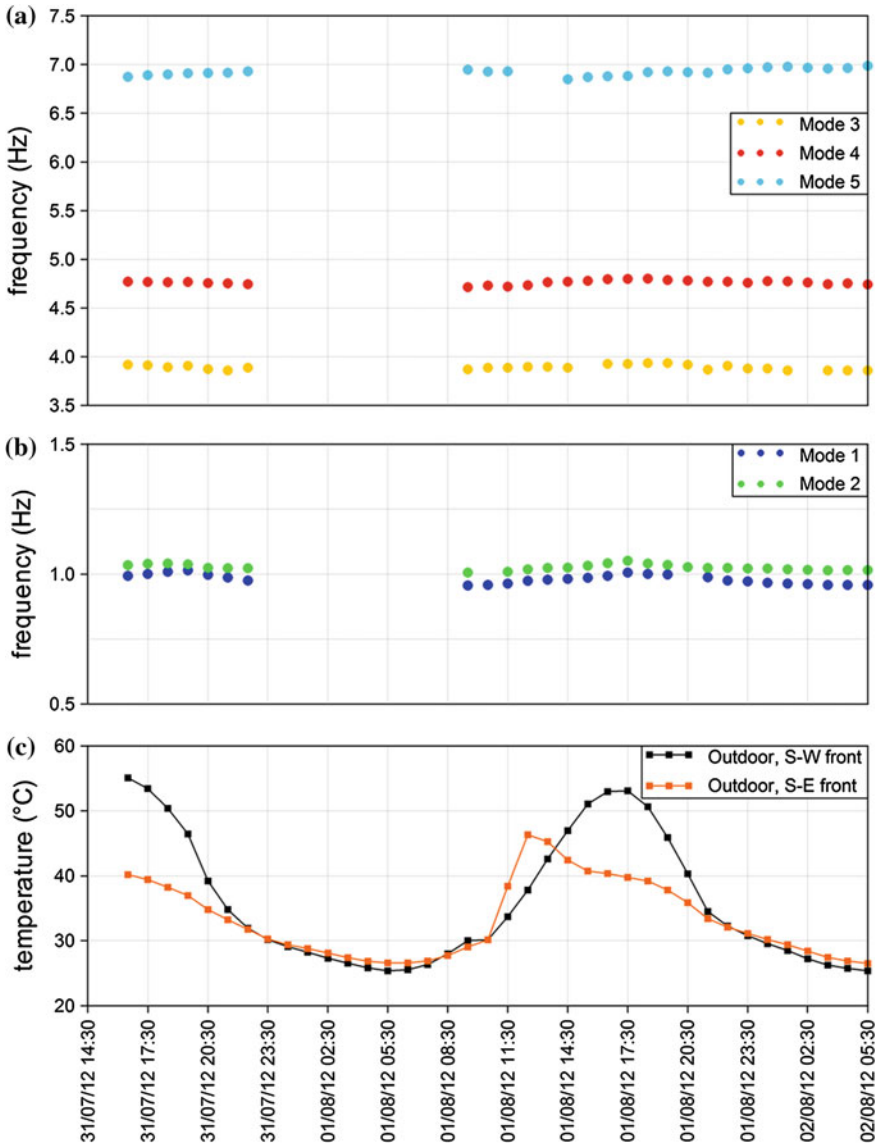
Due to the very low amplitude of ambient excitation that existed during the 28 h of acquisition, the variation of natural frequencies is conceivably related to the environmental (i.e. temperature) effects. In order to investigate the possible relationships between natural frequencies and temperature, Fig. 14 shows the evolution of natural frequencies, identified via SSI, and the hourly averaged temperature, measured outdoor on the fronts S-W and S-E. The inspection of Fig. 14 suggests that:

1. the natural frequencies of the lower modes (global modes B1–B3 and T1 defined in Table 1) seem to increase with increased temperature. This behaviour, observed also in past experiences [6, 10] on masonry structures, can be explained through the closure of superficial cracks, masonry discontinuities or mortar gaps induced by the thermal expansion of materials. Hence, the temporary “compacting” of the materials induces a temporary increase of stiffness and modal frequencies, as well;
2. for the higher mode identified (that is a local mode of vibration), the variation in time of the natural frequency seems quite different.
3. the oscillation in time of natural frequencies of lower modes seems almost perfectly in-phase with the outdoor temperature on the S-W front.

Fig. 14 Variation in time of: **a, b** the natural frequency of identified vibration modes (SSI) as defined in Table 1; **c** the temperature measured outdoor on the fronts S-W and S-E

Unlike the global modes, the natural frequency of the local mode L1 (Fig. 15e) decreases as the temperature increases and the coefficient of determination assumes a high value ($R^2 \cong 0.75$). This result suggests that the thermal expansion of materials in a very inhomogeneous area of the structure causes a general worsening of the connection between the masonry portions; hence, further evidence seems to be provided, again in agreement with the main observation of the visual inspection, of the poor state of preservation of the upper part of the tower.
