8.1 General

8.1.1 Hardware Return from Space

8.1.3 Recent Investigations Using Retrieved Materials

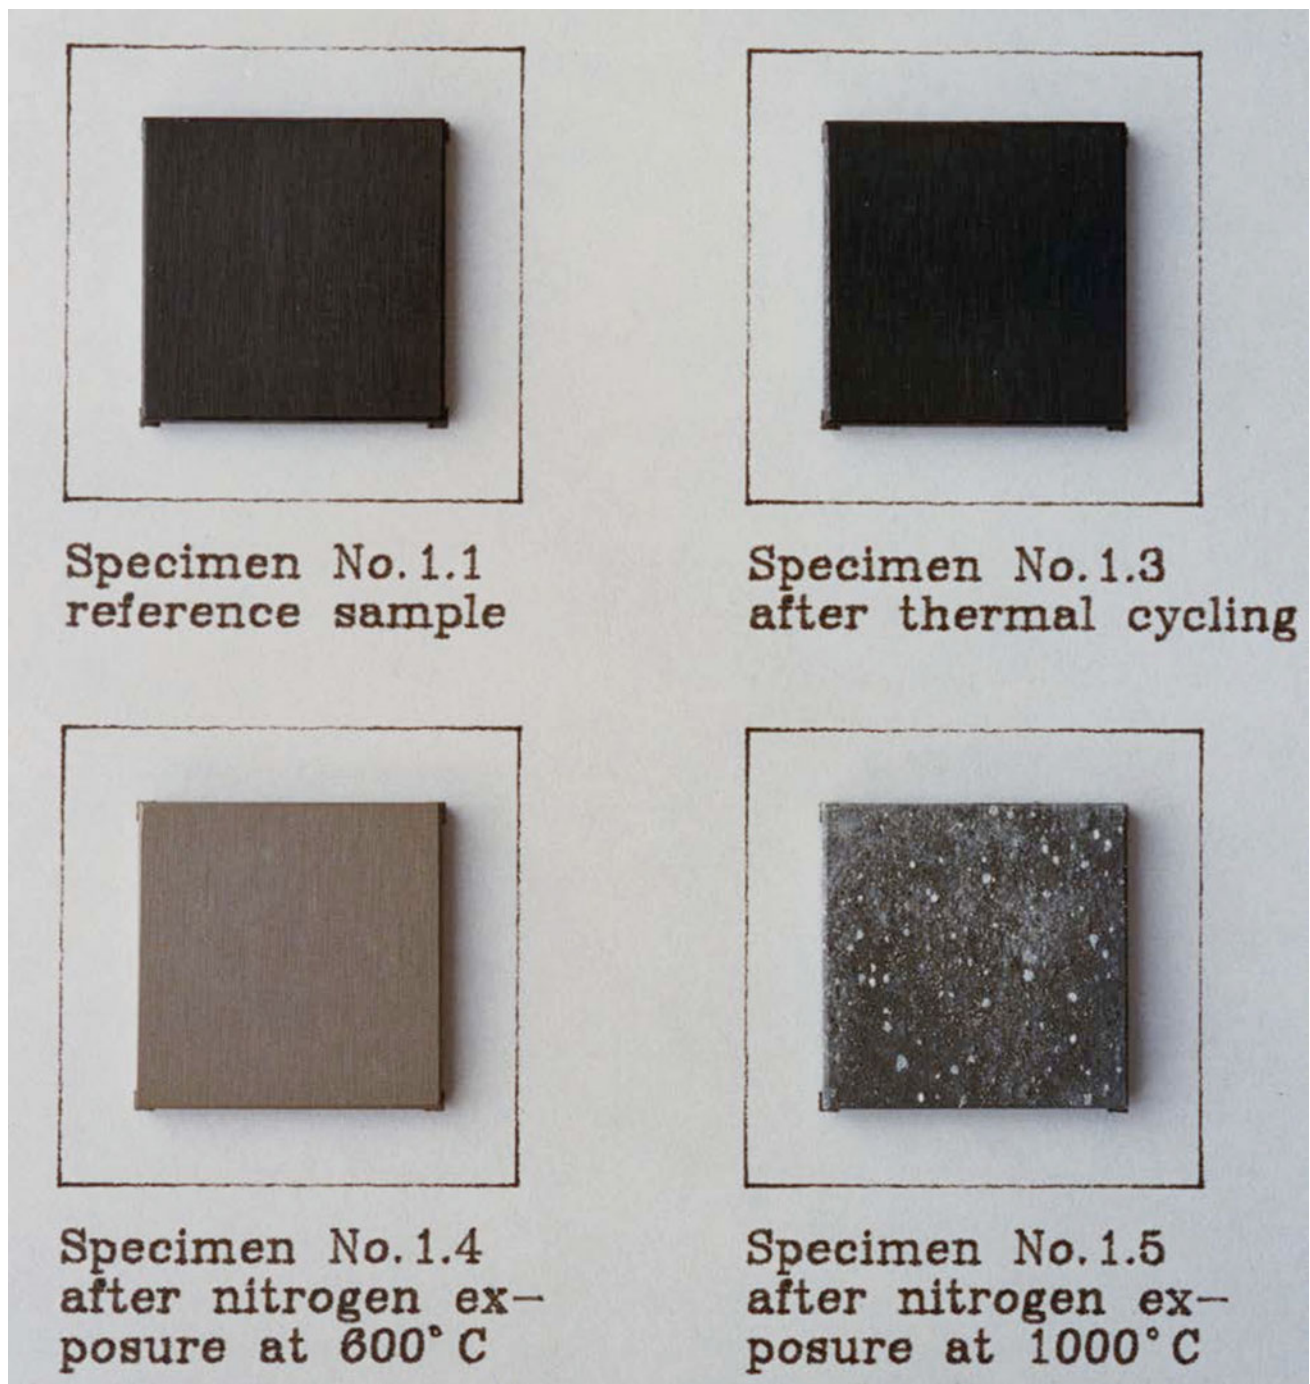
The changes in appearance of the Be-samples due to the environmental exposures were identical for the thin- and thick-anodized layers. The thin-anodized samples are shown in Fig. 8.26. The original Be-oxide layer appears dark black with the rolling texture of the Be sheet just visible. After thermal cycling there is no macroscopic or colour change (only the thick-anodized finish shows some microscopic hairline cracks). After the additional 600 °C nitrogen exposure there is a pronounced colour change to grey/ochre, but the oxide layer still shows no macroscopic defects (the microscopic hairline cracks are still seen on the thick-anodized samples). After exposure to 1000 °C in nitrogen, the surface becomes rugged. White pustules appear, their number and height being greater for the thick-anodized samples. The colour reverts to a darker grey and the rolling texture disappears.

Fig. 8.26 Change in appearance of the Be-samples after different environmental tests (Be-oxide process 1:5 μm)

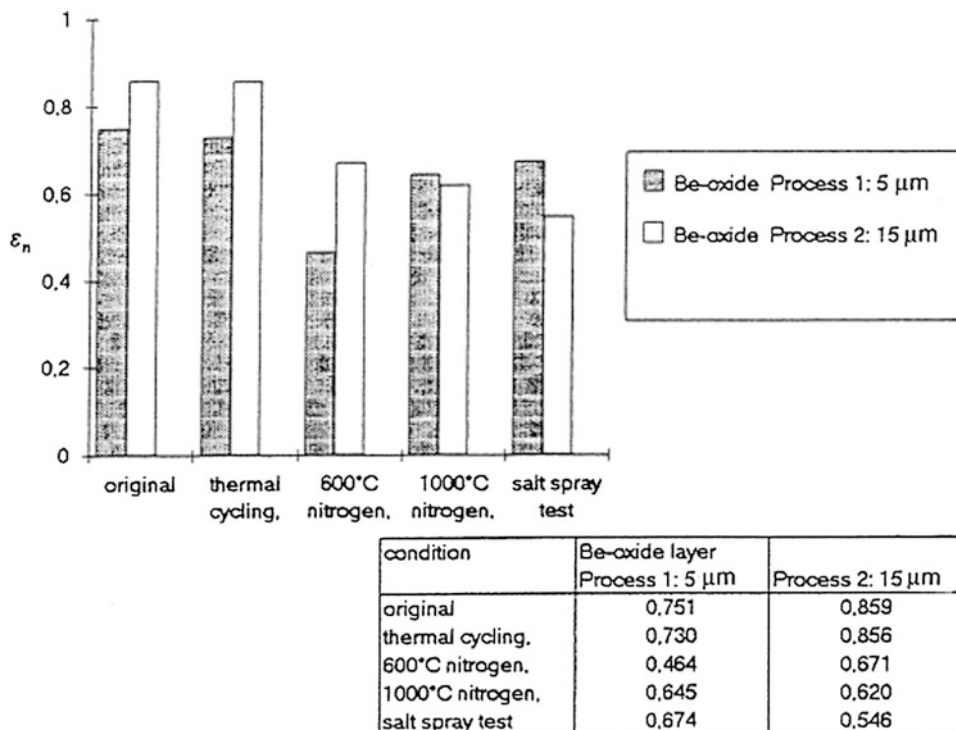
decrease of solar absorptance in the course of the high-temperature nitrogen exposure lowers the heating by Saturn/Titan and solar radiance, but is considered much less important than the observed changes in emissivity. The total hemispherical emittance (average of three samples) is shown in Fig. 8.27. The observed decrease in the emittance after the 600 °C exposure can be understood either as a change of the intrinsic properties of the Be-oxide layer, or in analogy to the

Fig. 8.27 Total hemispherical emittance, ϵ_n , of the anodized Be-samples in sequence of the environmental tests

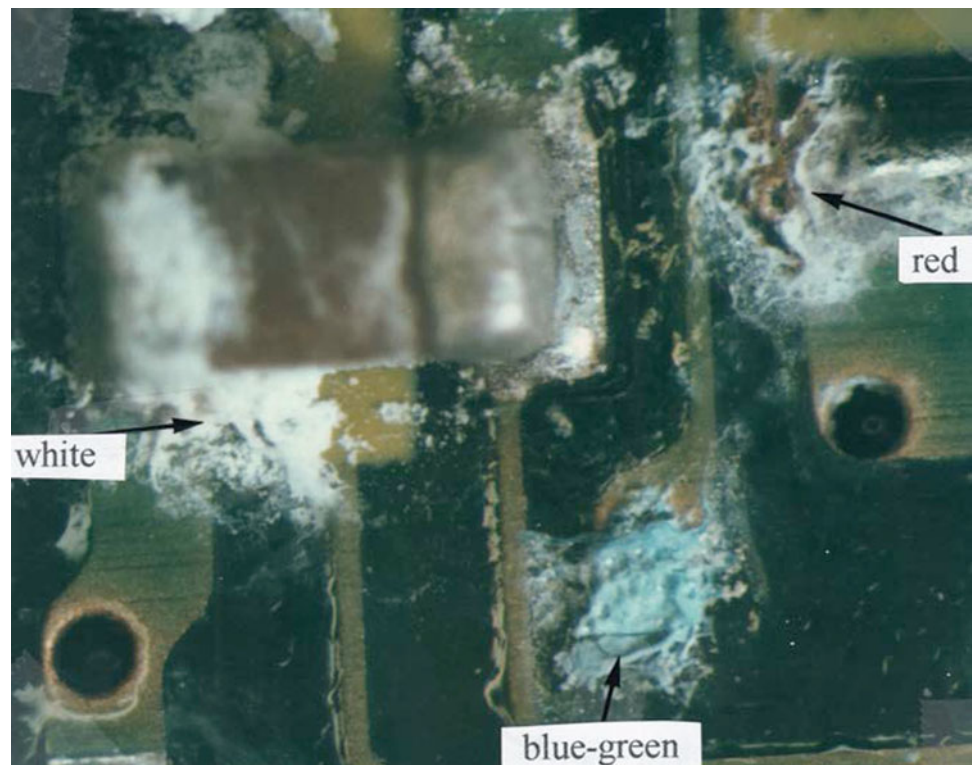
- the residues from liquid solder flux were present adjacent to many solder joints
- one typical region that supported corrosion products was photographed at a high magnification (as shown in Fig. 8.36 in the colour section), the voluminous products having characteristic colours: red, blue-green and white

Fig. 8.36 Colour photomicrograph of corrosion products seen on failed video camera electronic circuit (approximately $\times 50$ magnification)

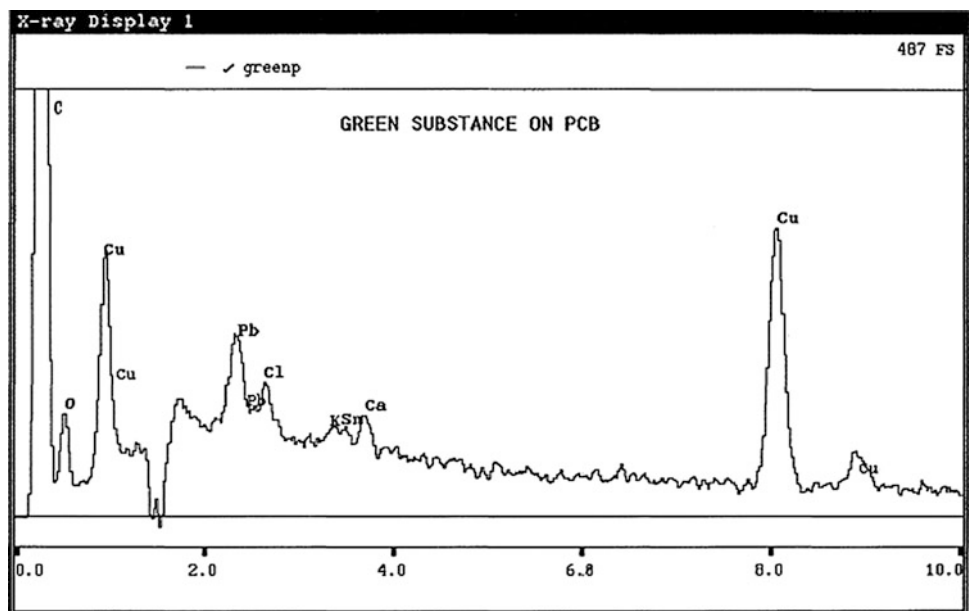
- the distinct corrosion products were carefully removed from the board and chemically analysed by energy-dispersive X-ray analysis.
- the results are given in Figs. 8.37, 8.38 and 8.39, white deposits being mainly lead oxide, blue-green deposits containing copper chloride, and red deposits containing cuprous oxide (chlorides are expected to originate from solder flux, as the AFFF liquid and original French tap water showed no white precipitation when mixed with a solution of silver nitrate—a very sensitive test for chlorides)

Fig. 8.38 EDAX analysis of green product. This contains mainly copper with associated chlorine, calcium, and lead. This is similar to 'green plague', the reaction product of solder flux with copper oxide (solder flux generally contains chlorine)

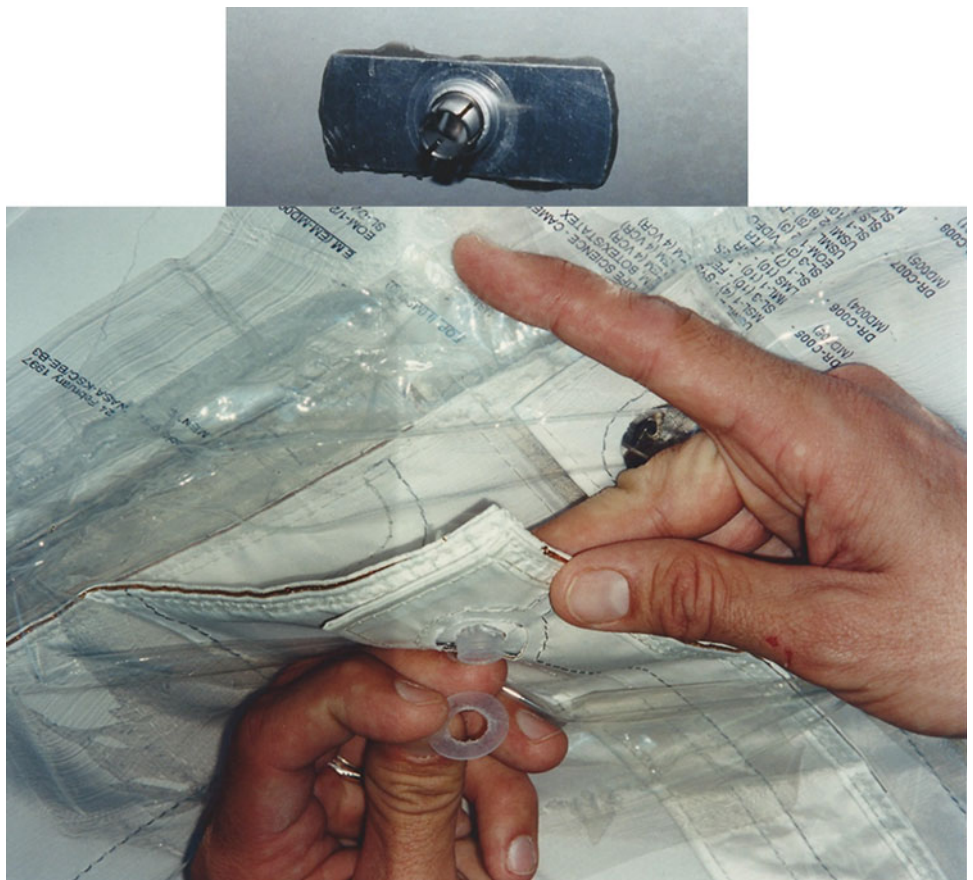
Fig. 8.47 These plastic attachment devices for holding together the blankets have a tendency to pop-off and the plastic ring, shown here, can uncontrollably spring away from the retaining groove of the tubular post (insert) during flight (creating debris)

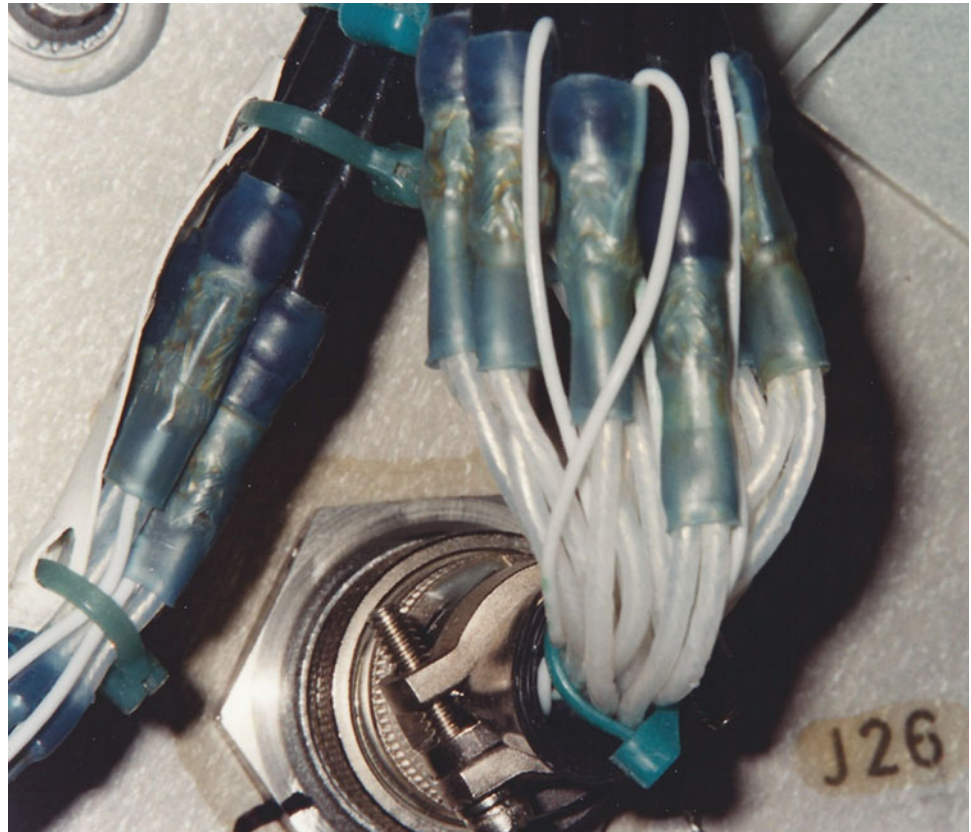
Fig. 8.51 Several wire bundles containing spliced wire joints made with Solder Sleeves. These wire interconnections would not be permitted for vacuum applications due to the entrapped solder flux and its residues (seen as a *yellow-brown* layer beneath the sleeving)

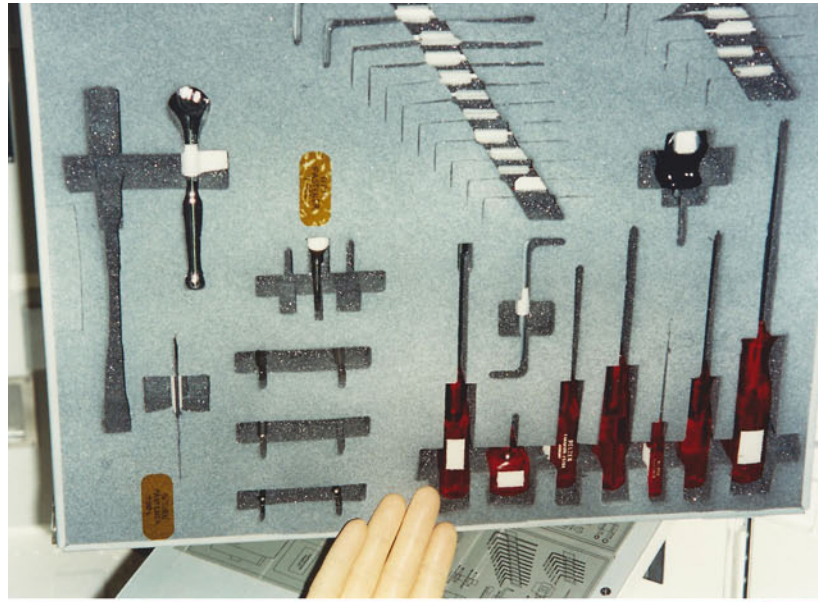
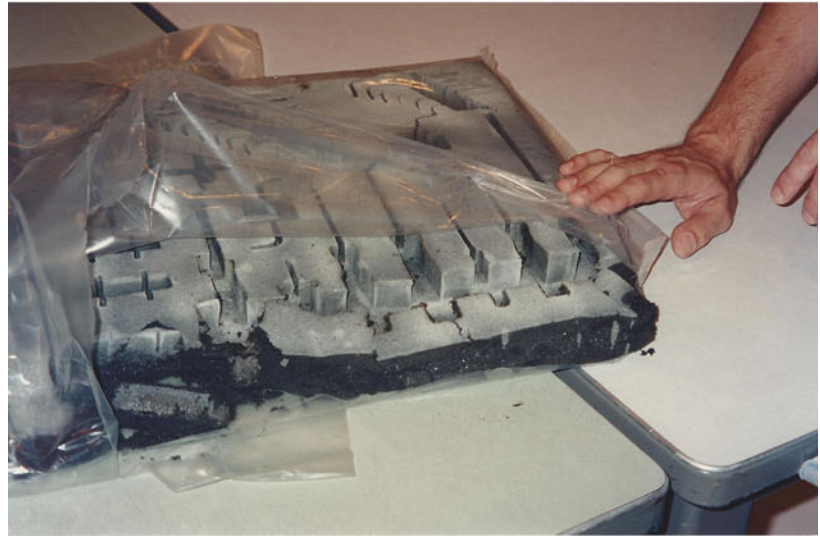
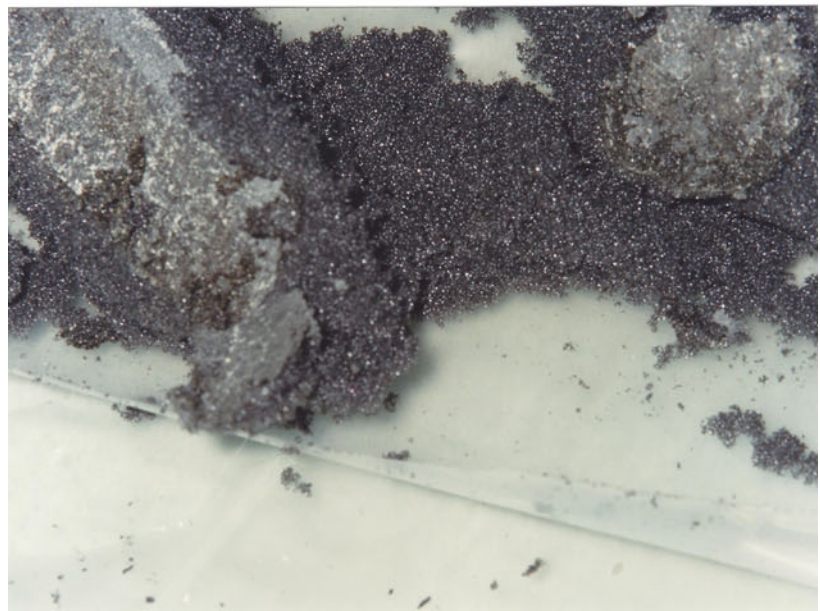
Fig. 8.52 *Top photograph* show a new on-board tool holder made from Solamide 301 foam for the ISS. It is expected to have a longer life than the Pyrel foam seen for the Spacelab tool holder. After 6 years of use the Pyrel has completely degraded. When compressed by slight handling during this inspection, it pulverises to the powder seen in the lower photograph. Pyrel foam (non-flammable, no off-gassing and non-toxic) was used for sound insulation and packaging in toolboxes, work boxes and Spacelab drawers

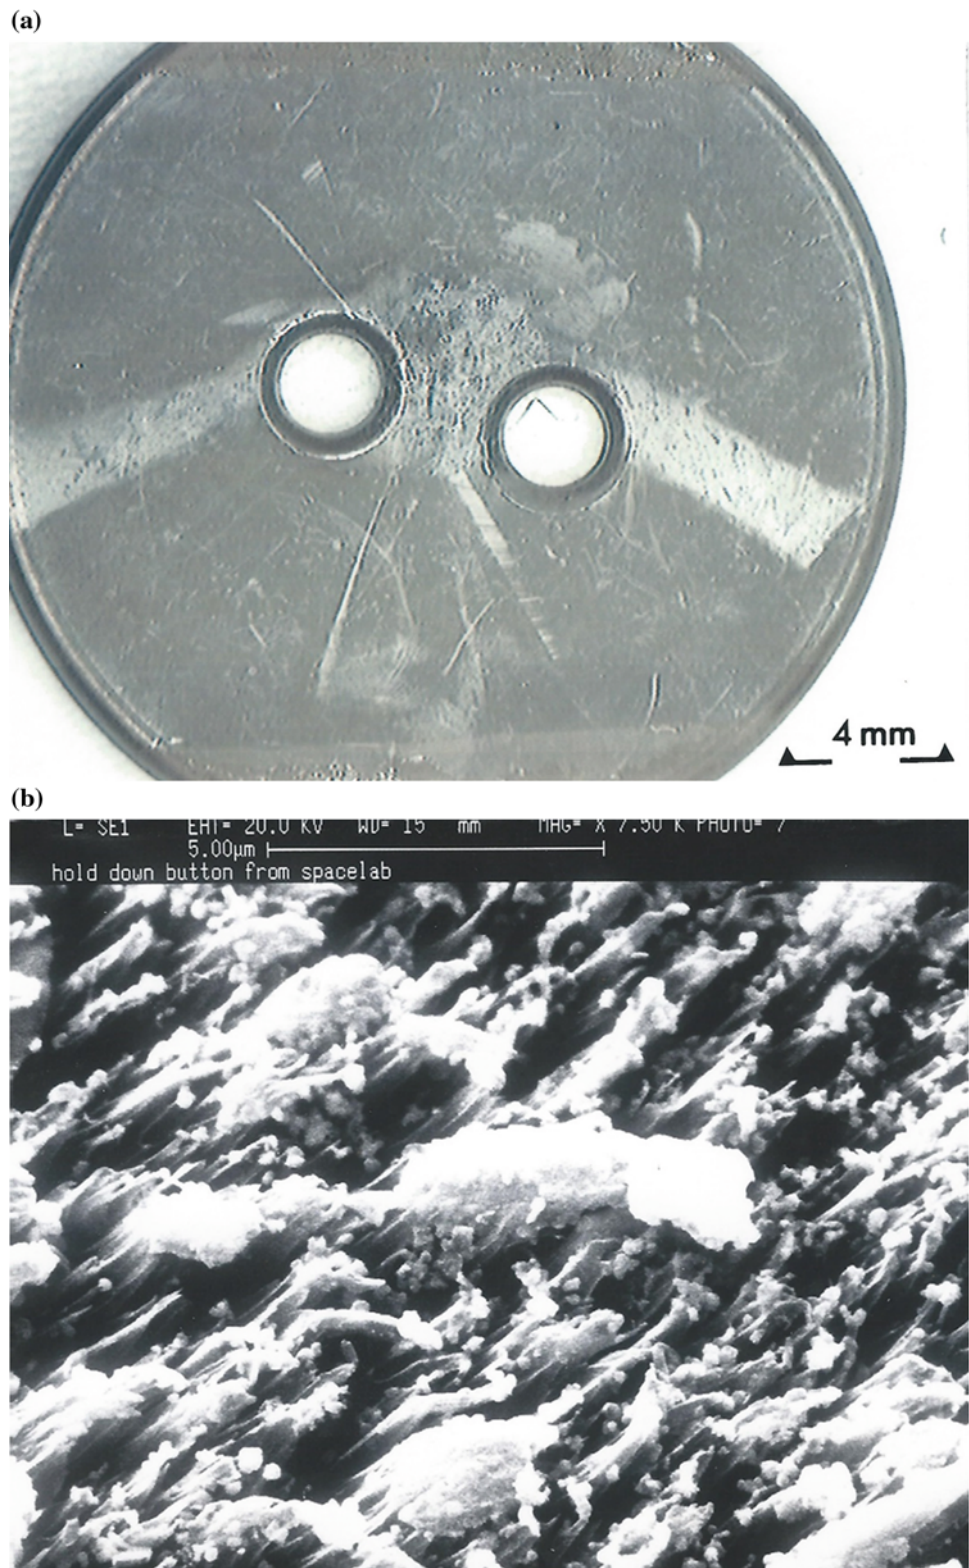
Fig. 8.55 **a** This post-flight hold-down button for the external multilayer insulation is severely attacked by atomic oxygen, the white bands show location of lacing tape (masking the button's surface). **b** SEM image at $\times 7500$ showing the typical cone-shaped features of ATOX attack on a polymer, some inorganic additives are left as white non-conducting residues on the surface
