Assessing Deterioration of an In-field RC Bridge Deck by AE Tomography

M. Fukuda, K.C. Chang, H. Nakayama, H. Asaue, T. Nishida, T. Shiotani, T. Miyagawa, K. Watabe, and T. Oshiro

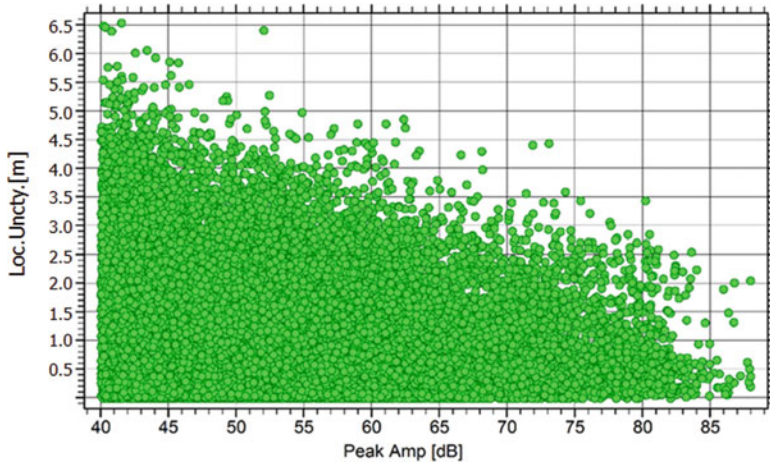
Fig. 2 Relation between peak amplitude and LUCY

AE measurement system is AMSY-6 MB19 by Vallen Systeme GmbH. Twelve AE sensors of 30 kHz resonant frequency (VS30-V by Vallen Systeme GmbH) were installed on the bottom surface of the highway bridge deck, 6 on the panel severely deteriorated (upper panel in Fig. 1) and 6 on another panel slightly deteriorated (lower panel) by visual inspection. AE activities under normal traffic loadings were monitored from 10:08 AM, 24th Dec., 2014 to 9:28 AM, 26th Dec., 2014 and a total of 29,438,265 AE events were acquired. Most of AE data obtained in-situ measurements are secondary AE induced by traffic loads. The relationship between the AE peak amplitude and LUCY (Location Uncertainty, defined in VisualAE[®]) [4] is shown in Fig. 2. It shows that as the peak amplitude increases, the number of AE events and LUCY decrease. Herein, the threshold was set as 60 dB for peak amplitude and 0.3 m (half of sensor spacing) for LUCY, i.e., AE events with peak amplitude smaller than 60 dB and a LUCY larger than 0.3 m are filtered out for further analysis.

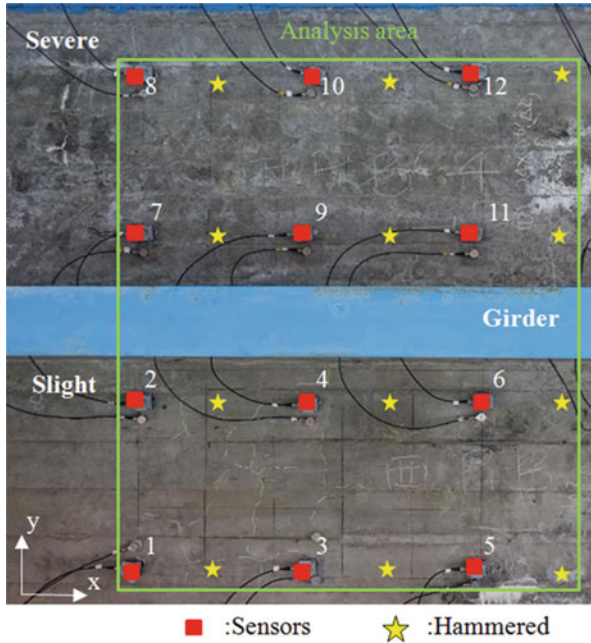
Fig. 5 Area of tomography analysis and hammering points

Elastic wave tomography analysis (see [1, 2] for detailed algorithm) was also implemented using hammering impacts. Area of tomography analysis and hammering points are shown in Fig. 5. In the elastic wave tomography analysis, velocity distribution of surface or measured media is acquired. It is known that the velocities tend to be high when the media is uniform and sound. The elastic wave velocity distribution overlaid with AE sources location is plotted in Fig. 6. It is observed that AE of large amplitude occurred at moderate-velocity areas (3300–3800 m/s) and the boundaries of low-velocity areas (3300 m/s or lower); fewer AE occurred at high-velocity areas (4100 m/s and higher) and low-velocity areas.

This observation can be explained in mechanical sense as follows. In high-velocity areas, which are generally regarded as sound areas, AEs are inactive and

their amplitudes are small because there are little defects causing internal frictions. It means that crack interface is mostly contact in this area. Therefore, this result indicates less defects area. In the low-velocity areas, which are regarded as highly deteriorated areas, AEs are inactive as well since the defects like cracks have fully developed and little new defects propagating. This area can be estimated as crack interface with less contact; AEs are difficult to generate because of less friction. The area is regarded as a defected area.

As for the moderate-velocity areas and the boundaries low-velocity areas, AEs are active and their amplitudes are large due to the propagation and frictions of newly developing defects. It is estimated that the results of velocity structures indicate edge of clacks. AEs are easy to generate in the area because clacks will make progress at this area. Fatigue damage by traffic load has been progressing during the measurement.

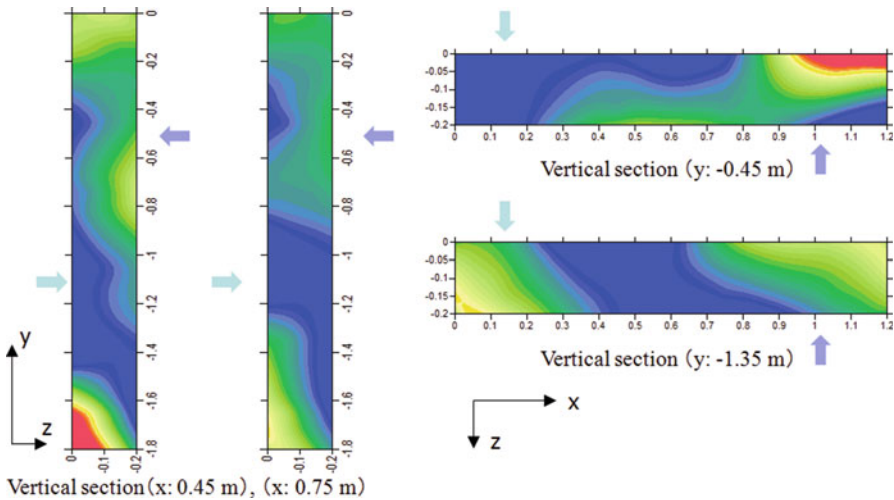
Fig. 10 Elastic wave velocity distribution (x-axis and y-axis)

3D elastic wave velocity distribution from 3D AE tomography analysis is shown in Fig. 8, where variations of the internal velocity can be observed. The elastic wave velocity distributions extracted at the horizontal planes $z = -0.05$ and -0.15 m are shown in Fig. 9. Near the bottom surface of the deck ($z = -0.05$ m), low velocity areas were observed and those areas were considered as deteriorated areas. On the other hand, at the plane $z = -0.15$ m, high velocity was observed in most areas, which indicated the internal deterioration was less progressed than the surface. The velocity distributions at cross-section of $x = 0.45$ m, 0.75 m and $y = -0.45$ m, -1.35 m, are shown in Fig. 10. It was observed that velocity distributions were not uniform in the concrete deck and low velocity (around 2000 m/s) areas were distributed below the depth of 0.1 m measured from the bottom surface (the sensor side). As mentioned above, 3D AE tomography analysis would be able to visualize the interior distribution of concrete quality, which is unavailable by both the 2D AE tomography analysis and conventional visual inspection.
