Large Area Nondestructive Evaluation of a Fatigue Loaded Composite Structure

Joseph N. Zalameda, Eric R. Burke, Michael R. Horne, and Eric I. Madaras

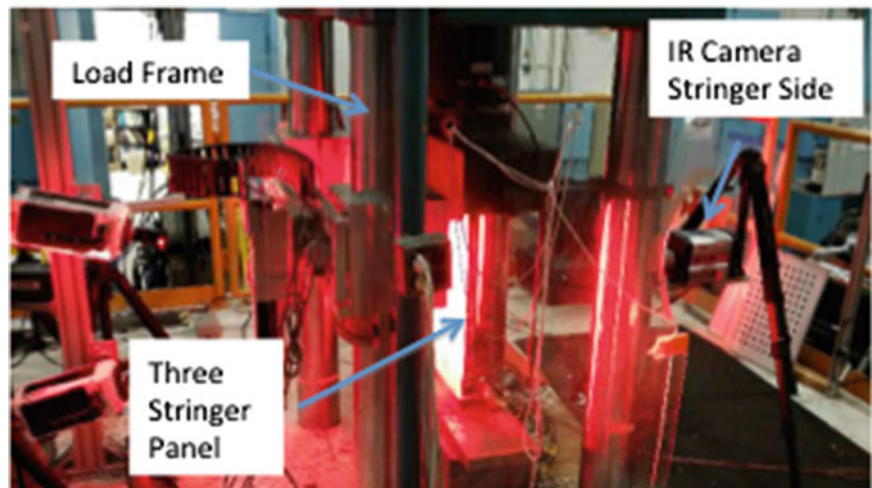
Fig. 4.2 Fatigue loading setup for three-stringer panel

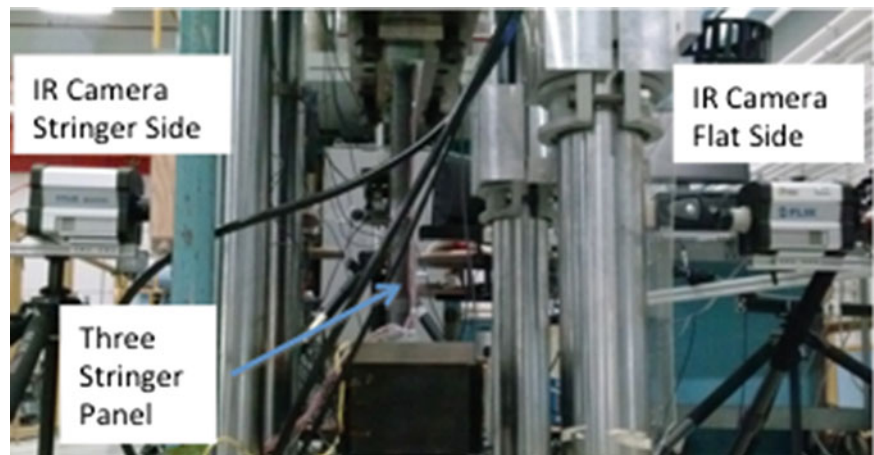
The thermal measurement setups are shown in Fig. 4.3. The basic system consists of two IR cameras operating in the 3–5 μm (midwave) IR band and an image data acquisition computer. The IR cameras were both configured with 25 mm germanium optics. The focal plane array sizes for the cameras were 640×512 and 1024×1204 . The passive inspection captured the thermal variations during the fatigue loading. The setup required a Plexiglas[®] shield to contain fragments if ultimate failure occurred. The IR cameras were located behind the shield with the lens positioned in front of a viewing hole. The added benefit of the shield is it filters out spurious IR background sources. The cameras were synchronized using the load signal from the test machine. The sinusoidal load signal was offset corrected and the zero crossover points were used to produce a TTL trigger signal. The trigger signal was converted to a series of pulses using a signal generator. The IR cameras were operated at a frequency range of 16–90 Hz depending on acquisition time duration. Higher frequencies were used to capture the damage progression as the panel approached ultimate failure. The thermography data were processed using an image differencing technique [5]. Ultrasonic inspections were implemented at intervals determined by the indication of damage growth from thermography and acoustic emission. The ultrasonic inspection technique utilizes a broadband 10 MHz transducer (1.27 cm diameter with 5.08 cm focus) contained in a captive water column with a flexible membrane tip design [1]. Water is misted onto the surface for ultrasonic coupling. The probe is scanned over the entire panel on the flat side. A picture of the ultrasonic probe is shown in Fig. 4.4.

Fig. 4.3 Three-stringer panel setup for passive thermography inspection of both flat and stringer sides

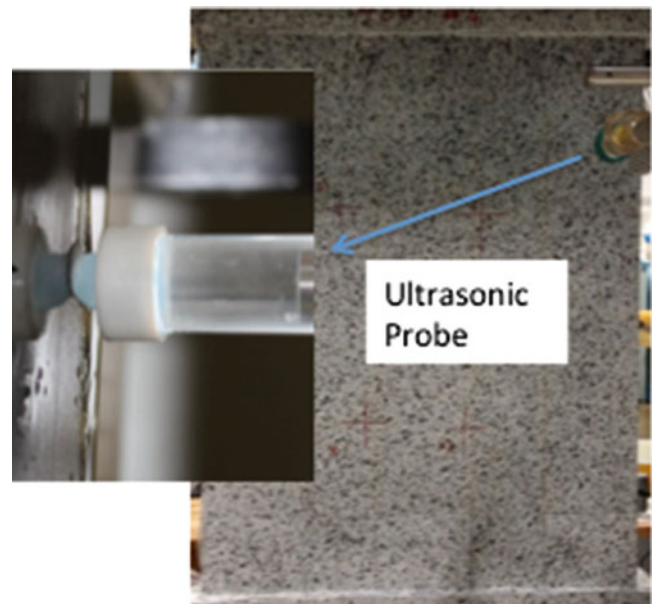
Fig. 4.4 Close up of ultrasonic probe

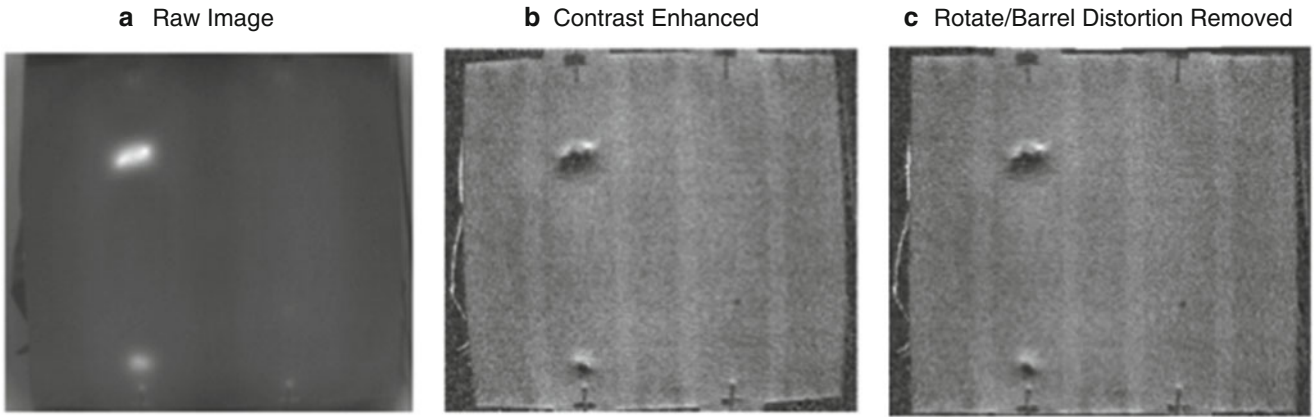
An image processing routine was developed to map the acoustic emission data onto the thermal imagery. The procedure is shown in Fig. 4.7 along with some example thermal images. This method required improving image contrast, removing angular rotation, and correcting for optical barrel distortion. In addition, the resolution per pixel was determined by measuring known distances on the composite structure. The acoustic emission data were then mapped onto thermal imagery, revealing the cluster of acoustic emission event locations around the thermal signatures of interest. The removal of angular rotation is performed using an affine transformation [13]. The barrel distortion is corrected using an image forward transformation given by the equation below [14].

Cartesian vector distance from the center of the image. The parameter d was set to 0.2 to remove the distortion. The pixel resolution was calculated to be 8.2 pixels per cm. A comparison of the contrast enhanced, rotation corrected and barrel distortion thermal images are shown in Fig. 4.7b and c. The image in Fig. 4.7c is used to map the acoustic emission data.

Fig. 4.7 Procedure to process thermal imagery for mapping of acoustic emission data
