# Historic Renders and Their Weathering at the Temple Wat Mahathat, UNESCO World Heritage Site of Ayutthaya, Thailand

H. Siedel, E. Wendler and B. Ullrich

**Abstract** Investigations of renders on buildings of the temple Wat Mahathat in Ayutthaya showed that two different types of mortars have been applied. The original mortars from the period before 1767 are lime mortars, whereas hydraulic mortars were obviously used for restoration and stabilisation of the ruins in the 20th century. The use of organic additives like starch from boiled rice for historic mortar production is suspected, but could not be proved by analytical means. The analysis of probable additives is made more difficult due to microbiological activity in tropical climate which might have led to enzymatical decomposition of the primary organic compounds. The porosity and the hardness of renders, analysed in situ by easily applicable, non- or less-destructive investigations like Karsten tube measurements and drilling resistance, reflect a wide range of different weathering states. Therefore, appropriate restoration measures must be planned in detail for every part of the buildings; an overall treatment with water r

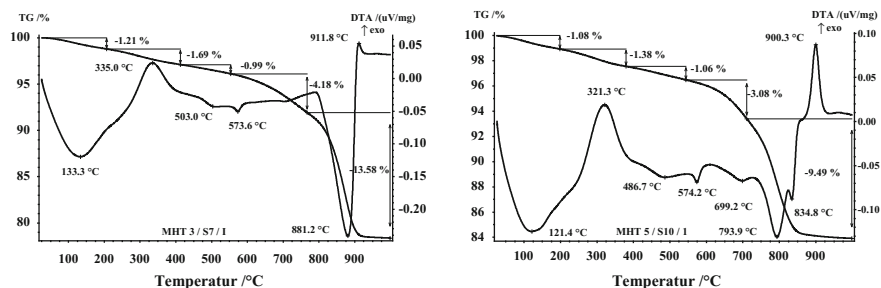
**Fig. 2** Typical DTA/TG diagrams of mortars from Ayutthaya: MHT 3/S7 I (lime mortar/stucco, left) and MHT 5/S10 I (hydraulic mortar, right)

mortars (MHT 1/S2, MHT 2/S6, MHT 3/S7, and the joint mortar MHT 6/S13) and hydraulic mortars (MHT 1/S3, MHT 4/S8, MHT 5/S10 and MHT 6/S12). At least some of the latter seem to be modern cement mortars with little calcite, which might have been produced by carbonation of the surface layer. They are regarded as materials of younger restoration measures from the 20th century, which are not well documented at Wat Mahathat. EDS analyses of binder areas in a thin section of MHT 6/S12 under the SEM showed high contents of SiO<sub>2</sub> beside CaO (in a relation of about 1:2). The formation of a wollastonite phase (CaSiO<sub>3</sub>) and no or little lime (CaO) after 1000 °C heat treatment suggests a remarkable content of reactive SiO<sub>2</sub> in the binder, whereas the mortars with high calcite contents form high lime

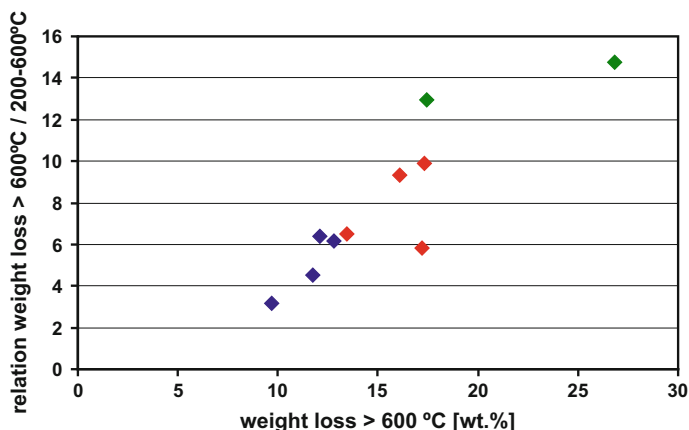
Figure 3 shows the relation of the weight losses according to TG at temperatures between 200 and 600 °C (mainly assigned to hydraulic phases which cannot be clearly distinguished in thermal analysis due to their continuous weight loss over a wide range of temperatures, cf. Fig. 2) and >600 °C (assigned to carbonate phases; Moropoulou et al. 1995, 2005) for all investigated samples. The weight loss between 200 and 600 °C used for calculation was corrected by subtracting the weight loss assigned to ignition of organic matter, indicated by an exothermic reaction in DTA (see below). The results, which are in good accordance with the results of XRD analysis (cf. Table 2), allow to distinguish between the pure lime mortars (samples MHT 2/S6 I and II, green), weakly hydraulic limes (MHT1/S2 I and II, MHT 3/S7 I, MHT 6/S13 joint, red) and hydraulic limes (blue).

**Fig. 3** Weight losses in TG indicating carbonate phases vs. those indicating hydraulic phases (Moropoulou et al. 1995, 2005) for the investigated samples. Green: pure lime mortars (MHT2/S6); red: slightly hydraulic mortars (MHT 1/S2, MHT 3/S7 and MHT 6/S13), blue: hydraulic mortars (MHT 1/S3, MHT 4/S8, MHT 5/S10 and MHT 6/S12) (Color figure online)

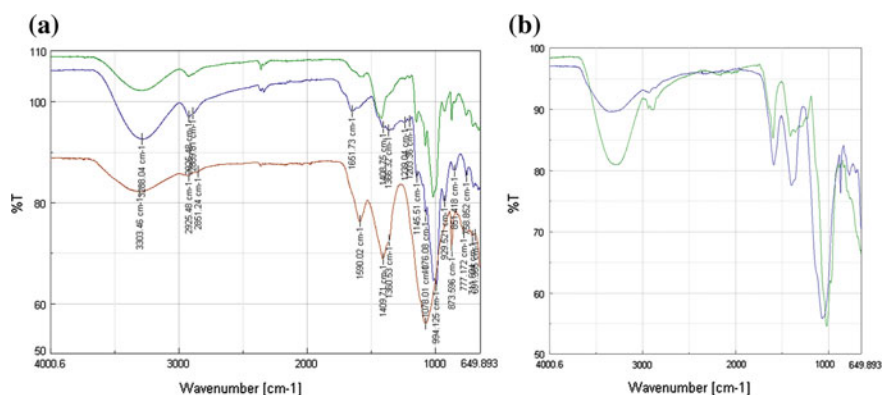
As expected from Table 3, the FTIR spectrum of sample MHT 1/S3 II does not fit to the vibration bands of starch extracts (Fig. 5a). However, C–H-vibrations at some  $2900\text{ cm}^{-1}$  can be clearly recognized. Comparing with the spectrum of gum arabic (Fig. 5b), there is a much better correlation though there are some deviations in the fingerprint region due to contaminations with clay and lime. Identical (gum) spectra have been obtained with samples MHT 1/S2 II and MHT 3/S7 I. Some of the samples contained small amounts of oils, and the joint mortar sample MHT 3/S7 I even showed some trace of a nitrogen-organic compound (but no protein could be found).

**Fig. 5** **a** FTIR-Spectra from: hot water extractions of starch-containing reference mortar (green) and of sample MHT 1/S3 II (brown); water from boiling rice (blue); **b** FTIR-Spectra from hot water extractions of: sample MHT 1/S3 II (blue) and gum arabic (green) (Color figure online)
