# Some Examples of Incomplete Diagnostic Analyses of Industrial Machinery

Nicolò Bachschmid<sup>(✉)</sup>

**Abstract.** Diagnostic tasks on industrial machinery can sometimes be dealt basing only on previous experience with successful model based identification techniques. This may be required when necessary time and resources for complete diagnostic analysis are not available. Some examples of machines affected by malfunctions that have been more or less successfully analyzed, often without resorting to machine specific models, are presented. Journal ovalisation in a HP-IP steam turbine was identified in the first example, the vibration changes in a LP steam turbine could be attributed to coupling misalignment and to a loose last stage blade of the shaft in the second example. Rubs and thermal bow combined to axial shaft expansion restriction could explain the severe vibrational behavior of a steam turbine that prevented its operation in a third example. The abnormal noise of a vertical shaft generator of a hydroelectric power plant was attributed to a structural resonance excited by electromagnetic forces in a third example, where the diagnostic process was completed by validat

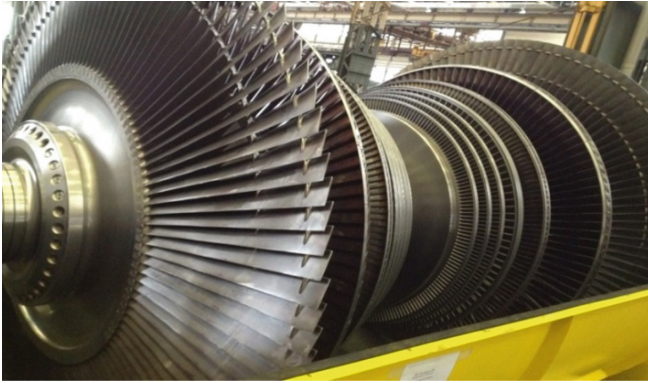
The double flow LP steam turbine rotor, shown in Fig. 3, was supported on two lemon shaped bearings, each one equipped with two proximity probes. The measurements showed a behavior with rather high vibration amplitudes, especially on the bearing which was close to the connecting flange with the HP-IP rotor, which also was affected by high vibrations in the higher speed range. This behavior was attributed to an angular and radial misalignment of the two shafts due to coupling flange tightening after a foundation settlement that had been discovered and measured only recently.

**Fig. 3.** Double flow low pressure steam turbine rotor after finishing at factory

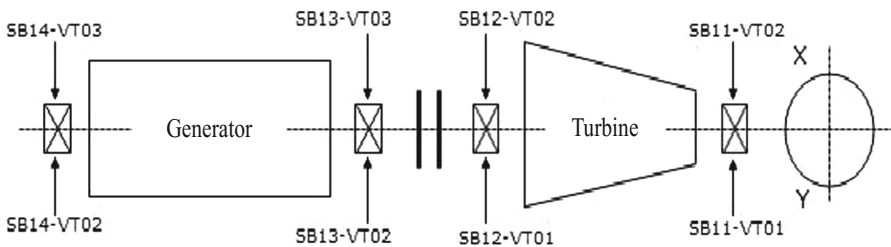
The 100 MW power generation group shown in Fig. 6 while increasing output power after a smooth start up transient, suddenly reached trip level in the turbine bearing.

Fig. 6. Sketch of the 100 MW power generation group.

It was finally discovered that the axial elongation of the shaft due to heating, at the increasing of output power, had been restricted by error after the overhaul. This caused the bending and rubbing of the shaft. After having removed the axial restriction the machine could be operated smoothly at full power.

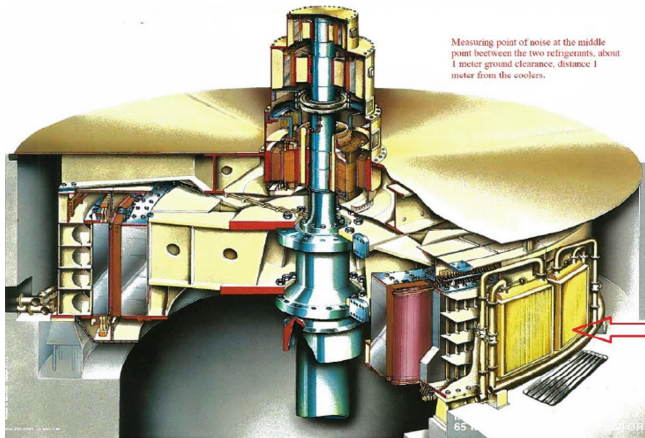
The generator of the 55 MW vertical shaft hydrogenerator shown in Fig. 9 had been partially rebuild introducing some smaller changes in the design of the machine.

At the startup of the group, huge noise was measured close to the casing of the machine and also in the control room. The noise was produced in all different operating conditions with only small changes in amplitude: at load and no-load, with excitation and without excitation.

**Fig. 9.** Sketch of the generator: arrow indicates the noise measurement point.

Independently of the cause of the severe noise emission, it was mandatory to provide means to reduce the noise at least in the control room.
