Numerical Analysis of Settlement-Induced Damage to a Masonry Church Nave Wall

Abstract. Differential soil settlements can induce structural damage to heritage buildings, causing not only economic but also cultural value losses. In 1963, the Saint Jacob's church in Leuven was permanently closed to the public because of severe settlement-induced damage caused by insufficient bearing capacity of the foundation. Currently, the church is stabilized using a temporary shoring system. This work aims at implementing a practical modelling approach to predict damage on church nave walls subjected to differential settlements. For that purpose, a finite element model of the Saint Jacob's church nave was generated and validated through on-site monitoring data including levelling, damage survey and laser scanning. The model takes into account the non-linear behavior of the masonry by means of continuum smeared cracking. The paper introduces two approaches to model the settlement on the structure. One of them consists in the direct application of vertical displacements underneath the structure according to the deformation profile measured on-site. In the second approach, interfaces with different

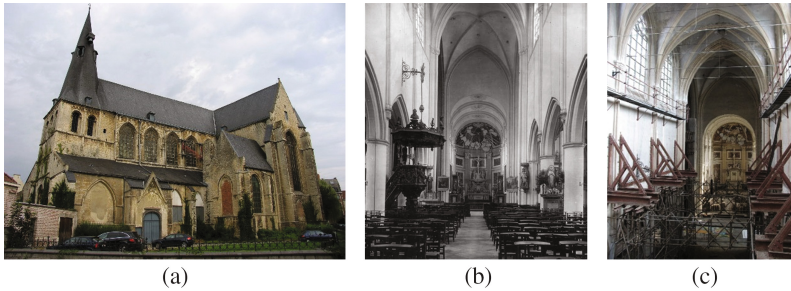
Fig. 1. Saint Jacob's church (a), view of main nave with choir in the back, in 1918 (b) and 2016 (c)

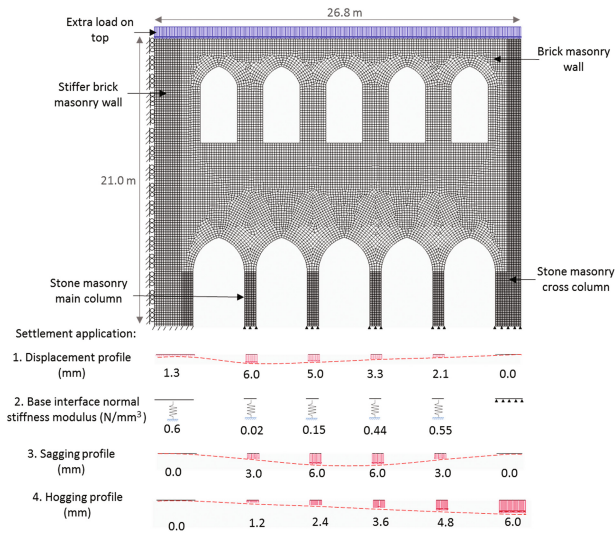
Fig. 3. Model of the nave wall with applied settlement profiles and interface stiffness values

The numerical model is shown in Fig. 3. The extra load on top represents the roof, the main vault and the non-structural elements, having a load value of 7.6 kN/m [9]. The nave wall model is composed of a 850 mm thick brick masonry wall, 740 mm thick stone masonry main columns, a 1300 mm thick stone masonry cross column and a stiffer brick masonry wall on the side with a thickness of 2000 mm. The mechanical properties of the materials are shown in Table 1. The underlined properties were taken from testing campaigns [1, 9]. The tensile strength of the stone masonry was assumed equal to 1.0 MPa (about 10% of the compressive strength). The rest of the values were taken from literature [4, 13–15].

Two approaches for the settlement application were considered. Approach 1 consists in the direct application of vertical displacements in the nodes underneath the structure, equal to the deformation profile measured on-site, as schematically indicated in Fig. 3 (1. Displacement profile). In this approach, the displacements induced by the self-weight and extra dead load were reset to zero. Then, the displacement profile was applied in 50 steps, so that the damage evolution could be easily tracked until it reached the maximum displacement value, for instance 6.0 mm under the second column.

In approach 2, interfaces with different stiffness values were placed at the base nodes, allowing the structure to deform under its self-weight. The normal stiffness values for the interface were obtained after a calibration procedure, which consisted in the variation of the stiffness values to match a base deformation profile similar to the profile measured on-site. The final values are indicated in Fig. 3 (2. Base interface normal stiffness modulus). In this approach, the self-weight and extra dead load were applied in 50 load steps and the vertical displacement at the base was monitored after each load increment. The possibility for the structure to deform according to its self-weight makes this approach more realistic. However, the selection of the normal stiffness modulus values is not straightforward, and a set of values that differ in orders of magnitude from each other might be required. For instance, in this case a very low value (0.02 N/mm^3) was applied under the column that presented the maximum vertical displacement. The ratio between the normal and shear stiffness modulus typically ranges from 2.18 to 2.5 [16]; for the current study, this ratio was assumed equal to 2.4.
