The 2006 and 2009 Landslide and Flood Events in the Tartagal River Basin (Argentina)

José Daniel Brea, Pablo Spalletti, and Gabriel Amores

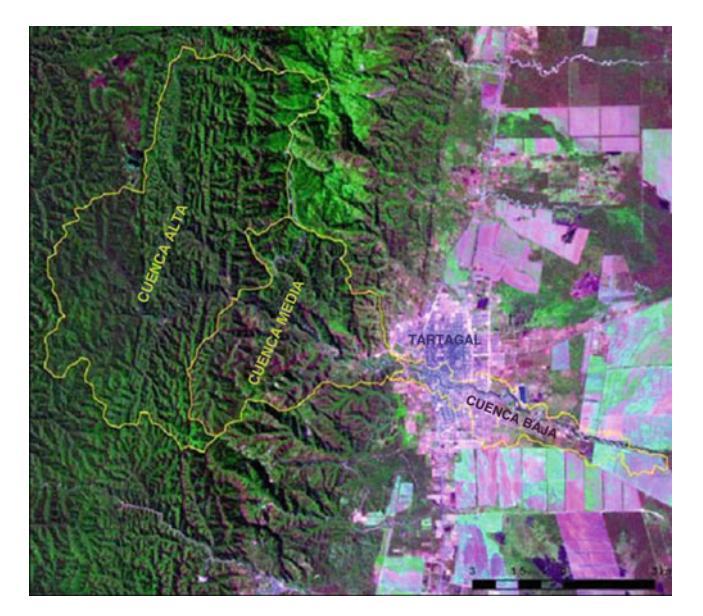
Fig. 2 Tartagal River basin and Tartagal City

With respect to natural morphoevolutive processes, those linked to surface runoff actions are manifested in the form of water erosion in all its forms, to an extent dependent on the alteration of natural vegetation cover, which acts as a regulator. The landslide processes governed by factors such as terrain nature and slope, and have the weather as the main trigger, are evident in the basin, in the past and present, by the frequent presence of scars on the hillsides. These scars have varying degrees of evolution, manifested in the growth state of natural vegetation, which may be dragged when processes are reactivated. Tartagal City is located in the foothills, growing on both banks of the Tartagal River. The basin upstream the city has an area of 96.68 km² and a perimeter of 75.67 km, with minimum and maximum altitude of 405 and 1,032 m a.s.l., respectively (Fig. 2).

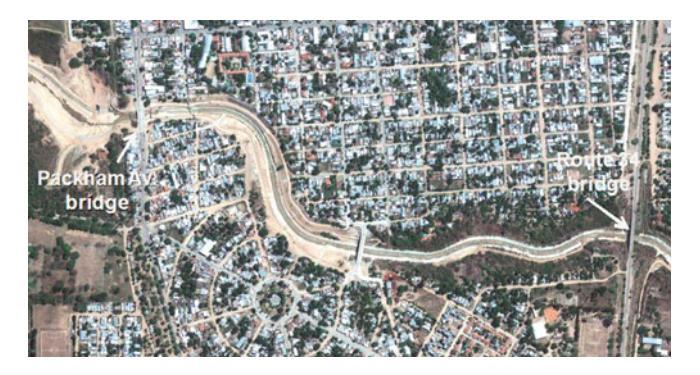
Fig. 3 Tartagal City detail

Tartagal River was channelled around 1980 in the segment that crosses the city, with concrete slabs from Packham Avenue to the National Route 34 forming a trapezoidal section (Fig. 3).

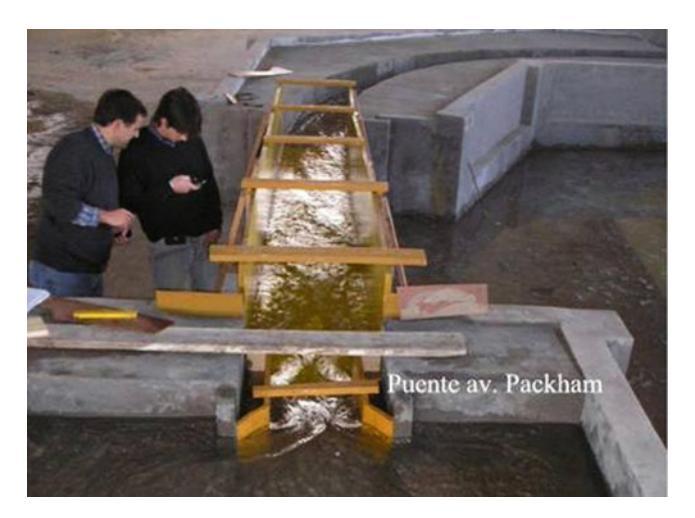
Fig. 6 Physical model at the National Water Institute – Argentina. Scale 1:40

A design discharge of 800 m³/s was adopted from available information, being necessary to carry out a verification for a flow of 1,000 m³/s. With this information, the control work was planned, which was also studied in a physical model developed for this purpose in the laboratories of the National Water Institute of Argentina (Fig. 6).
