Chapter 9

The Severe Reactor Accidents of Three Mile Island, Chernobyl, and Fukushima

Abstract Three major severe accidents with core meltdown/core disruption occurred at Three Mile Island (USA) in 1979, Chernobyl (Ukraine) in 1986 and Fukushima (Japan) in 2011.

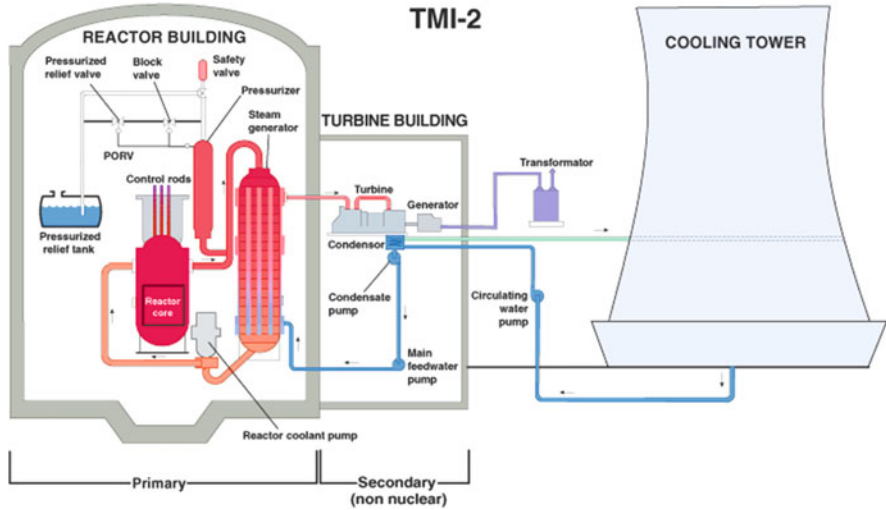
Fig. 9.1 Simplified schematic diagram of unit 2 [1]

It had a reactor power of 880 MW(e) and only two cooling circuits, A and B. The sequence of accidents began with technical problems in the feed water loop for the steam generator. This caused a turbine trip and triggered the startup of the emergency feed water systems. However, the valves in the emergency feed water system were closed by mistake. As the steam generators did not get enough feed water and, for this reason, were not able to remove enough heat, also the temperatures and pressures in the primary cooling circuit started to rise. When an excessively high primary pressure had been reached, the pilot-operated relief valve (PORV) of the pressurizer opened, and the steam was released into the pressure relief tank in the containment. The “primary pressure too high” signal caused the reactor to be shut down. The reactor power dropped to the residual heat level. As a consequence, also the primary pressure dropped. Apart from the mistake mentioned above the events went on in accordance with the measures planned for that incident condition.

However, the PORV did not shut again at the lower pressure, but remained open. The operators, though, were given the opposite information by the instruments in the control room, namely the indication that the PORV had closed again. The open PORV continued to discharge more steam, and the primary pressure continued to drop. When the primary pressure reached the level at which the high-pressure emergency cooling pumps start to feed, these pumps were activated automatically in order to compensate for the loss of primary coolant. The pressure relief tank was overfilled by the steam released, the water spilled over and collected in the sump of the reactor building. From here it was automatically pumped into storage tanks for radioactive water in the auxiliary systems building (not shown in Fig. 9.1).

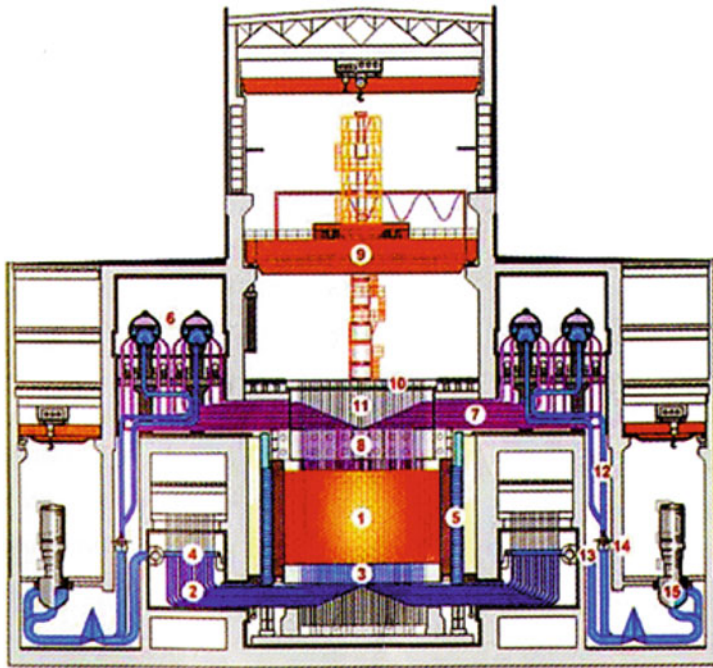
The positive coefficient of coolant temperature of the RBMK1000 reactors was known to cause instabilities in this low power range. When the eight primary coolant pumps were activated during startup, this gave rise to instabilities in power production, coolant flow and temperatures. Various alarms started going off at this time. The operators received emergency signals regarding the levels in the steam/water drums and large variations in the feed water flow as well as from the neutron flux or power monitors, respectively (Fig. 9.3).

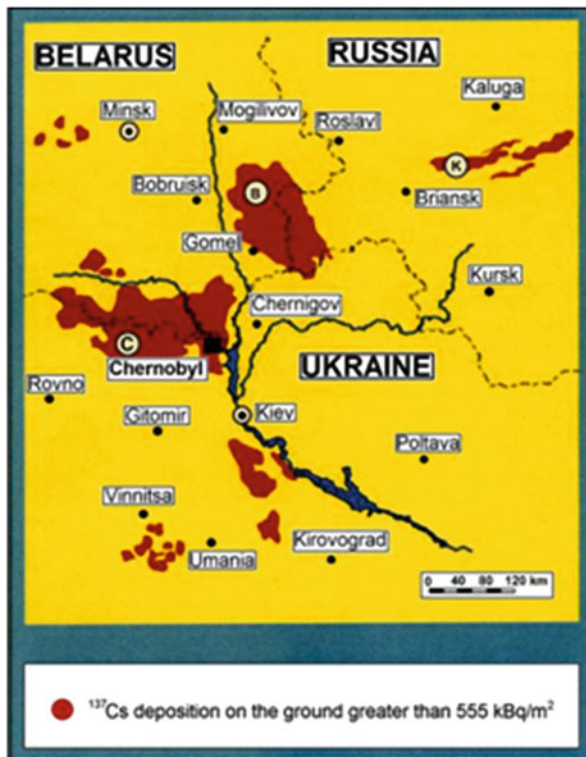
As a result of the prevailing weather conditions with precipitation, a number of areas in Ukraine, Belarus and in the western part of Russia were very highly contaminated over the first 10 days. While iodine-131, with a halflife of 8 days, had decayed already after roughly 1 month, cesium-134 (halflife 2 years) for the first 10 years or so and, above all, cesium-137 (halflife roughly 30 years) over approximately 100 years will determine the radiation exposure of the population due to ground-borne exposure and food ingestion [4, 5]. The regions with the highest exposure levels are shown in Figs. 9.5 and 9.6.

In the region of Bryansk, Belarus, the highest soil contamination in some villages was measured to be up to 5,000 kBq/m². In the Kaluga-Tula-Orel region, contamination of 600 kBq/m² was found.

Fig. 9.5 Cs-137 contamination caused by the Chernobyl accident in various regions of Ukraine, Belarus, and Russia [4, 5]

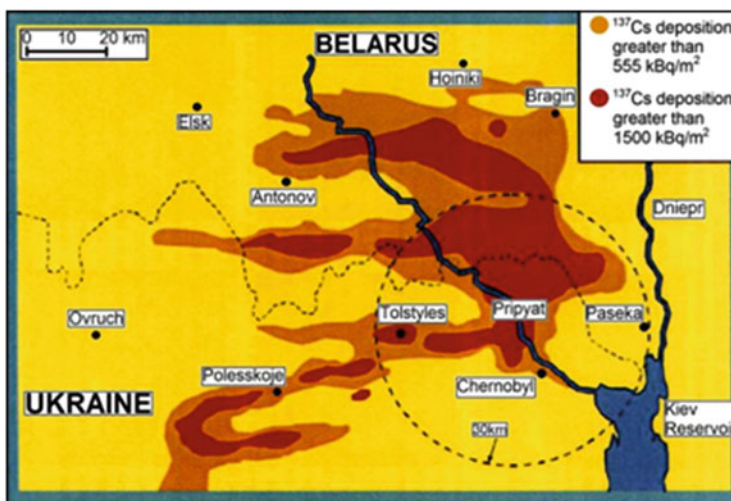
Fig. 9.6 Cs-137 contamination caused by the Chernobyl accident in Ukraine [4, 5]

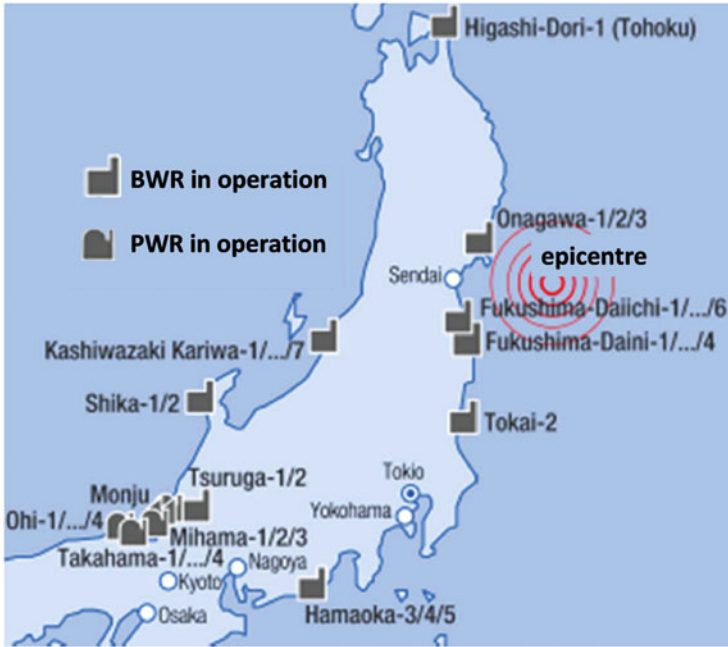
On March 11, 2011, an earthquake of the intensity $M = 9$ (Richter scale) hit the northeastern coast of Japan east of the city of Sendai (Fig. 9.7). This intensity corresponds to intensity XI on the European MSK/EMS-98 seismic intensity scale [12–21].

Four nuclear power plants with an aggregate 14 BWRs in the environment of the city of Sendai were hit by the earthquake (with a number of subsequent seismic events) and the tsunami wave on March 11, 2011. These were (Fig. 9.7) the nuclear power plants of Onagawa with three BWRs, Fukushima-Daiichi with six BWRs, Fukushima-Daini with four BWRs, and the Tokai Research Center with one BWR and one research reactor. At that time, only three BWRs were in operation in the Fukushima-Daiichi plant, while the fourth BWR was down (with all fuel elements removed and located in the spent fuel pool), and BWRs 5 and 6 had been shut down for inspection and repair. The eleven BWRs in operation **were duly shut down automatically by the earthquake instrumentation and changed into the residual heat removal mode.**

Fig. 9.7 Nuclear power plants operated in Japan (Honshu Island) when the earthquake and tsunami hit the coast [12, 13]

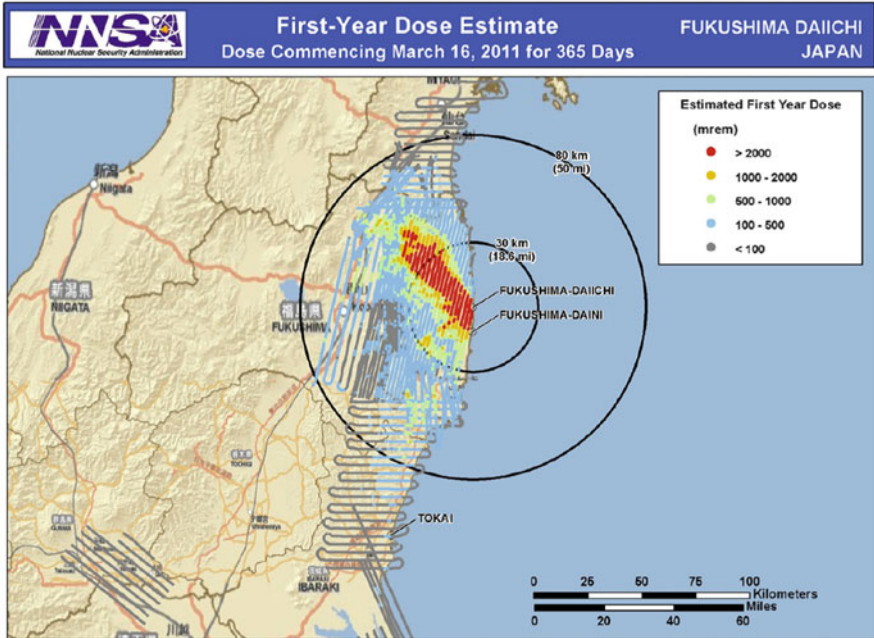
Large parts of the radioactivity released were initially carried out to the sea by the prevailing winds. Measurements of the radioactivity released over land (radioactive noble gases, radioactive I-131 (half-life 8 days) and radioactive aerosols, such as Cs-134 (half-life 2 years) and Cs-137 (half-life 30 years)), were carried out by specially equipped aircraft of the American National Nuclear Security Agency (NNSA). These measurements (Fig. 9.11) showed a particularly pronounced distribution of radioactivity towards the northwest of Fukushima. The measurements were evaluated in order to determine the radioactive exposure, which must be known for decisions about evacuation of the public. The Japanese government then evacuated the population (roughly 200,000 persons) in the vicinity of the nuclear power plants. The initial evacuation zone was soon expanded to a radius of 20 km. Afterwards, also some places situated beyond the zone of 20 km were evacuated because the annual dose to the population there had been estimated to run up too high [18, 19].

Fig. 9.11 Measured radioactivity and calculated dose levels from radioactive exposure within the first year after the accident of March 11, 2011 [16–19, 21]

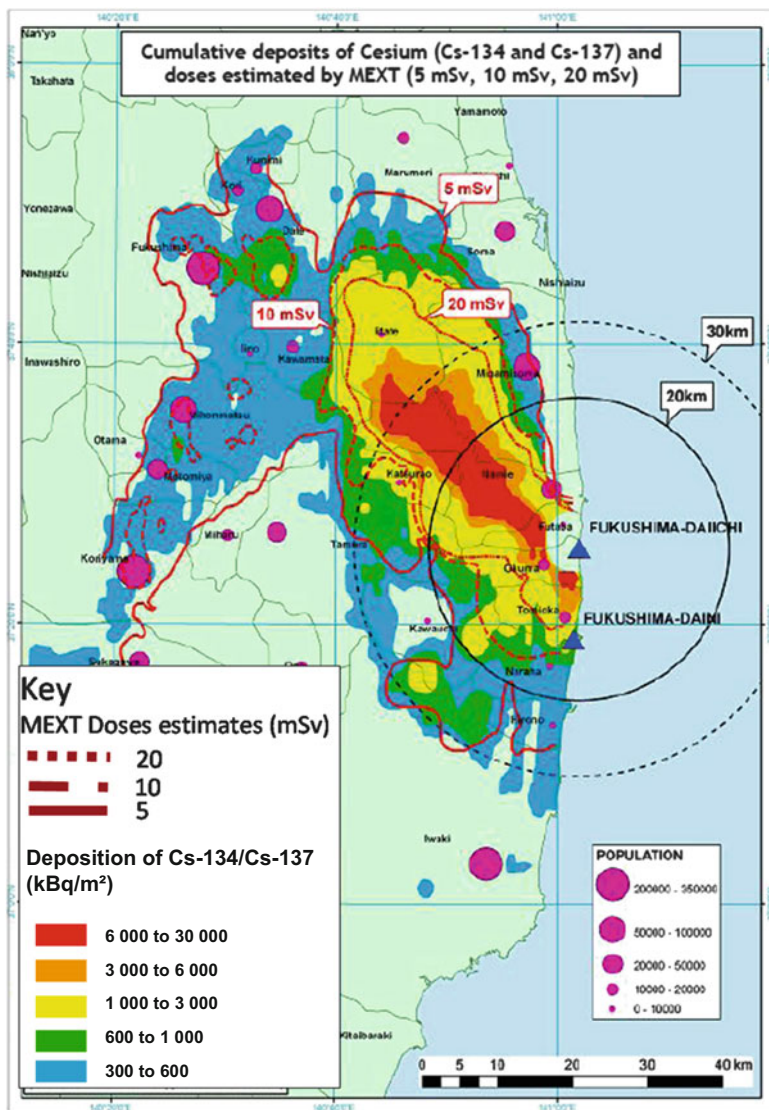
Fig. 9.12 Areas of Cs-134 and Cs-137 deposits in kBq/m² as well as estimates for radiation exposure of the Japanese public in certain locations during the first year after the Fukushima-Daiichi accident [18, 21]

While iodine-131, with a halflife of 8 days, had decayed within a month, depositions of Cs-134 stay on the ground for about 10 years, and depositions of Cs-137 remain for roughly 100 years. Japanese, French, and American measurements of ground depositions of cesium are shown in Fig. 9.12.
