Concise History of Liberty Bridge in Budapest

Keywords: History of Liberty Bridge, Erection methods, Damages of bridges, Refurbishment of bridges.

Abstracts: The “Fővám tér” (1896), “Ferenc József” (1896-1946), “Szabadság” Liberty Bridge (1946-) was completed in 1896. The bridge was demolished by explosion during the Second World War (1944). On the site of the bridge a temporary bridge was used for a while and in 1946 the bridge was reconstructed. In 1979-80 the deck of the bridge has been replaced. The reconstruction of the main structure was started in 1985, which has been finished successfully in 1986 after several unexpected events. In 1998 some changes has been applied to the deck again, which was followed by a full reconstruction in 2009. Since that time the bridges being an ornament and jewel of Budapest, but also it is a symbol of the Hungarian Capital development to a metropolis.

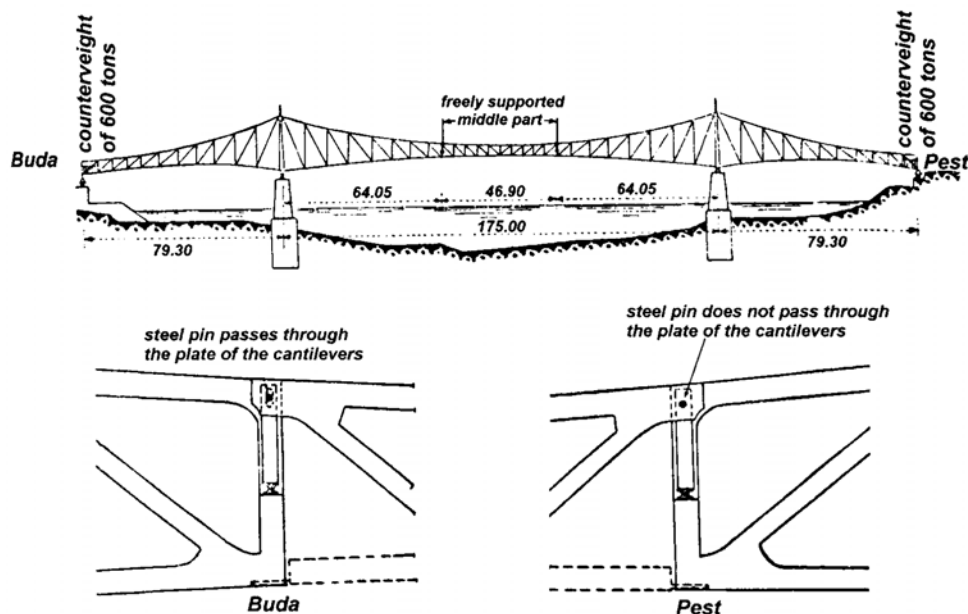
Figure 7: The cantilever type main girders

The first stage of the reconstruction was the lifting of the cantilever parts. The main girders of this steel bridge are cantilever type running over three spans (Fig. 7) [Haviár, 1947].

The reconstruction was carried out based on the original plans. 2250 tons of iron were needed for the reconstruction - representing 38% of the total material. About 550 tons of steel necessary for the less important cross girders were taken from the wrecks of other two Danube bridges, therefore only an amount of 1700 tons had to be supplied by the rolling mills.
