Fukushima Nuclear Power Plant Accident and Thereafter

Tadashi Narabayashi

Keywords Fukushima Daiichi Nuclear Power Plant • Isolation condenser • Emergency core cooling system • Hydrogen explosion • New regulatory requirements • Defense in depth

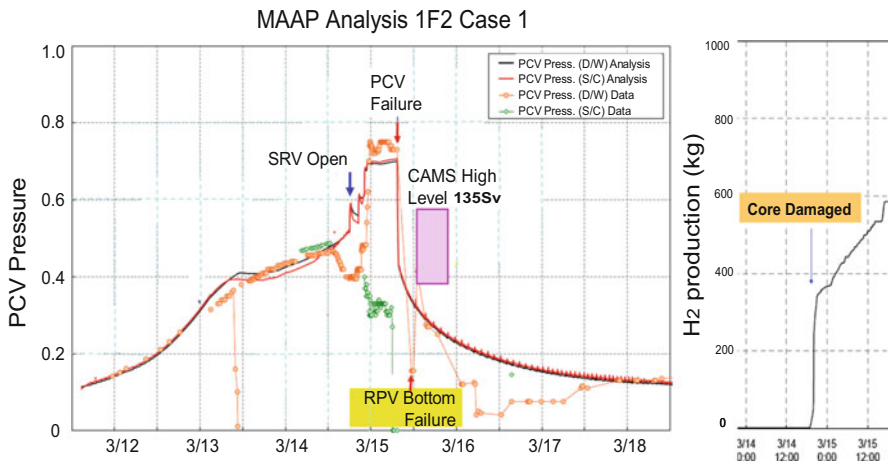
At Unit 2, reactor core isolation cooling (RCIC) continued to function for about 3 days. Figure 6 shows that soon after the loss of RCIC water injection, the water level in the RPV declined. The safety relief valve (SRV) was opened and seawater injection started. But, RPV pressure shows fluctuation due to water evaporation and metal-water reaction in core. Dry well (DW) pressure increased from 400 to 750 kPa (abs), and PCV top flange leak began through silicon rubber O-ring. It was an initiation of severe contamination around the NPS. In the afternoon on March 15, wind blew toward Iitate village. Melted core relocation into the lower plenum caused the RPV bottom CRD pipe failure and PCV pressure and radiation level increased (Fig. 7). The radiation level was measured by containment atmospheric monitoring system (CAMS) [15].

Fig. 7 MAAP analysis results compared with actual plant data for Unit 2 [15]

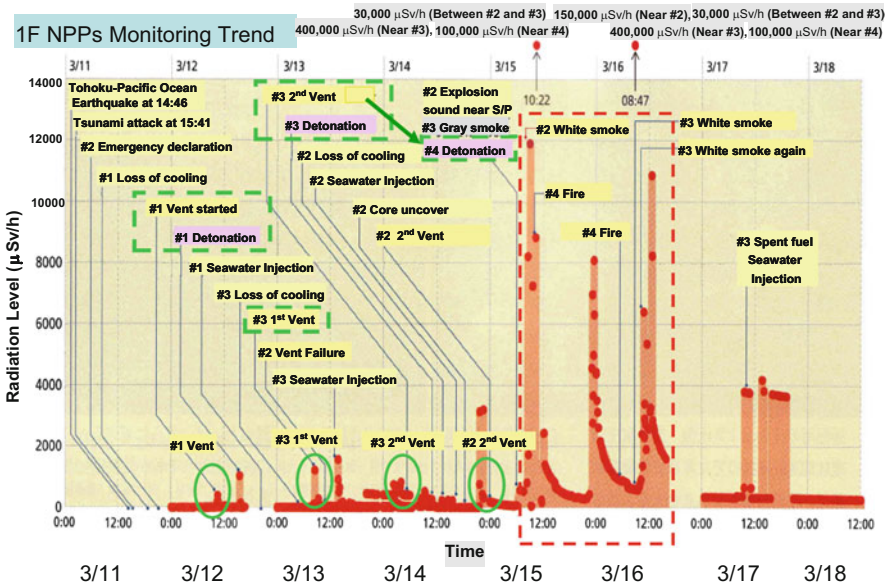
Fig. 9 Monitored radiation levels for Fukushima Daiichi Units 1, 2, 3, and 4 [2]

It appears that the explosion occurred after venting operations. The radiation level increased soon after the Unit 2 PCV rupture on March 15. A loss of core cooling occurred because of the IC trip in Unit 1, and the RCIC steam turbine also tripped owing to loss of battery power in Units 2 and 3. Suppression pool (S/P) temperature and pressure became so high that water injection actions for accident management took a long time. This was the reason for the chain of severe accidents in the four units of the Fukushima Daiichi NPS, as shown in Fig. 10 [11].

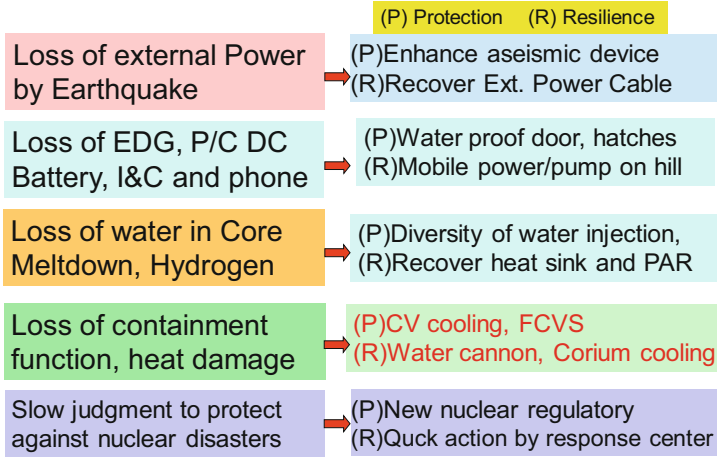
NISA ordered that the licensees make a new independent vent line for filtered vent system. This is one of the lessons learned. There were no accident reports about Fukushima Daiichi pointing out the vent system fault and potential risks. The causes of severe accidents and countermeasures are shown in Fig. 15, in which (P) means protection and (R) resilience action. Corium cooling was very effective in achieving the cold shutdown cooling, even after the containment failure at the Fukushima Daiichi NPPs.

Fig. 15 Causes of severe accidents and countermeasures

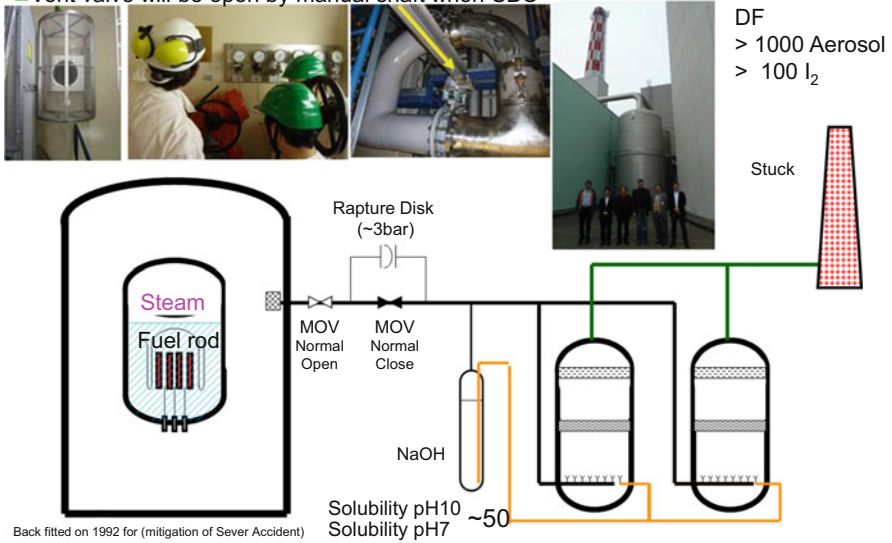
Figure 21 shows a schematic diagram of the FCVS installed in the Leibstadt NPP. Venting is automatically initiated when the CV pressure reaches the pressure set for the rupture disk. An operator who wishes to vent early can easily open the vent valve using a hand wheel drive shaft [8].

■ Vent valve will be open by manual shaft when SBO

Fig. 21 Schematic diagram of FCVS in Leibstadt NPP [8]

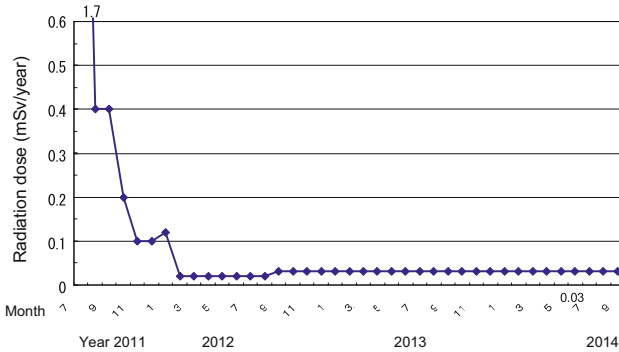
Fig. 47 Annual radiation dose at site boundary of Fukushima Daiichi NPS [18, 19]

Figure 47 shows the annual radiation dose from radioactive materials at the site boundary of Fukushima Daiichi NPS, released from Units 1 through 4. At the time of the accident, a vast amount of these materials were released, but the maximum annual dose is now 0.03 mSv/y equivalent to 1/70 that from background radiation.

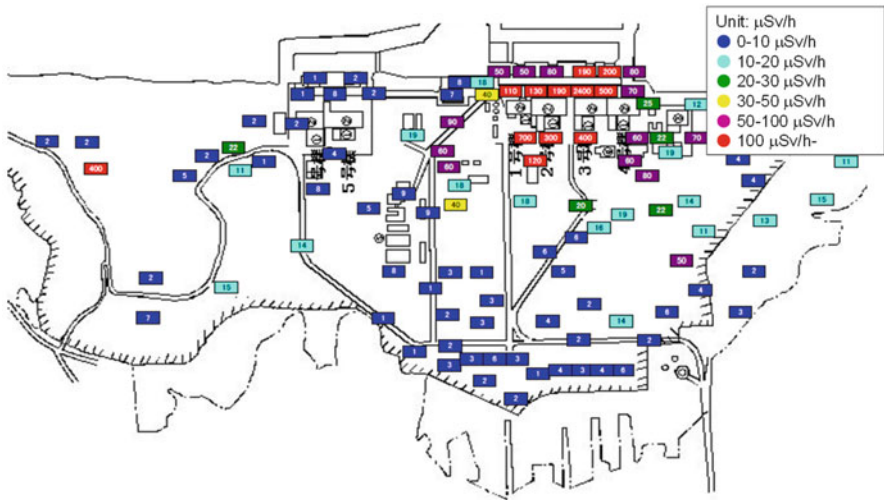
Fig. 48 Exposed dose distribution at Fukushima Daiichi NPS [18, 19]

Figure 48 shows that an approximate half area dose is $<10 \mu\text{Sv/h}$ (87.7 mSv/y), but the dose in the reactor building is $>100 \mu\text{Sv/h}$ (877 mSv/y).

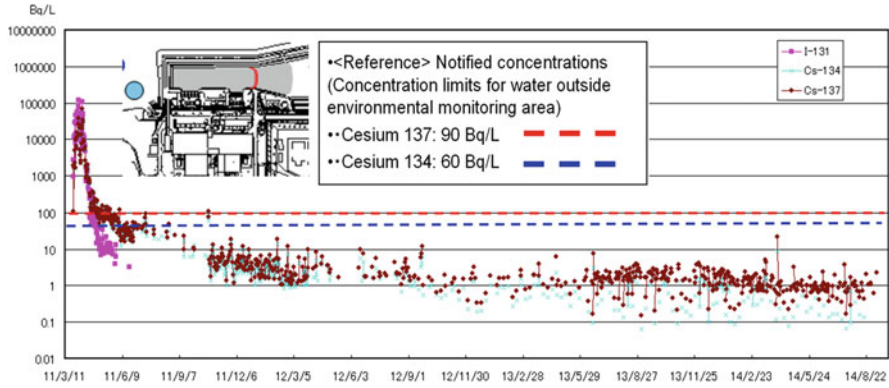
Fig. 49 Concentration of radioactive materials in seawater at the north side of water outlets in Units 5 and 6 [18, 19]

Just after the accident, contaminated water accumulated in the reactor and turbine buildings leaked into the plant harbor through an underground tunnel. The leak was stanchied at the end of October 2014. The current concentration of

radioactive materials in the seawater is below WHO’s (World Health Organization) standard for drinking water (Fig. 49).

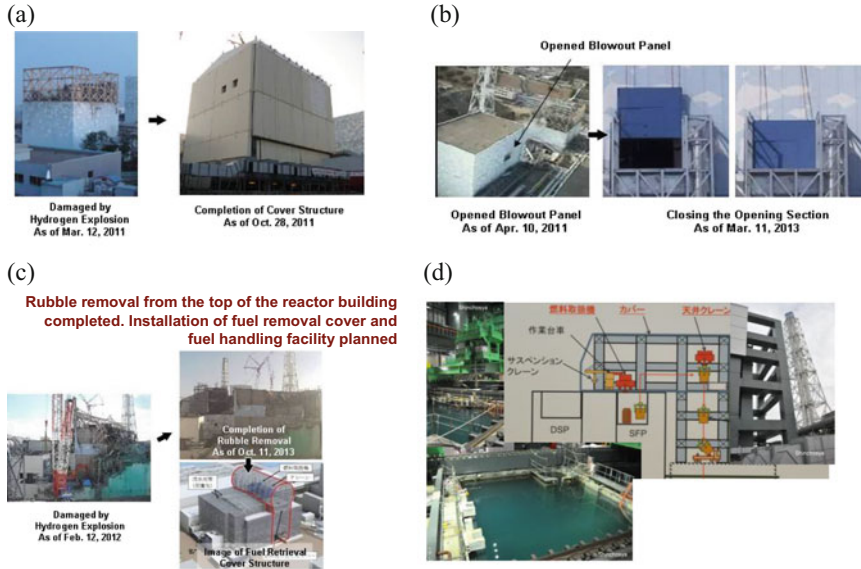
Fig. 50 Current status of reactors; Units 1 through 4 [18, 19]. (a) Unit 1, (b) Unit 2, (c) Unit 3, (d) Unit 4

Figure 50a shows the reactor building of Unit 1 after the hydrogen explosion on March 12, 2011. The cover structure was constructed with a controlled ventilation system, to minimize the dispersion of radioactive material. To remove the spent fuel from the SFP, rubble should be removed, and cover should be removed after ensuring countermeasures for local communities during the removal operation.

Figure 50b shows the current status of Unit 2. Its reactor building is undamaged, because the blowout panel was opened owing to the hydrogen explosion in Unit 3. Therefore, the dose rate in the Unit 2 reactor building is very high. Considering this fact, the process for removing SFP fuels is under study.

Figure 50c shows the current status of Unit 3. Rubble removal at Unit 3 was completed in October 2013. Preparations are continuing for installation of a temporary cover, to be used while fuels are removed from the SFP by remote-controlled handling equipment. The current level of radiation on the operating floor remains high for workers to safely install the necessary equipment. Therefore, the next step is to reduce the radiation to an acceptable dose.

Figure 50d shows the current status of Unit 4. A cover structure was constructed and fuel-handling machine and heavy-duty ceiling crane were installed, and spent fuel removal from Unit 4 was completely ended by the end of December 2014. The cover structure is supported by a huge cantilever structure, which enables to support the handling of the fuel into transport cask with the ceiling crane.

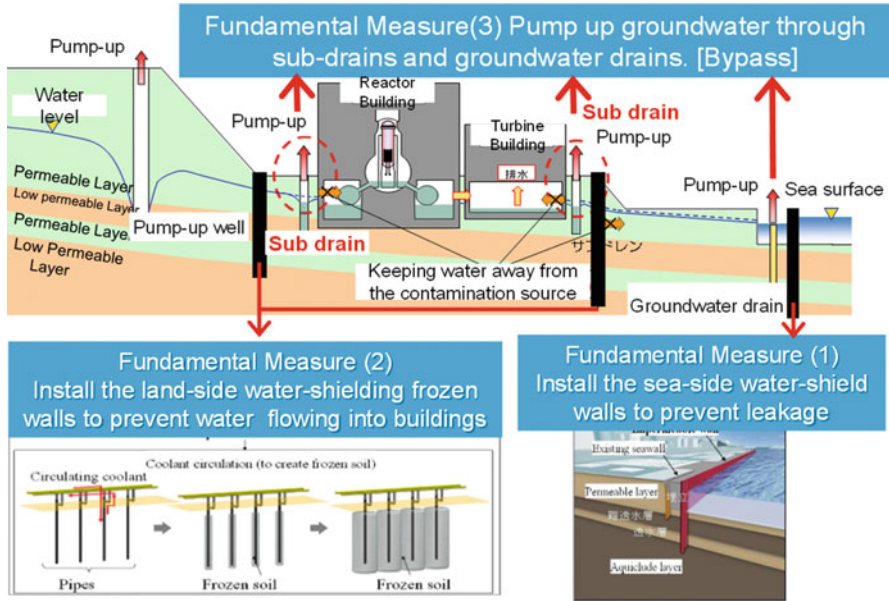
Fig. 55 Measures to prevent contaminated water flowing into the sea by isolation of groundwater [18, 19]

There are several trenches for pipelines and power lines between buildings and pumps in the seaside area, in which extremely contaminated water was discovered. To isolate groundwater mixed with contaminated water flow from the buildings to the trenches, a groundwater bypass system was installed and began operation in May 2014 (Fig. 55). With this system, the volume of water flow into the buildings

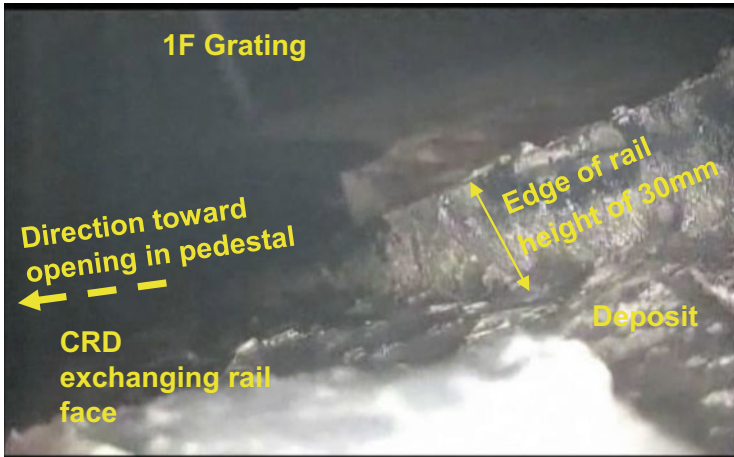
Fig. 62 Video capture at position (2) on CRD exchange rail [18, 19]

identifying the location of fuel debris will then follow. This is the result of the first preliminary investigation, using X-53 penetration. Figure 55 is video capture at position (2) on the CRD exchange rail, in Fig. 62. It is possible to identify an edge of rail and some deposit on the rail. However, the robot could not enter the pedestal because of some blockage by an unknown deposit on the CRD rail.
