# Chapter 9

## Back Analyses in Forensic Geotechnical Engineering

Richard N. Hwang

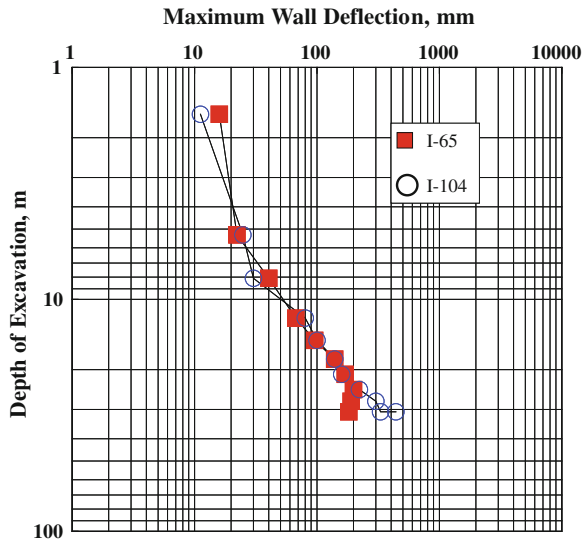
**Fig. 9.5** Deflection paths for diaphragm walls

30.5 m 4 days earlier. There were two inclinometers, i.e., I-65 and I-104, available for monitoring wall deflections. Figure 9.4 shows the wall deflection paths, which are the plots of maximum wall deflections versus depth of excavation in a log-log scale, for these two inclinometers (Hwang et al. 2007). Wall deflections on the two sides of the excavation were about the same till 9 March, 2004, when excavation reached a depth of 25 m, and deflections of 198 and 215 mm were recorded by Inclinometers I-65 and I-104, respectively. Subsequently, there was a period in which I-104 was not read because it was damaged. When monitoring resumed on 26 March, the deflection of the southern wall was found to have increased by 67 to 282 mm while the readings for Inclinometer I65 on the north were fairly steady in this period. The readings for Inclinometer I-104 kept on increasing while those for I-65 remained to be steady subsequently, presumably, because of the asymmetry of ground conditions. In fact, I-65 appeared to move outward by 27 mm and the maximum deflection reduced from 202 mm on 26 March to 175 mm on 20 April, as depicted in Figs. 9.2 and 9.4. On the other hand, Inclinometer I-104 moved inward by 90 to 441 mm in the 3-day period from 17 April to 20 April as shown in Fig. 9.5.
