# **Blast Loading of Sandwich Structures and Composite Tubes**

#### H. Arora, P.A. Hooper, and J.P. Dear

Abstract This chapter reviews blast impact experimentation on glass fibre reinforced polymer (GFRP) and carbon-fibre reinforced polymer (CFRP) sandwich composite materials and laminate composite tubes. Explosive charges of 0.64-100 kg TNT equivalent were used during these air- and underwater-blast tests. The difference in response and damage inflicted from underwater- and air-blast loading was assessed from strain-field measurements and post-blast specimen analysis. Procedures for monitoring the structural response of such materials during blast events have been devised. High-speed photography was employed during the airblast loading of GFRP and CFRP sandwich panels, in conjunction with digital image correlation (DIC), to monitor the deformation of these structures under shock loading. Failure mechanisms have been revealed using DIC and confirmed in post-test sectioning. The improved performance of composite sandwich structures with CFRP skins compared to GFRP equivalent constructions is demonstrated for air-blast experiments. Strain gauges were used to monitor the structural

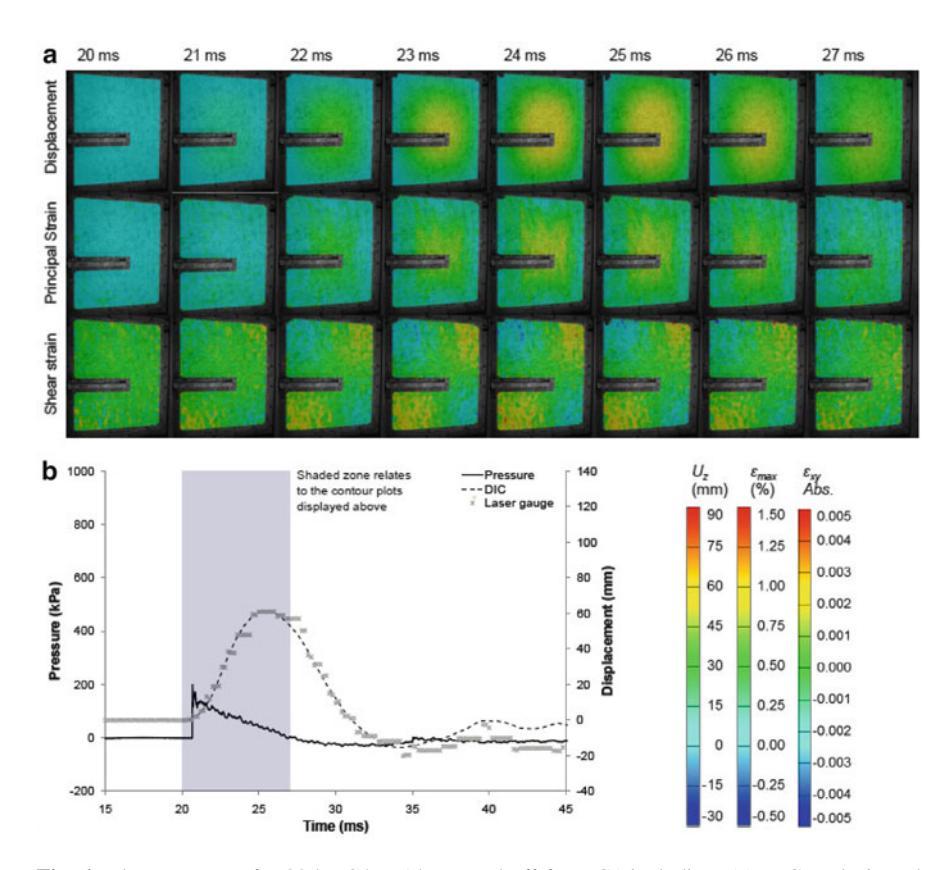
Figure 6 shows the central point deflection of G1 subjected to a recorded peak pressure of 2 bar (30 kg of C4 at stand-off of 14 m). The computed results from the image correlation are shown in the form of contour plots of out-of-plane displacement, principal strain and shear strain for the various times highlighted. It can be seen that the line from the left hand edge to the centre in the contour plots is the region of the specimen obscured by the laser gauge and its mount. This was employed to give an independent measure of central displacement in addition to DIC data. G1 was seen to deflect to a maximum distance out-of-plane of 63 mm (whilst Fig. 6 shows G2 deflected 78 mm). These deflection measurements agreed well with the laser gauge measurements for this single (central) point data, details to be discussed later in Sect. 5.1. The level of major principal strain peaked in the

**Fig. 6** Blast summary for 30 kg C4 at 14 m stand-off from G1 including: (a) DIC analysis and (b) a plot of pressure-time and displacement-time using both DIC and laser gauge centre point measurements. The DIC analyses features contour plots of out-of-plane displacement, maximum principal strain and shear strain, corresponding to various stages in the graphical plot. *The horizontal bar* visible in the contour plots (from the *left hand edge* to the *centre*) is the region of the specimen obscured by the laser gauge

region of 1% on the back face for G1. The G1 panel was deformed within a limit such that no visible damage was sustained. There were no obvious signs of damage shown within the DIC analysis for G1.

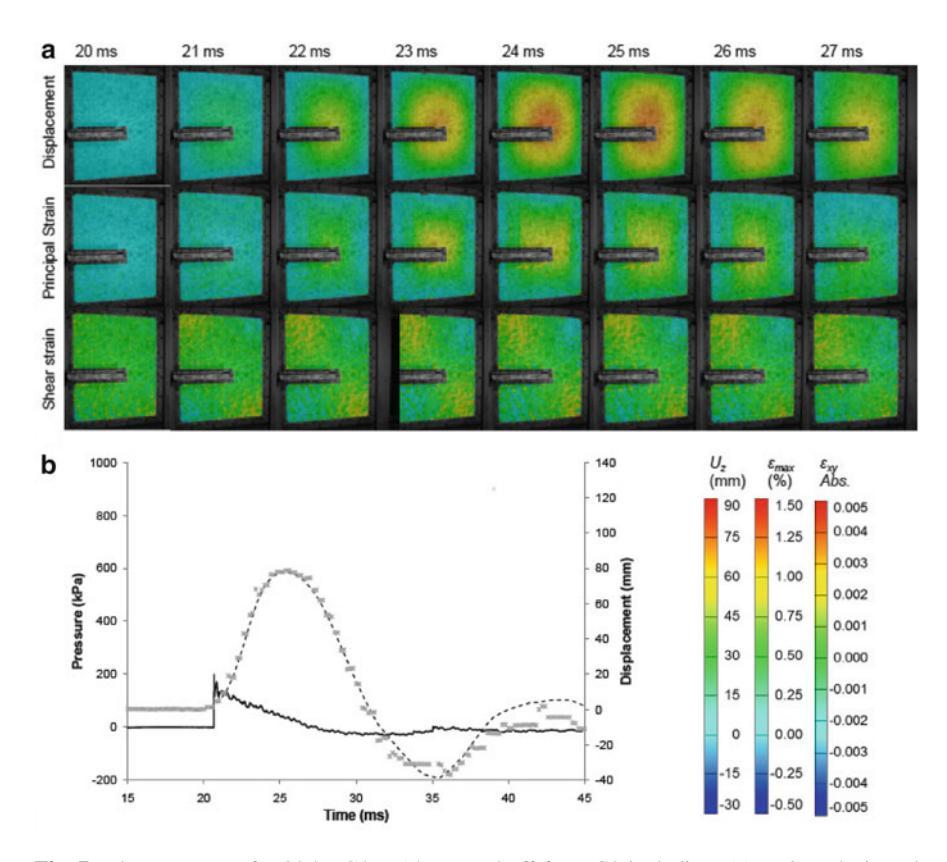
A similar response was exhibited in Fig. 7 for G2 with its reduced core thickness when subjected to a recorded peak pressure of 2 bar (30 kg of C4 at stand-off of 14 m). For G2, surface strains peaked at 1.25% and below the expected failure strains of the fibres. The lower limit (assuming a linear elastic relationship) for fibre strain to failure is 1.4% (as stated in Table 1). Signs were, however, observed within the DIC analysis that mild sub-surface core cracking had occurred. Early discontinuities in the major principal strain plots indicate possible detachment of the skin from the core i.e. possible cracking. This was confirmed upon sectioning of the panel after the blast.

**Fig. 7** Blast summary for 30 kg C4 at 14 m stand-off from G2 including: (a) DIC analysis and (b) a plot of pressure-time and displacement-time using both DIC and laser gauge centre point measurements. The DIC analyses features contour plots of out-of-plane displacement, maximum principal strain and shear strain, corresponding to various stages in the graphical plot. *The horizontal bar* visible in the contour plots (from the *left hand edge* to the *centre*) is the region of the specimen obscured by the laser gauge

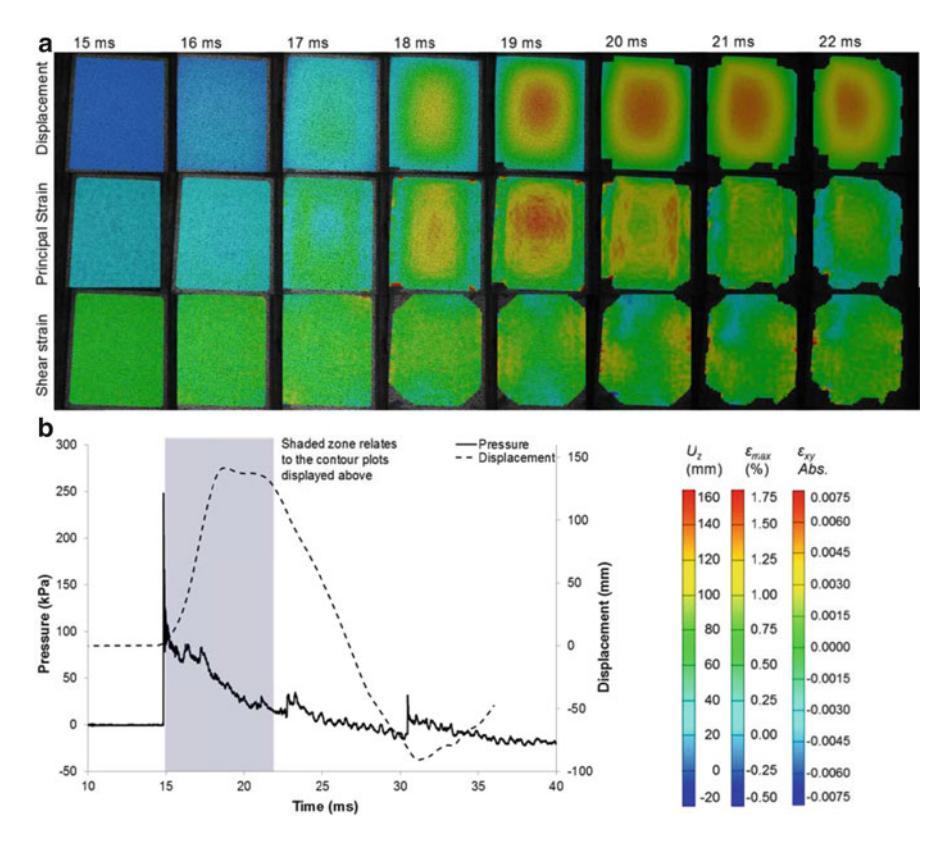
Figure 12 shows a summary of the blast data recorded for G3 in this blast (100 kg Nitromethane at 14 m stand-off). From the graphical plot in this summary, around maximum out-of-plane displacement, the distortion (due to damage initiation and propagation) of the return stroke of the target is clear. Between the time period 19.0–22.0 ms, one can observe a flattening in the displacement curve around its maximum. This coincides with the time period over which the crack was observed to initiate and propagate in Fig. 11 from the top right-hand corner of the GFRP panel. Maximum deflection was found to be 140 mm and the strain peaked in the region of  $\sim 1.6\%$  prior to the crack developing.

**Fig. 12** Blast summary for 100 kg TNT equivalent at 14 m stand-off from G3 including: (a) DIC analyses and (b) a plot of pressure-time and displacement-time using both DIC and laser gauge centre point measurements. The DIC analyses features contour plots of out-of-plane displacement, maximum principal strain and shear strain, corresponding to various stages in the graphical plot

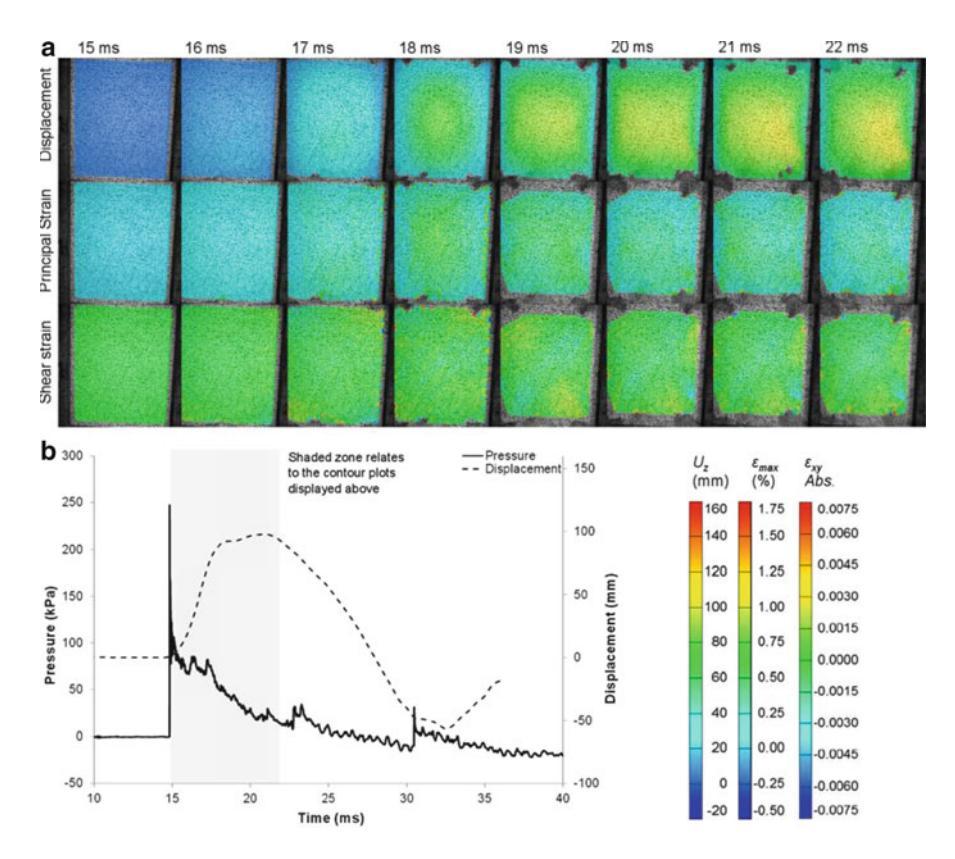
Fig. 13 Blast summary for 100 kg TNT equivalent at 14 m stand-off from C1 including: (a) DIC analyses and (b) a plot of pressure-time and displacement-time using both DIC and laser gauge centre point measurements. The DIC analyses features contour plots of out-of-plane displacement, maximum principal strain and shear strain, corresponding to various stages in the graphical plot

more widespread core cracking. Conversely G3 did not distribute the blast energy quick enough throughout the entire structure leading to a major localised failure of the skin and core. This type of damage mechanism (core cracking) accounts for the elongated return of C1 observed in Fig. 13. The time taken for the panel to return to its original position took an extra millisecond in the carbon panel compared to the glass panel. This extended response time absorbed the blast energy over a longer time period, resulting in a lower observed maximum deflection (107 mm) and maximum strain ( $\sim 0.8\%$ ) compared to G3.

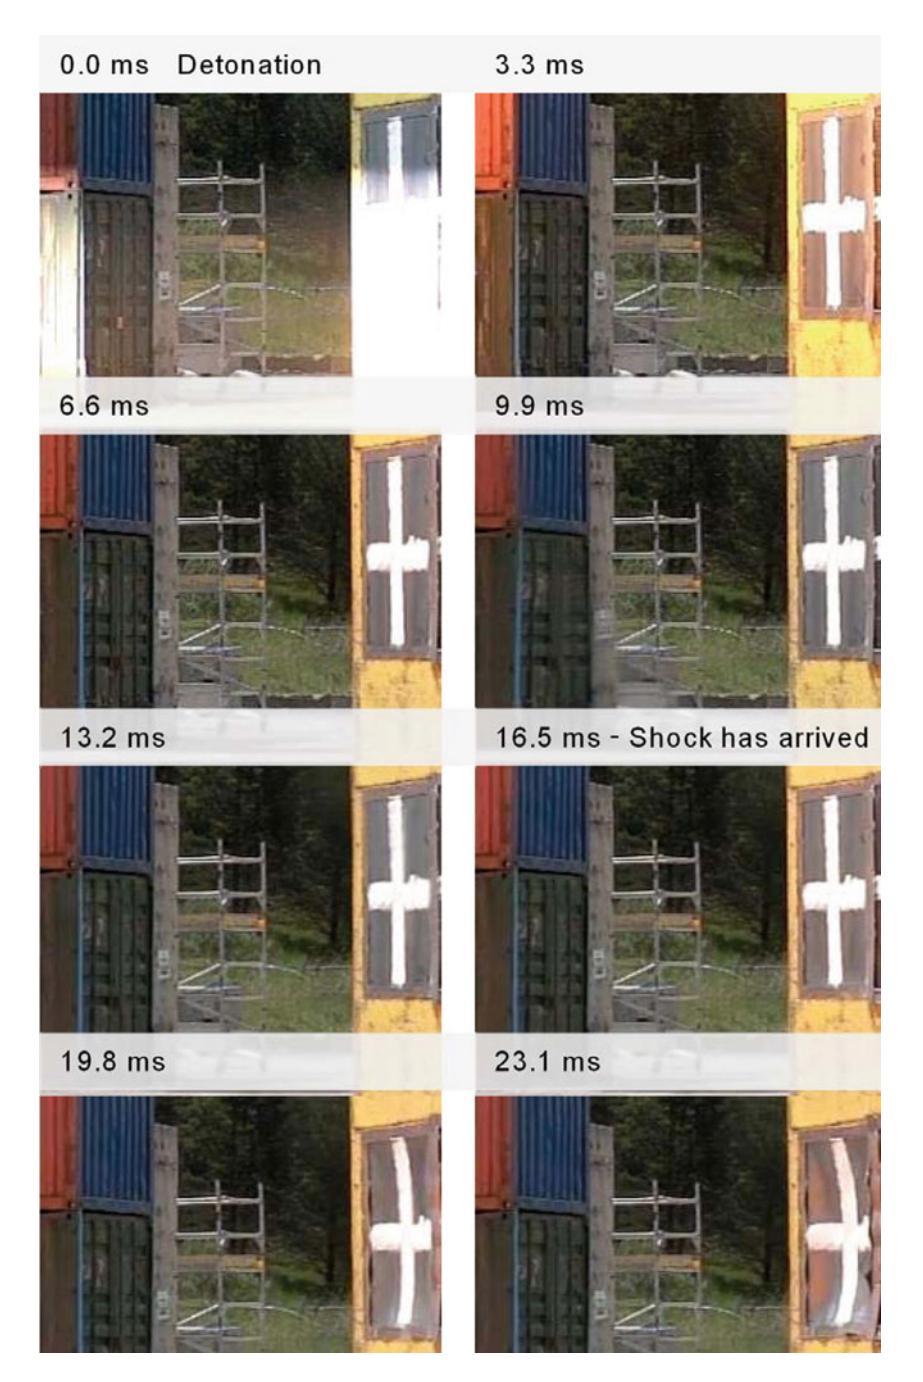
**Fig. 15** Images of shock wave progression and front-face deformation of S1 (3 mm thick steel plate). Images are shown from the detonation (0 ms) through the shock wave arrival at target (15 ms) until targets begin their first rebound. Exact time at which these event occur are not shown in the images (due to availability), therefore timings of interest are highlighted around those exact times

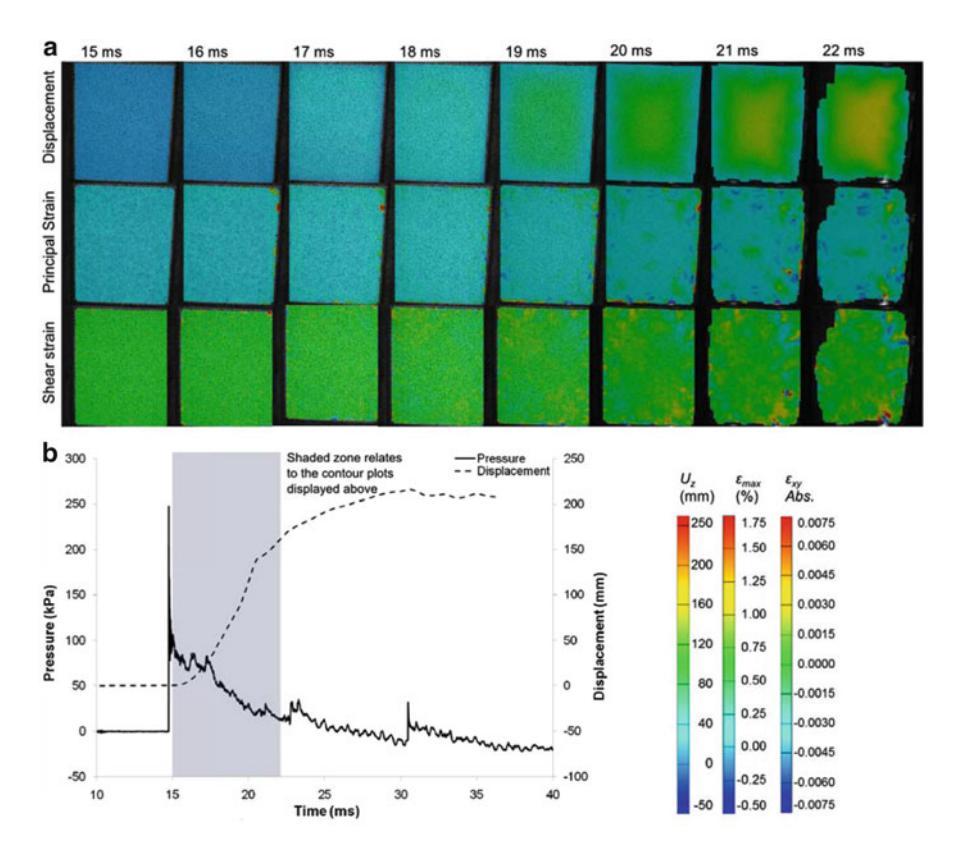
The contour plots in Fig. 16 only show the deformation within the time period shown for that of G3 and C1. This shows that the panel deformed significantly more than the sandwich structures. Moreover S1 folded and crumpled in the regions between the bolt holes where high shear stresses causing this crumpling to occur.

S1 had a peak deflection which was 270 mm, which is considerable more than GFRP and CFRP skinned sandwich panels. A deflection of approximately 120 mm was attained prior to bolt shear, which dissipated some energy and also relieved some of the blast pressure. Major principal strain peaks at approximately 1.1%. The damage sustained by S1 is featured in Fig. 17, showing the final deformed profile relative to its original at profile.

Fig. 16 Blast summary for 100 kg TNT equivalent at 14 m stand-off from S1 including: (a) DIC analyses and (b) a plot of pressure-time and displacement-time using both DIC and laser gauge centre point measurements. The DIC analyses features contour plots of out-of-plane displacement, maximum principal strain and shear strain, corresponding to various stages in the graphical plot

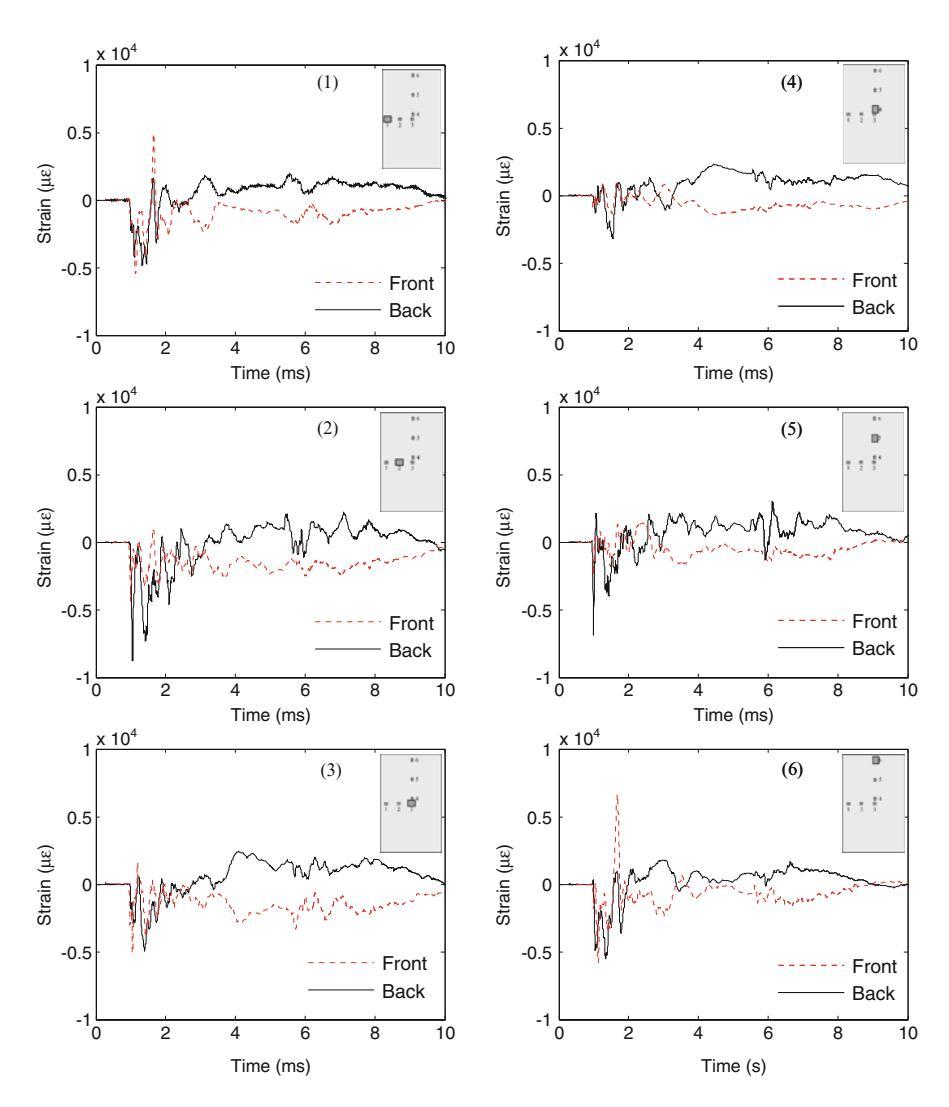
The water supporting the rear face of panel G5 was observed to dampen the overall response of the panel during the blast. The large strains observed in G4 were not observed in G5 due to the fact that the water medium supported the panel and restrained its response to the blast. Typical flexural response of the plate under a distributed transient pressure load was not observed. This is why surface strains generally remained low over the entire target area of G5 (water-backed) in comparison to the blast on G4 (air-backed), where strain magnitude rose towards the centre of the target. The fact that G5 experienced a decreased impulse was irrelevant; the change in the response characteristics is what has occurred. Figure 20 shows that strains peaked at  $\pm 0.6\%$  on the front face and -0.6% on the back face of G5. Each face initially went into a state of compression, forcing the sandwich panel inwards on itself. After this, typical oscillatory motion ensued with strains of  $\pm 0.2\%$  resulting. There was no visible damage to the skins after the blast; however, the 15 mm thick core suffered significant crushing as shown in Fig. 21c (7 mm core thickness reduction). This was again in the region of 50% core thickness reduction this time for a peak shock pressure of 300 bar (130 bar lower than that observed for G4) and an impulse of 4.82 bar ms (compared to 6.41 bar ms for G4). The

**Fig. 20** Sample strain gauge data displayed for G5 (core thickness 15 mm) sandwich composite panel with water on the front and back face (300 bar; 1 kg of C4; 6 m depth; stand-off 1.4 m). Data is displayed for the first 10 ms for each gauge position (numbered as shown in Fig. 3)

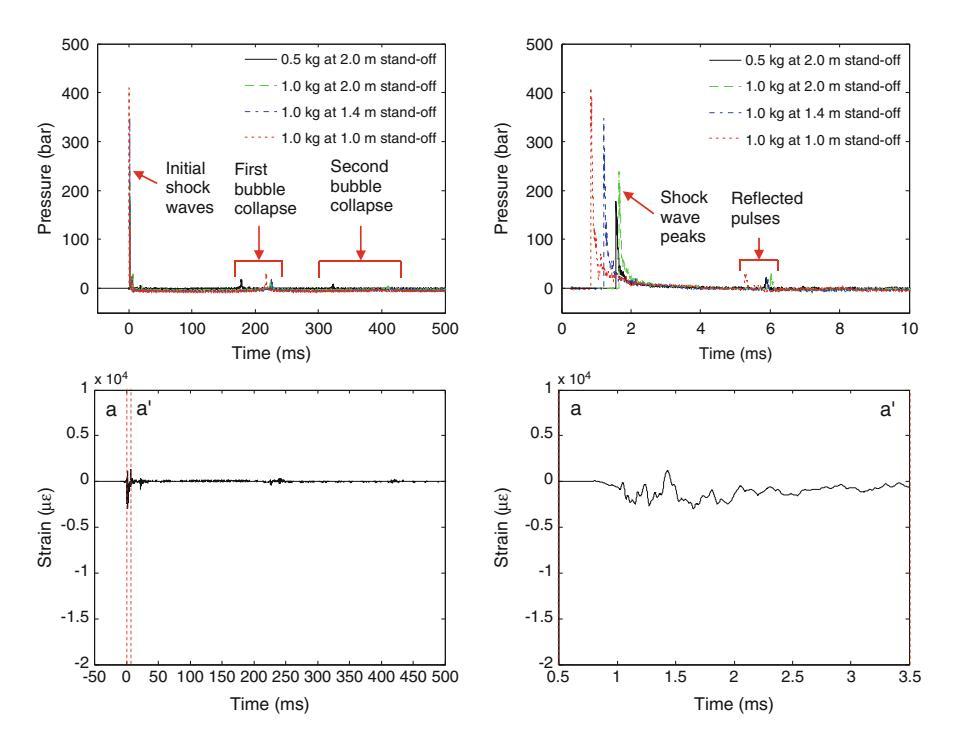
Figure 22 shows the combined pressure time traces for each underwater blast on composite tubular laminates of air-filled (AF) design. Peak pressures ranged from 180 to 400 bar for a range of blast parameters from 0.5 kg C4 explosive charge at a 2.0 m stand-off distance at a 6 m depth to a 1.0 kg charge at 1.0 m stand-off distance at the same depth. Figure 16 shows the combined results for the progressive loading of these tubular laminates. The 180 bar blast produced no visible skin damage to the targets with the surface strains sufficiently low to form an agreement with this observation. The 240 bar blast proved to be the threshold for damage evolution with surface strains reaching 1%. The tubes were then tested at a peak shock pressure of 350 bar and visible damage was inflicted on the targets with axial cracks forming along the front facing side of the sample as strains reached 1.5%. In the final test the tubes were taken beyond their limit, where complete shear failure was observed for a peak shock pressure of 400 bar. Similar signs of axial cracking were observed in this final sample (as for the blast of 350 bar) evident from the remains at the end-tabs featured in Fig. 23 prior to the entire gauge length shearing off at the supports.

Fig. 22 Pressure-time traces for 0.5–1.0 kg blasts at stand-offs of 1.0–2.0 m: the entire event including the first bubble pulse at  $\sim$ 200 ms (*top left*); and initial shock pressure including reflected shock from the water surface at  $\sim$ 5–6 ms (*top right*). Sample strain gauge data of the tubular laminate response is given over these time periods for strain gauge position 1 monitoring axial strain (as shown in Fig. 3) of the air-filled A1 when subjected to the 1 kg charge C4 at 1.4 m stand-off

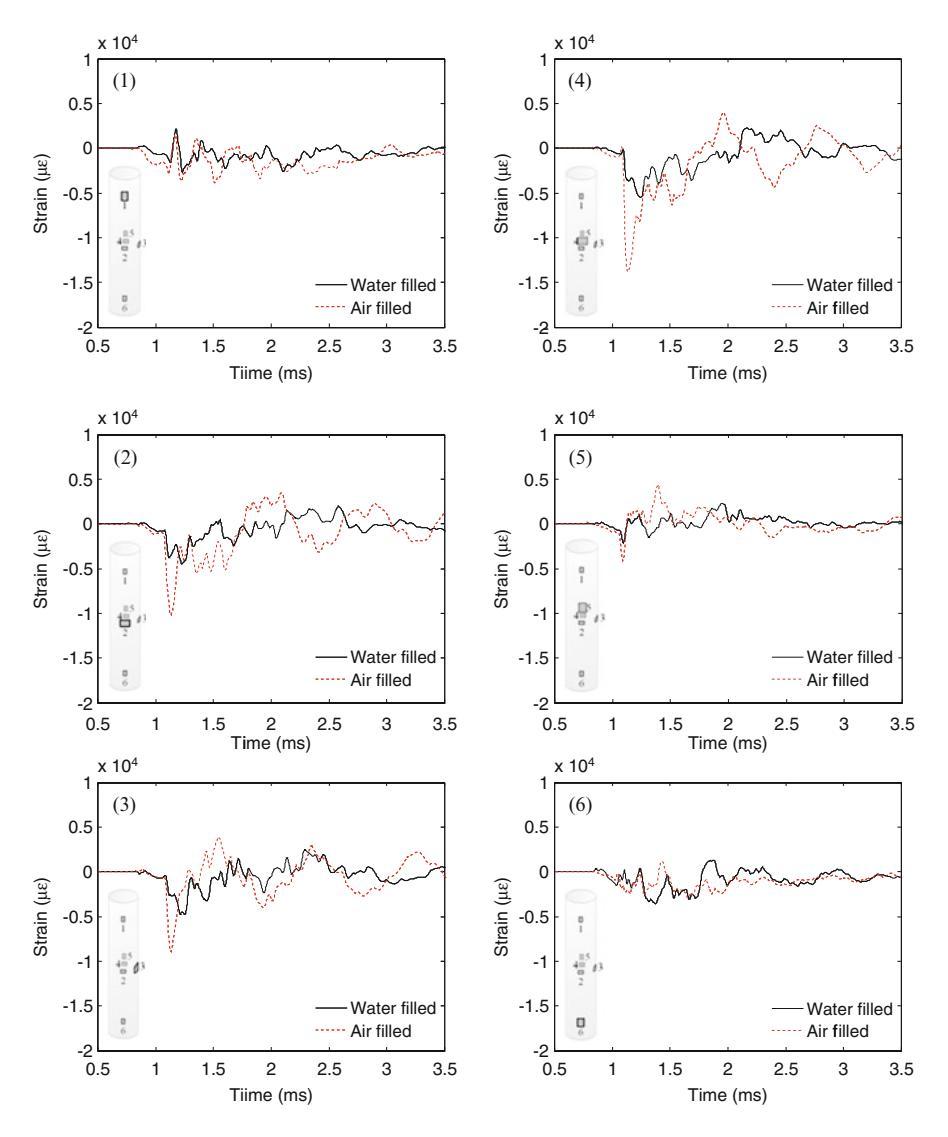
One tube of each air filled (AF) and water filled (WF) design were subject to 350 bar peak shock load caused by a 1 kg C4 charge at 1.4 m stand-off at 6 m depth (pressure-time history shown previously in Fig. 22). There is the initial compression/collapse of the tube inwards at its centre prior to the oscillatory squashing motion. However when these traces in gauges 2–4 for AF are compared to WF (see Fig. 24), there is a marked difference in response. Using water as the filler fluid causes a damped the amplitude of response, reducing peak strains from 1.5% in AF to 0.5% in WF (see gauge position 4 recording the fluctuation in hoop strain on the back facing side of the tube in Fig. 24).

The tubes were both subject to a pressure of 350 bar (there were two independent recordings of pressure either side of the targets). The damage sustained by AF relative to WF was apparent with no visible damage observed for WF whereas AF shown in Fig. 25 shows axial cracking, most likely caused by shear failure during the circumferential crushing phase of the sample deformation causing cracks to initiate.

**Fig. 24** Strain gauge data is displayed for the first 3.5 ms with peak shock pressure of 350 bar (1 kg C4; depth 6 m; stand-off 1.4 m) for each gauge position on tubes AF and WF, each plot shows the corresponding data for AF (air filled) and WF (water filled) at that particular location

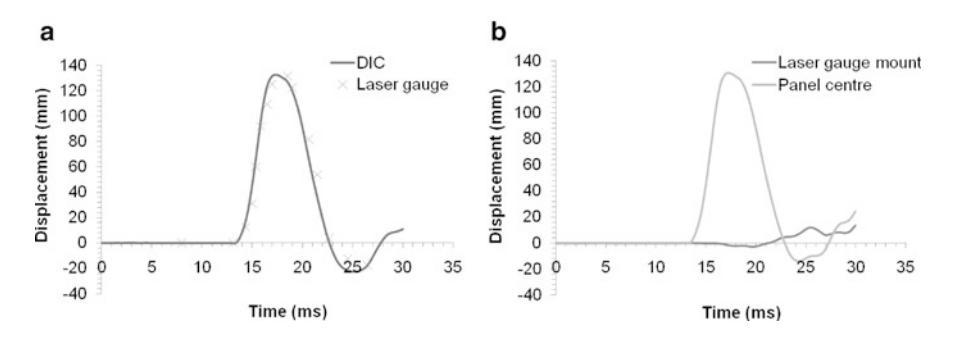
As stated previously, point data on the targets was taken from the DIC analysis and compared to the measurements recorded by a laser gauge for verification purposes (see Fig. 27). Data was taken from the point where the laser gauge was targeting, which was precisely identified in the raw images. There was good agreement, with a <1% error until maximum deflection, between the two sets of measurements as shown in Fig. 27a.

Fig. 27 Comparison of the central point displacement measured by the laser gauge and that recorded by the DIC analysis. The data shown is from the 30 kg at 8 m stand-off air-blast on G1: (a) analysis of the same point deflection during the blast measured by the DIC analysis and by the laser gauge; and (b) point data taken from the DIC analysis showing the relative movement of the laser gauge mount to its original target point on the panel

During the blast event, there reaches a point in time where the laser gauge (visibly) began to move and the data it was recording became compromised. The steel beam structure, comprising the mount for the laser gauge, flexed and vibrated after the (primary) target response reached peak deflection. To clarify when the laser gauge began to move, the steel beam itself was speckled and computed for its movements. It can be seen from Fig. 27b that the position of the laser gauge begins to move at the point where the panel is reaching its maximum deflection. This data shows qualitatively where the reliability of the data deteriorates. After this stage the laser gauge begins to flex and rotate (observed in the video recording) and so the validity of its results breaks down, since it was not at its original start position nor was it pointing at the same point. This exercise indicated a close agreement of the two systems for point displacement measurements until the point of maximum deflection. Therefore the validity of the measurements taken using DIC techniques under such extreme conditions can be taken to be true (provided vibrations of the cameras can be kept to a minimum). Provisions of heavy based tripods, held down with auxiliary weighting, supporting the cameras isolated on rubber mounts ensured minimal vibration transmission until the target's first period of oscillation completed. To be conservative within this analysis, the DIC data is accepted until the first rebound. All data presented and discussed is taken from within this period.

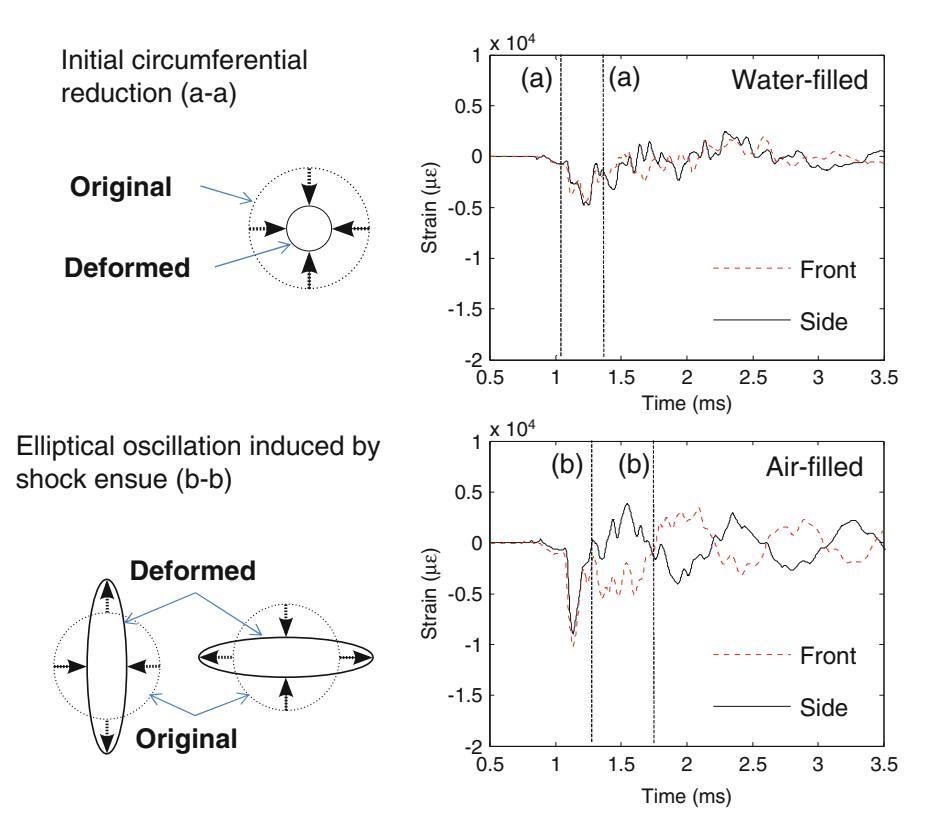
All common modes of response expected by tube structures to underwater shocks were present as mentioned in the previous section of analysis: circumferential reduction/expansions (breathing) and elliptical oscillations (squashing) as illustrated in Fig. 28. The tubes represent an alternative geometry to the flat panels. The initial shock wave wraps around the cylindrical geometry, causing an inward compression. After the pressure of the surrounding fluid reduces the energy gone into deforming

**Fig. 28** Diagram illustrating the two main modes of deformation observed, breathing (*top left*) and elliptical oscillation or squashing (*bottom left*) as the relative magnitudes of strain observed in both tube cases, water filled (*top right*) and air-filled (*bottom right*)

the tube in this manner is released in the mode of oscillatory vibrations with the dominant mode in the form of a circumferential squashing motion. These two modes of vibration were the most dominant of those observed during these trials, however, the most significant result to emerge from this trial is the fact that the backing fluid (filler fluid) made considerable savings with regard to damage sustained by the tube structures (visible in Fig. 25). The denser filler medium (water) made the tube effectively more rigid and reduced the magnitude of surface strains experienced and hence damage sustained. Figure 24 shows that the water filled tube experienced surface strains of half the magnitude of those experienced by the air-filled tube. To analyse this further, having a denser filler medium also dampens the vibrations quicker. After a few milliseconds, the strains in the air-filled tube. Moreover the water-filled tube seems to also resist the elliptical/squashing mode of vibration clearly observed with the air-filled tube. This is due to the fact that the tube needs to compress the filler medium to oscillate between tension/compression when going

through this squashing motion and the energy required to compress the denser filler medium is too great. Therefore the energy is dissipated within the water filler medium and in mild residual surface vibrations in comparison to the air-filled tube which freely vibrates with large magnitude of strains >1% (highlighted in Fig. 28).
