Structural Integrity Study for Additional Piles on an Existing Jacket Structure in Western Indian Offshore

Praveen Bhat and Bakul Master

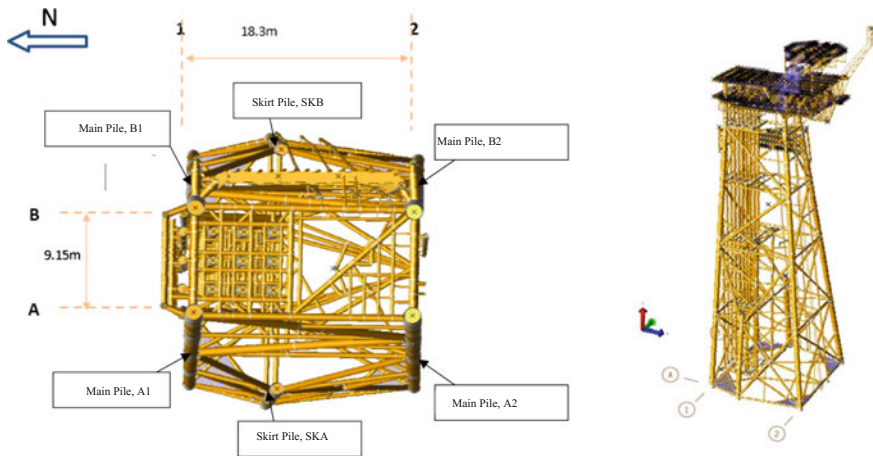
The study for this typical jacket structure, located in western offshore, for the structural integrity check on specific requirements from the asset/platform operator in the context of its design life has been outlined. The salient features of the platform have been listed in Table 1 and Fig. 1.

Fig. 1 Key plan and 3-D view of the jacket structure
