# Chapter 12

## Forensic Evaluation of Long-Distance Flow in Gently Sloped Ground During the 2018 Sulawesi Earthquake, Indonesia

Hemanta Hazarika, Divyesh Rohit, Takashi Kiyota, Mitsu Okamura, Siavash Manafi Khajeh Pasha, and Sukiman Nurdin

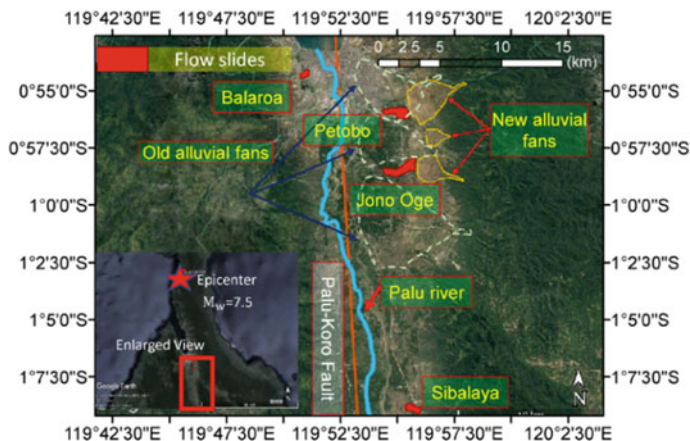
**Fig. 12.3** Distribution of alluvial fans and the locations of long-distance flow-slide (marked in red) in different areas of Palu (Hazarika et al. 2020)

As shown in Fig. 12.3, the flow-slide sites are all situated along the edges of Palu Valley in the low-lying regions, where the new alluvial fans converge with the old alluvial fan deposits of Palu River (Hazarika et al. 2020). Further, according to Kiyota et al. (2020) the recent alluvial fans situated at higher elevation are comparably small and with a gradient of 5% had groundwater at lower level due to the permeable coarse gravel layers. On the other hand, old alluvial fans located at lower elevation are comparably large with a gradient of 2–5%. Due to shallow water table and easy access to groundwater, these areas have been utilized for growing paddy, with formation of some human settlements. Extensive flow-slides occurred in the floodplain with loose overlying sediment layers, located in the lowland area between the large fans.

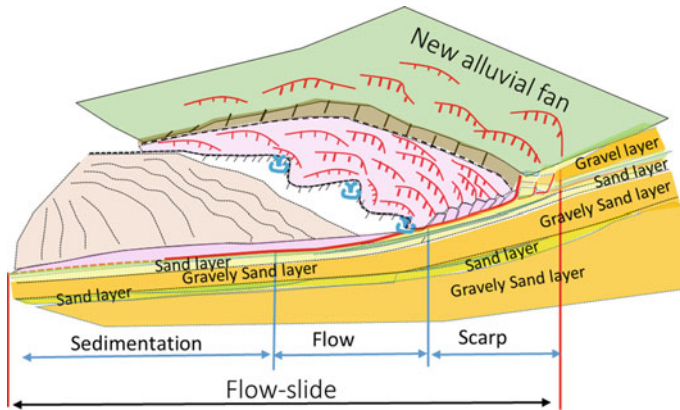
Figure 12.4 shows an outline of the flow-slide consisting the collapsed part (main scarp), flow part and sedimentation part. The devastated areas have very gentle gradient with an average of 1–5%, and they are located directly below a knick line on a new alluvial fan. Furthermore, surface water was present in all the damaged areas despite scanty rainfall prior to the survey. The subsections below discuss the findings of the field investigation at all the major flow-slide sites by the three

**Fig. 12.4** Outline of long-distance flow-slide (JICA 2019)

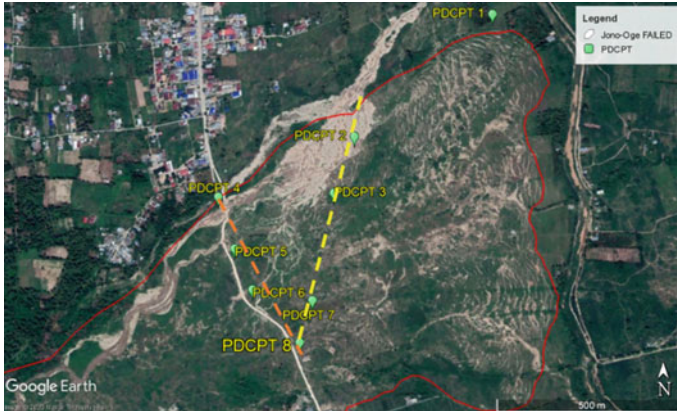
multiple locations in and outside the failure zone. One test (PDCPT1) was conducted outside the flow zone, and the other tests (PDCPT2 ~ 8) were conducted inside the flow-slide zone in two arrays, to assess the subsoil profile in two different directions as shown in Fig. 12.12 by two dotted lines.

Fig. 12.12 Locations of the PDCPT and collected soil samples at Jono Oge (Hazarika et al. 2020)

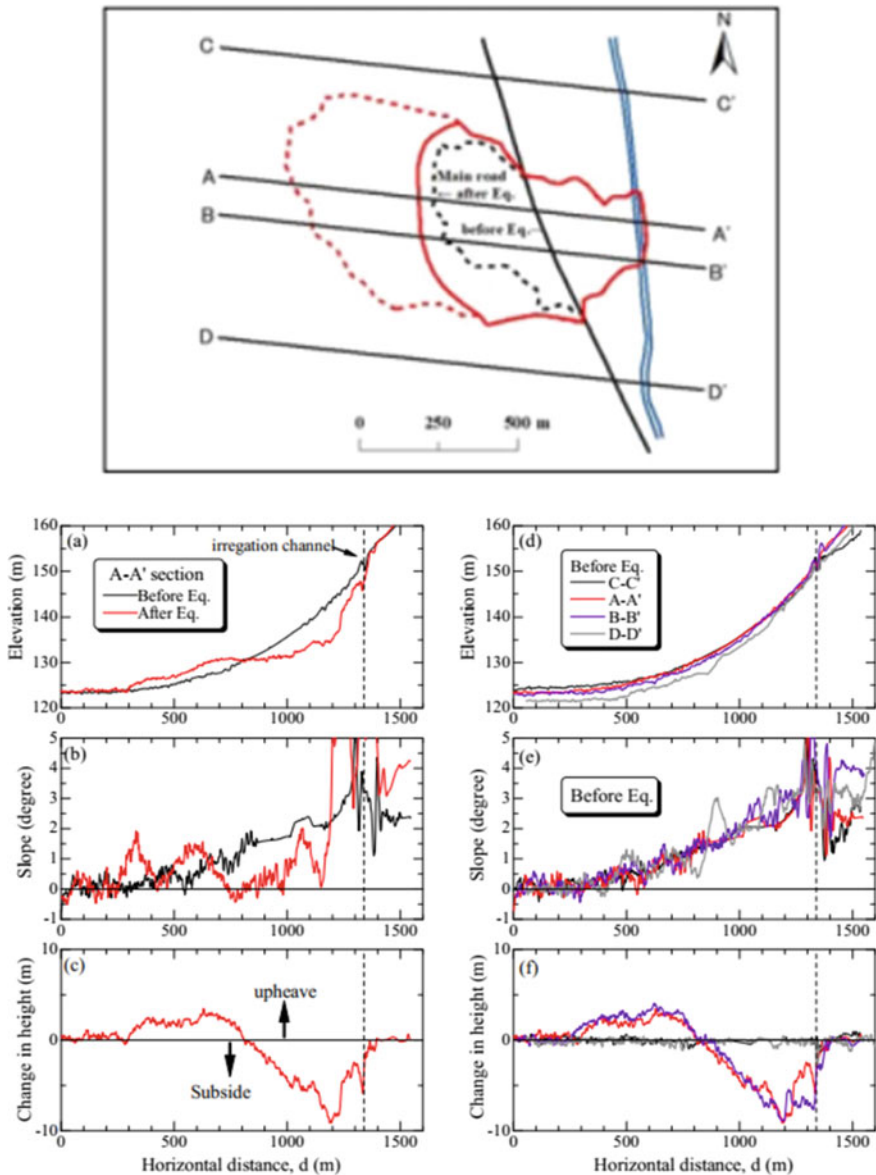
The terrain elevation from the AW3D maps is shown in Fig. 12.19a–f. In all the figures, the chainage of the irrigation channel is shown by a vertical dashed line set at 1340 m. Figure 12.19a–c shows the ground elevation profile along the flow-slide mainstream (section A–A') before and after the earthquake. Figure 12.19d–f shows the terrain elevation profile, ground slope and change in height of the flow-slide zone across sections A–A', B–B', C–C' and D–D'. All the sections were parallel to each other. It can be implied from Fig. 12.19a–c that the flow-slide caused an abrupt change in terrain elevation and slope profile in the damaged area. Also, the change in height (subsidence and upheaval) was caused due to the tension and compression strain in ground, as discussed before. Although the topographies of all these sections prior to the earthquake were similar, the post-earthquake deformations were significantly different. This could be attributed to the spatial variability of soil lithology, the mechanical properties of soils and the location of groundwater table.

Fig. 12.19 Surface terrain characteristics parallel to the flow-slide (Okamura et al. 2020)

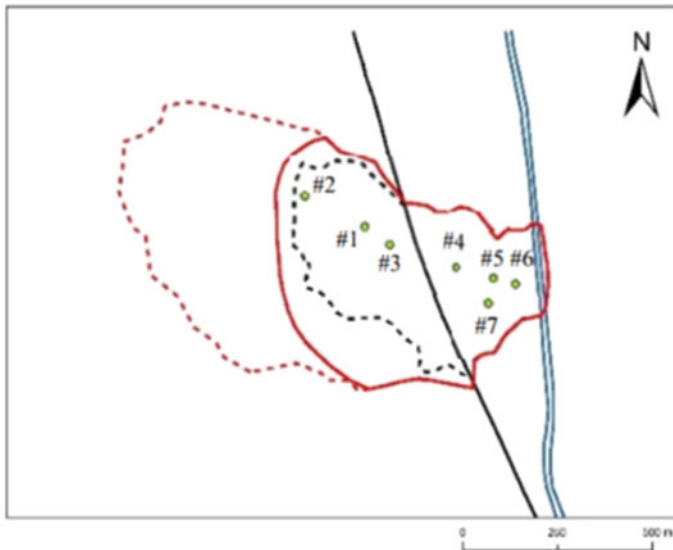
The research group from Ehime University conducted multiple trench excavation in the flow-slide zone in Sibalaya, to study the subsurface soil profile, the locations (indicated as #1 ~ #7) of which are shown in Fig. 12.21. This subsection will discuss the findings from one particular trench referred here as Trench #1.

Fig. 12.21 Locations of excavated trench in Sibalaya (Okamura et al. 2020)

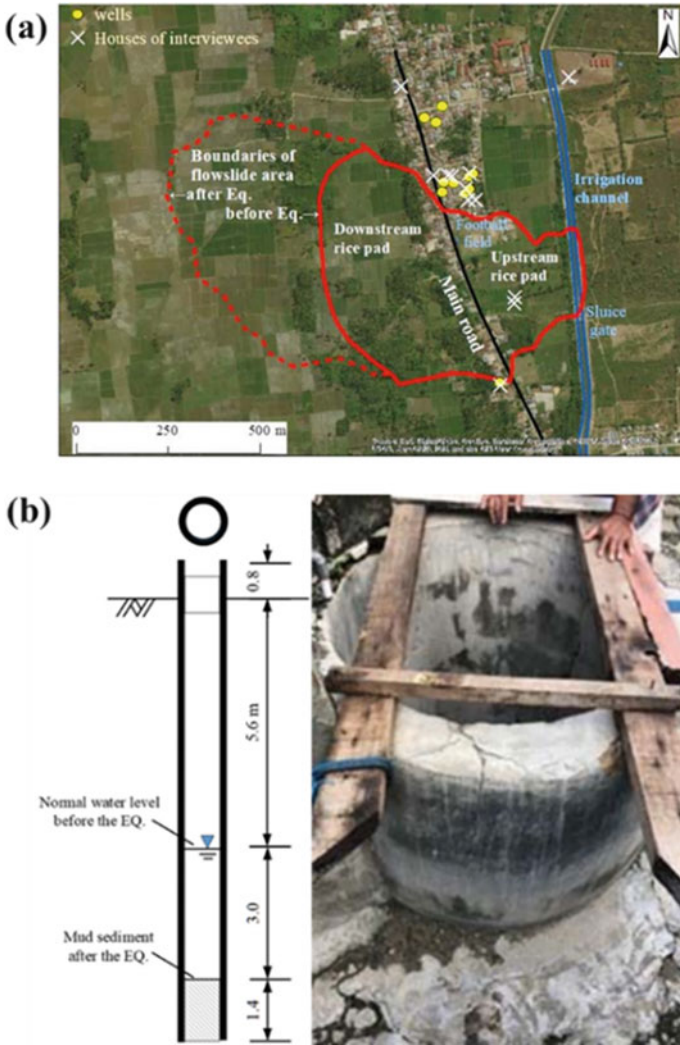
Okamura et al. (2020) conducted interviews of multiple residents living near the flow-slide area, who witnessed the flow-slide event (Fig. 12.23a). All the interviewees confirmed a strong ground shaking that continued for 10–20 s, which is in accordance with the ground acceleration recorded at the observatory near Balaroa.

**Fig. 12.23** Sibalaya flow-slide zone, **a** satellite image before the earthquake with locations of houses of interviewees, surveyed wells, main road, irrigation channel and flow-slide-affected area and **b** image and schematic diagram of well (Okamura et al. 2020)

Soon after the shaking ceased, within 10 s, almost all the interviewees felt a sudden drop in elevation. This vertical displacement, after the mainshock, was not recorded by the accelerometers near Balarooa, but was felt by many residents near the flow-slide areas on the east side of the Palu River, including residents of Sibalaya as well as Petobo and Jono Oge (Mason et al. 2019).

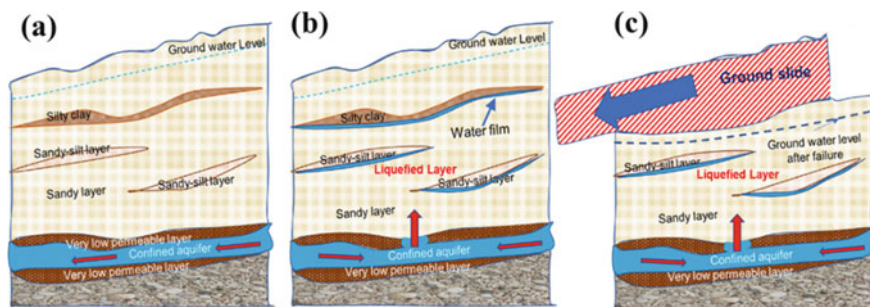
In consistent with previous studies and the soil stratification observed in this forensic investigation, Hazarika et al. (2020) have proposed a hypothesis explaining the combined effects including typical geology and terrains, and water film formation under the capping layer due to liquefaction of the sandy layer, and existence of underlying artesian aquifer could be a possible reason for such long-distance flow-slide (Fig. 12.34). At this stage, no general mechanism of failure could be hypothesized for all the sites.

**Fig. 12.34** Mechanism of flow-slide and development of water film under low-permeable layers **a** before the earthquake, **b** immediately after initiation of liquefaction and **c** after the earthquake (Hazarika et al. 2020)

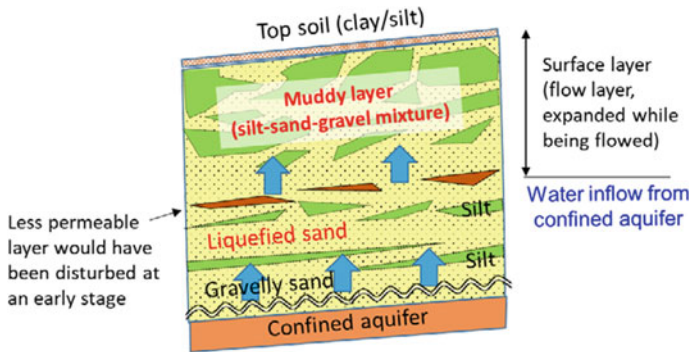
On the other hand, hypothesis proposed by Kiyota et al. (2020) suggested that the artesian pressure from the underlying confined aquifer triggered the flow-slide by reducing the shear strength of the overlying ground surface as shown in Fig. 12.35. Although the authors could not confirm the presence of such an aquifer yet, the JICA (2019) report confirmed the presence of a confined aquifer at a depth of 30 m through borehole tests, which is much deeper than expected. Also, the highly stratified subsoil lithology with alternating layers of sand, silt, gravel and organic soils reduced the effective permeability of the surface layers. The low permeability of surface layers inhibited the dissipation of excess water pressure, in spite of the upward pressure exceeding the critical hydraulic gradient contributed by the confined aquifer.

**Fig. 12.35** Schematic illustration of long-distance flow-slide based on water inflow from confined aquifer (Kiyota et al. 2020)
