A Case Study of Las Palmas Tailings Dam Failure

T. S. Aswathi, Ravi S. Jakka, and David Frost

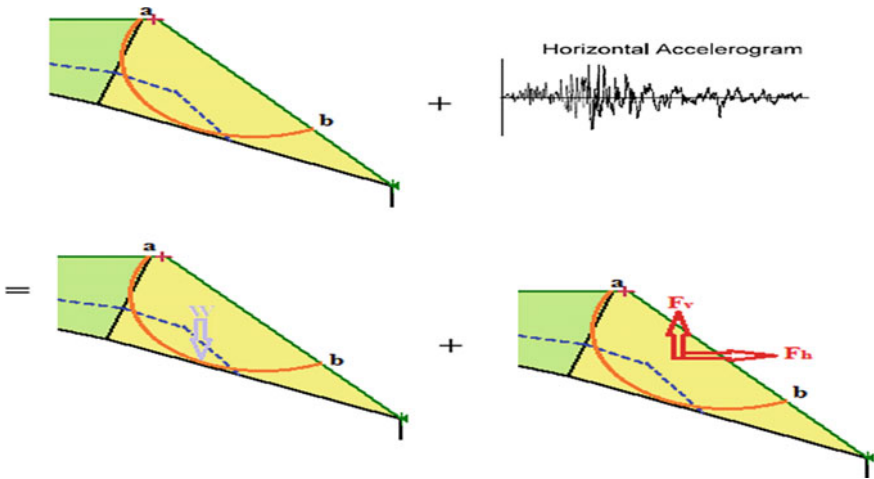
surface and divides the failure mass into slices. The seismic coefficients are used to calculate the forces created by the earthquake (Fig. 2). Then the overall equilibrium computation for the individual slices composing the failure surface is done.

Fig. 2 Pseudo-static procedure illustration considering downstream dyke

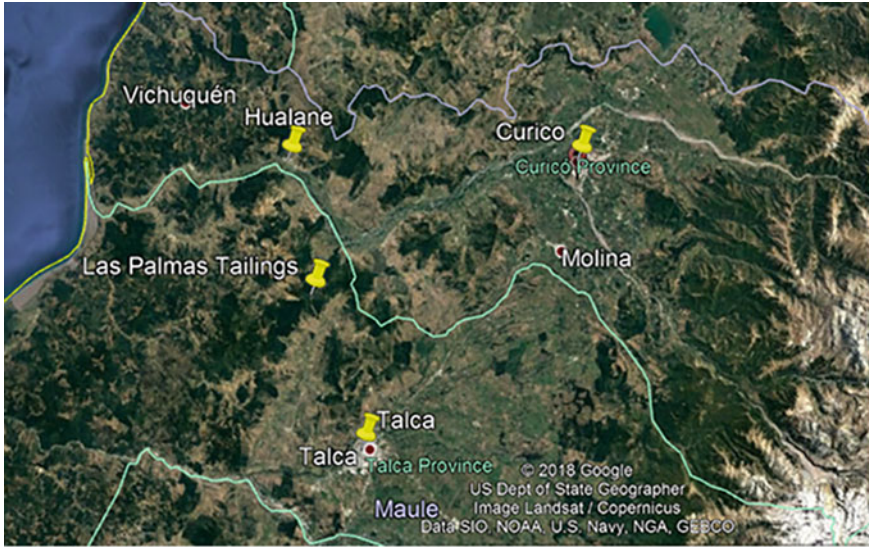
Fig. 3 Location of Las Palmas tailings dam along with Curico, Talca and Hualane stations

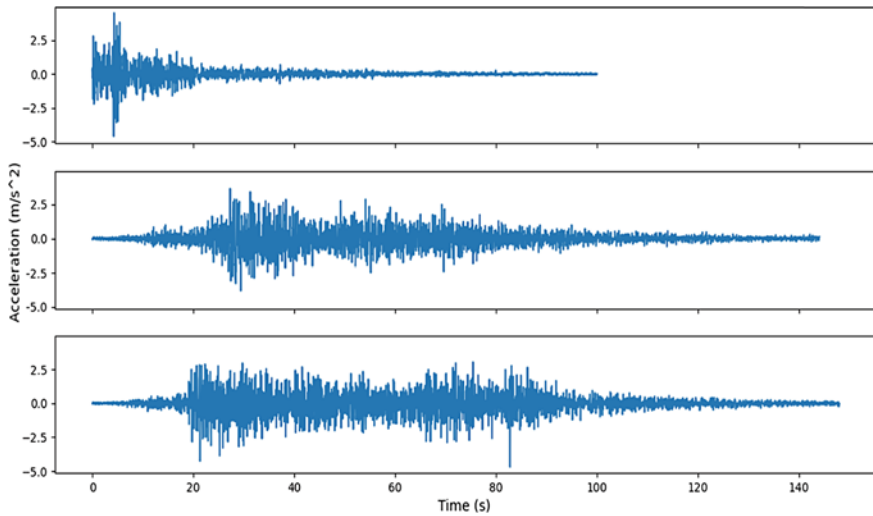
Fig. 4 Time history records at Curico, Hualane and Talca stations

stations to the tailings dam. This was done as there was no strong motion record recorded on the site. As the effect of the vertical seismic coefficient is negligible, only horizontal seismic coefficients are considered for this study. Table 1 gives the PGA and horizontal seismic coefficients of the three stations. Figure 5 shows that the factor of safety in the middle and downstream dyke are 2.325 and 1.472, respectively, indicating the tailings dam is stable under static conditions. Figure 6 shows that the factor of safety corresponding to the seismic coefficients 0.47, 0.39 and 0.48 in the downstream dyke are 0.806, 0.846 and 0.796, respectively. And Fig. 7 shows that the factor of safety corresponding to the seismic coefficients 0.47, 0.39 and 0.48 in the middle dyke are 0.935, 1.061 and 0.922, respectively.
