# Experimental Investigations and Numerical Simulations for the Seismic Assessment of a Masonry Building

Mariella Diaferio

, Marilena Venerito, and Michele Vitti

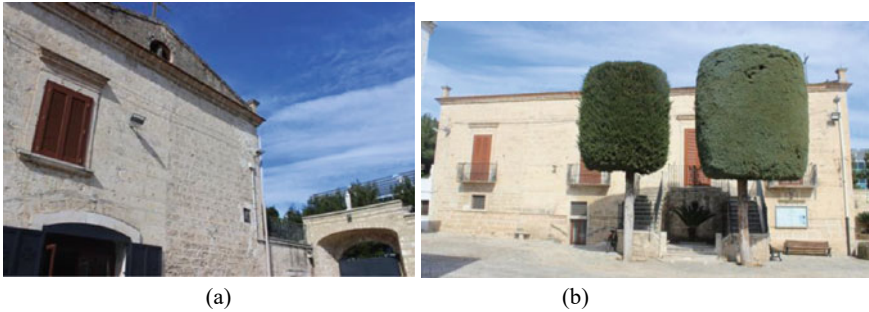
**Fig. 2** a Frontal view of the East façade; b Frontal view of South façade of San Marco Evangelista Church

The San Marco Evangelista church was built during the VIII century and its original function was farmhouse. The visual inspection of the structure highlights that it was built in two periods, as two different materials can be recognized in the structure. In detail, the main nave of the church and the apse have been realized in the same period and with the same materials, while the remaining rooms are characterized by a more porous material, and it was reasonable built prior to the first cited part. This consideration is confirmed by the presence of an arch which is not coherent with the actual orientation of the floor, it can be hypothesized that in the original structure, which did not comprehend the actual nave and apse, the floors were oriented orthogonally to the actual direction, coherently with the distribution of the masonry walls, however, when the other parts of the structure were built, the floors were substituted and oriented differently (see Fig. 2). The Church presents cracks localized in the zones where the two materials are connected.

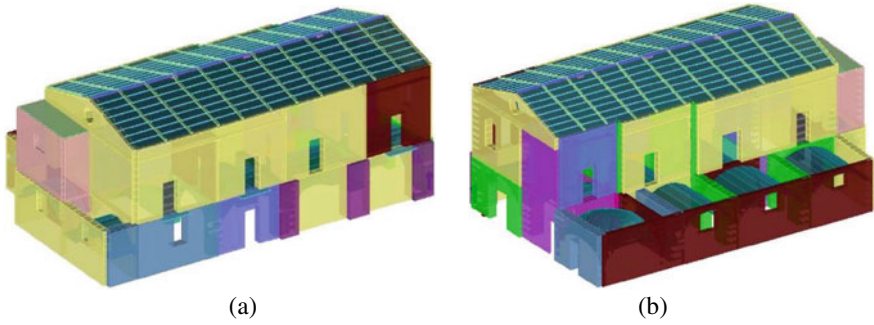
**Fig. 8** 3D view of the finite element model of the San Marco Evangelista Church: **a** south view; **b** north view

The numerical model assumes that the walls have a homogeneous stratigraphy whose thickness is imposed based on the endoscopic results. The vertical walls and the vaults have been modelled by means of 7338 shell elements, while the columns at the attic and the roof elements have been modelled through 861 beams, and the floors have been modelled by means of 502 elements which distribute the loads. The whole model is characterized by 7664 points; in Fig. 8 the 3D view of the model

is shown, the different colors are related to the adoption of different geometrical thicknesses.
