Preliminary Stage OpenSEES Simulation of the Collapse of Plasco Tower in Fire

Ramakanth Domada, Tejeswar Yarlagadda, Liming Jiang, and Asif Usmani

© Springer Nature Singapore Pte Ltd. 2024
M. Madhavan et al. (eds.), *Proceedings of the Indian Structural Steel Conference 2020 (Vol. 1)*, Lecture Notes in Civil Engineering 318,
https://doi.org/10.1007/978-981-19-9390-9_11

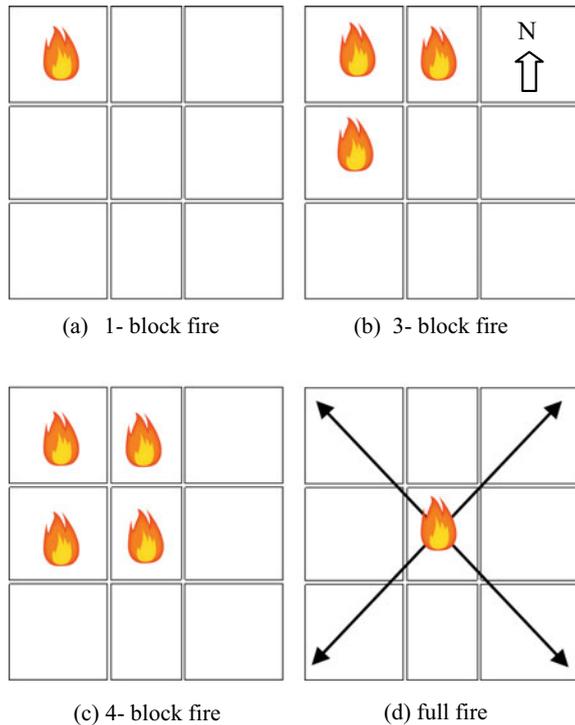
Four fire loads for the analysis are considered which involve one, three and four blocks and the entire floor as shown in Fig. 1.

Fig. 1 Considered fire load scenarios with block-wise extents (secondary beams are hidden in these representative pictures)

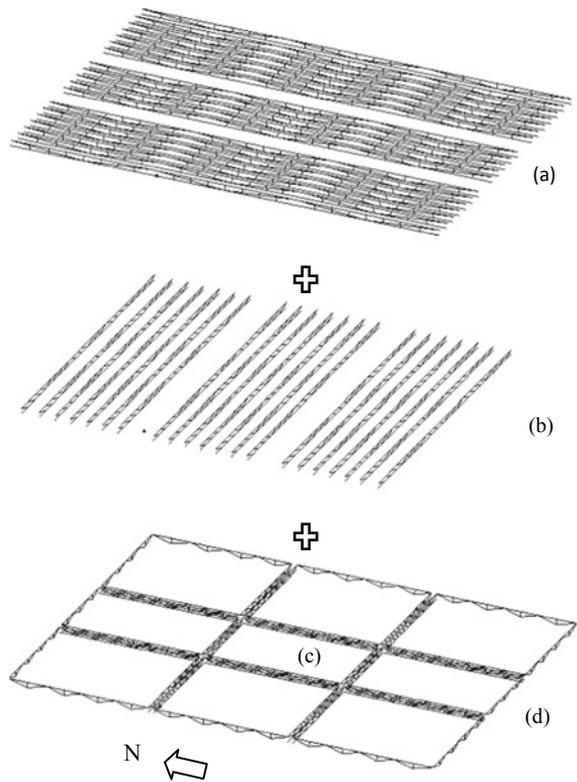
Trusses had been provided along the EW directions and Vierendeel beams along the NS direction. The plan looks almost square except that the distance in the NS direction is slightly longer than the EW directions (Fig. 2).

Fig. 2 Plasco tower floor assembly is made of **a** and **b** Secondary truss beams running in both directions, **c** Primary beams, **d** Edge beams

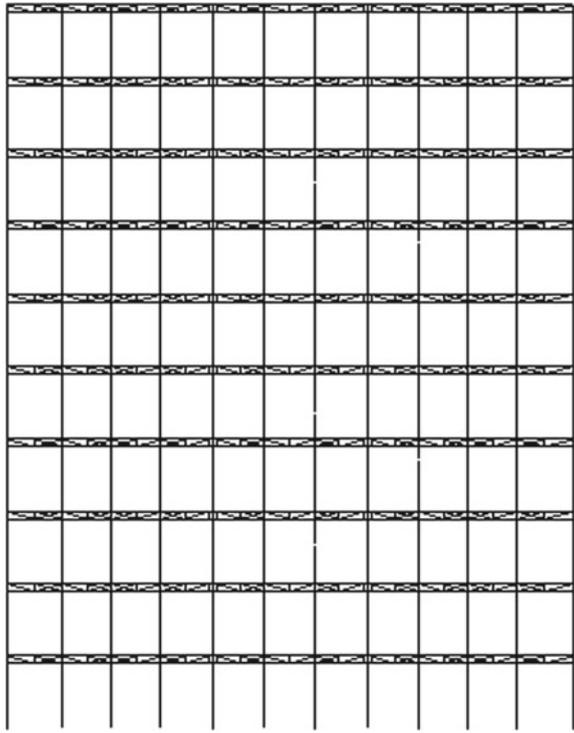
Fig. 3 Finite element model of Plasco tower visualized in OpenSEES GiD preprocessor

A UDL of 20 kN/m representing dead load, live load and super imposed dead load has been applied on all top cords of ceiling trusses. The element type of *dispBeamColumnThermal* has been used in this analysis which is a modification of existing *dispBeamColumn* element to accommodate thermal properties (Fig. 3).

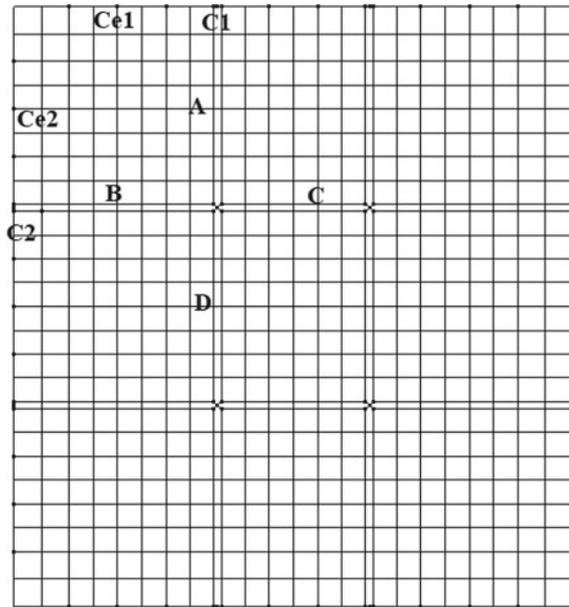
Observations have been made at the following locations in the floor and locations as shown in Fig. 4.

Ce1, Ce2 represent locations on the less stiff perimeter columns and C1, C2 are for stiffer columns which support primary beams. Beam mid-point deflections under fire have been observed at the locations A, B, C and D. Points A and B are on beams with equal length but they support different secondary trusses. C and D are on interior beams.

Fig. 4 Points of observation in OpenSEES model (plan)
