Flight Service Environmental Effects on Composite Materials and Structures

H. BENSON DEXTER

DONALD J. BAKER

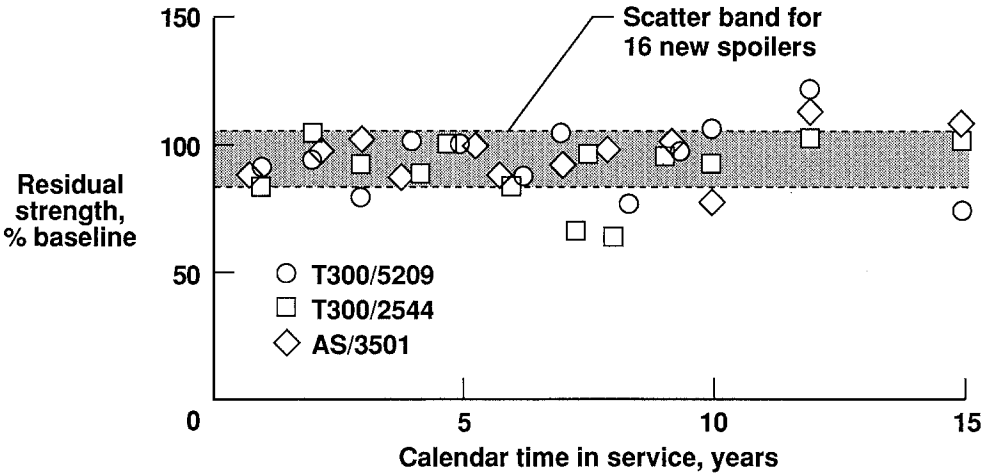
Residual strength tests were conducted on 37 graphite/epoxy spoilers to establish the effects of service environments. The spoilers were tested with compression load pads on the upper surface to simulate airloads. Trailing edge tip deflection was measured as a function of applied load for each spoiler tested. The test results are compared with the strength of 16 new spoilers in figure 8. The strength for each spoiler through 6 years of service generally falls within the strength scatter band for the baseline spoilers. However, spoilers with significant corrosion damage which were tested after 7 and 8 years of service, respectively, indicated a 35 percent strength reduction. An additional T300/2544 spoiler with no corrosion damage was tested after 7-1/2 years of service, which verified that the 7 year strength reduction was related to corrosion damage. Three spoilers tested after 9 years of service with little or no corrosion damage exhibited strengths equal to the strength of the baseline spoilers. An AS/3501 spoiler with 10 years of service and known corrosion damage failed at 78 percent of the average strength of the baseline spoilers. Two other spoilers with 10 years of service with no corrosion damage failed within the baseline strength scatter band. Spoilers tested after 12 years of service failed at or above the average strength of the baseline spoilers. One spoiler that had known corrosion damage after 15 years of service failed at about 75 percent of the strength of baseline spoilers.

Figure 8. Residual strength of B737 graphite/epoxy spoilers.

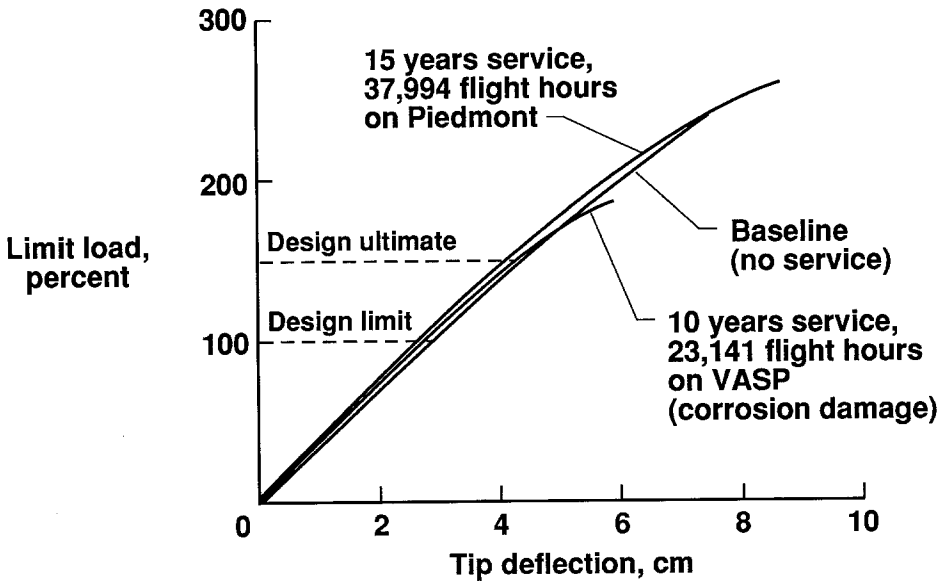
Load-deflection response of spoilers with 10 years and 15 years of service time are compared with the response of baseline spoilers in figure 9. The 10 year spoiler with known corrosion damage failed at about 78 percent of the baseline strength. However, the 15 year spoiler with almost 38,000 flight hours failed at about 8 percent above the baseline strength. Additional details of service experience with the spoilers can be found in [7].

Figure 9. Load-deflection response of AS/3501 graphite/epoxy spoilers for B737 aircraft.

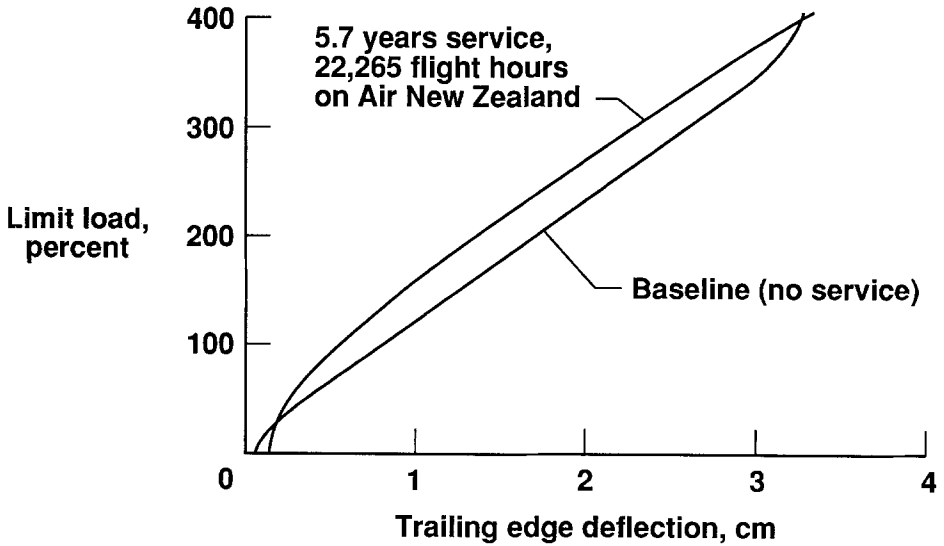
A graphite/epoxy rudder was removed from service for residual strength testing after 5.7 years and 22,265 flight hours on Air New Zealand. The load-deflection response shown in figure 13 indicates that the 5.7-year rudder had an initial stiffness higher than the baseline rudder, but the overall response is similar for the two rudders. The baseline and the 5.7-year tests were stopped at approximately 400 percent of limit load because of an instability of the loading apparatus. Although the rudders are designed by stiffness considerations and only

Figure 13. Load-deflection response of T300/5208 graphite/epoxy rudders for DC-10 aircraft.

one residual strength test has been conducted, the overall response of the rudder indicates that no degradation has occurred as a result of over 22,000 flight hours.

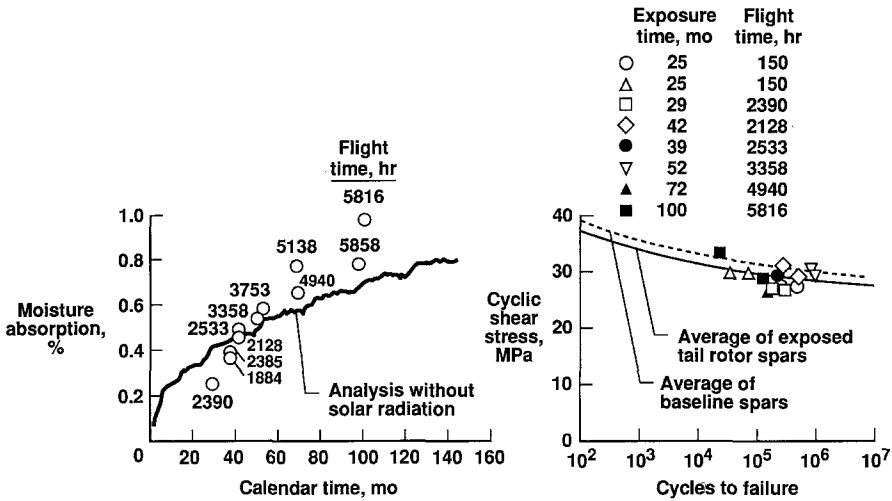
Four horizontal stabilizers and 11 tail rotor spars have been removed from aircraft and tested over a 9 year evaluation period. The components were inspected prior to residual strength testing and no significant service-induced defects or damage were found. Figure 17 shows predicted and measured moisture absorption data and strength retention of AS1/6350 tail rotor spars. All the spars were removed from helicopters operating in the Louisiana Gulf Coast region. Weather data from Lake Charles, LA were used in predicting the moisture absorption profile. Measured moisture absorption values shown in figure 17 are below the prediction by 0.05 to 0.15 percent for service times up to 40 months and are above the predicted values by 0.1 to 0.30 percent for service times beyond 70 months. During the development of design allowables and FAA certification testing, Sikorsky conducted accelerated conditioning at 87 percent relative humidity and 88°C on material coupons. The predicted moisture saturation level for AS1/6350 graphite/epoxy was 1.1 percent. After 9 years of service, the moisture level in the AS1/6350 tail rotor spars was slightly below 1.0 percent. Cyclic shear stress as a function of cycles to failure for the flight service tail rotor spars is shown in figure 17, along with data for baseline dry spars tested at room temperature for FAA certification. The shape of the curves was based on interlaminar shear fatigue tests. The results in figure 17 indicate a 95 percent strength retention for the service exposed spars compared to the baseline strength data used for certification.

Figure 17. Moisture absorption and strength retention of AS1/6350 Sikorsky S-76 tail rotor spars.

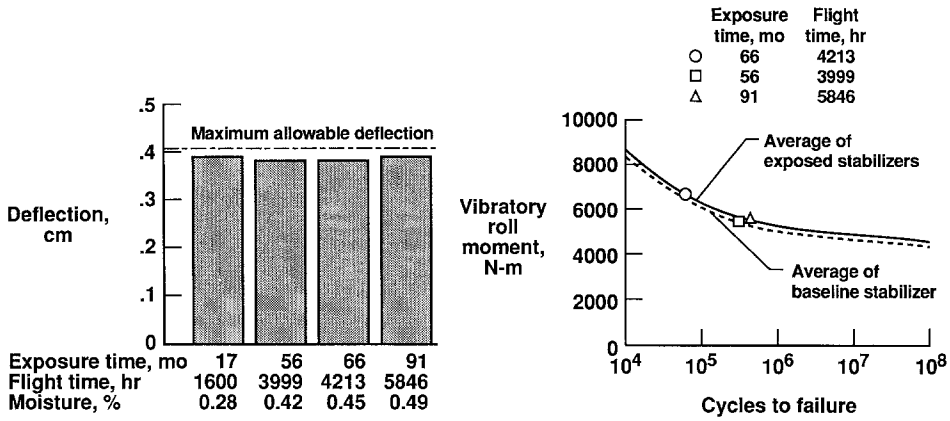
Structural response of the S-76 composite horizontal stabilizers is shown in figure 18. Proof load deflection data for the four stabilizers returned from service indicate deflections

below the maximum allowable deflection of 0.41 cm, indicating no significant stiffness loss. The maximum moisture content for the stabilizers, 0.49 percent, occurred after 91 months of service and 5846 flight hours. Full moisture saturation has not yet been reached. Vibratory roll moment as a function of cycles to failure is plotted in figure 18. The three stabilizers with 56, 66, and 91 months of service were fatigue tested at applied loads exceeding loads used for FAA certification. The average vibratory roll moment at failure for the service exposed stabilizers was approximately 2 percent higher than the corresponding roll moment for the baseline stabilizers used for certification. The shape of the curves was established by evaluating graphite/epoxy and Kevlar/epoxy coupons in the laboratory. The same shape was assumed to apply to full scale components. Additional details on the S-76 flight service program can be found in [14].

Figure 18. Structural response of Sikorsky S-76 composite horizontal stabilizers.

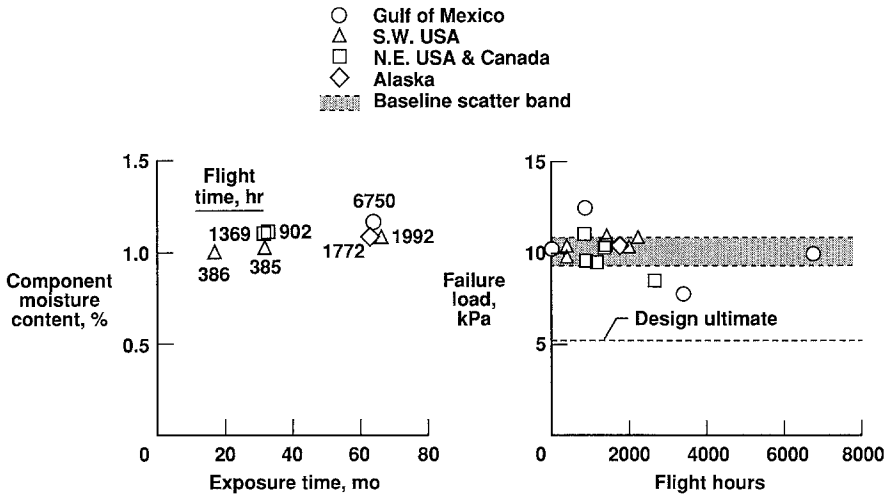
A total of 78 composite components have been removed from service for structural testing. The exposure times range from 12 to 84 months and flight times range from 386 to 6750 hours. Moisture absorption and strength retention data for T300/E-788 vertical fins are shown in figure 19. The moisture content was determined by drying plugs removed from the fins. The plugs included painted graphite/epoxy skins, adhesive, and honeycomb core material. The average moisture content measured for the fins is approximately 1.1 percent by weight. The fins operating in the humid Gulf of Mexico had moisture contents slightly higher than those for fins operating in other exposure locations. The residual strengths for 15 fins removed from service exceeded the design ultimate strength requirement. Failure loads for 12 of the fins fall within the baseline scatter band for five fins selected at ran-

Figure 19. Moisture absorption and strength retention of T300/E-788 Bell 206L vertical fins.

dom. One of the fins operating in the northeast USA and Canada was struck by lightning. This fin was damaged at the top but no apparent damage was inflicted on the structural box. This damaged fin failed below the baseline scatter band, but well above the design ultimate requirement.

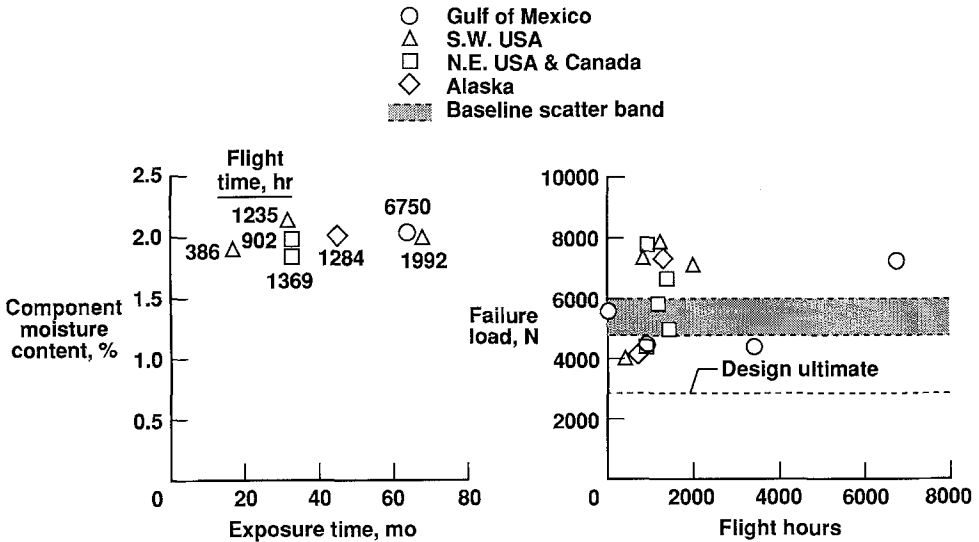
Moisture absorption and strength retention data for Kevlar-49/F-185 litter doors are shown in figure 20. Average moisture content for the litter doors is approximately 2.0 percent. This high moisture content was expected since laboratory tests and other outdoor exposure tests indicated that Kevlar/epoxy composites absorb about twice the moisture of graphite/epoxy

Figure 20. Moisture absorption and strength retention of Kevlar 49/F-185 Bell 206 L litter doors.

composites. There is considerable scatter in the strength data for the 15 litter doors that were removed from service and tested. All the litter doors exceeded the design ultimate strength requirement. Seven litter doors failed above the baseline scatter band and five litter doors failed below the baseline scatter band. The large scatter is expected since some of the failures were a result of metal hinge failures and latch pins slipping from the test fixture.
