The potential for catastrophic dam failure at Lake Nyos maar, Cameroon

JP Lockwood¹, JE Costa², ML Tuttle³, J Nni⁴, and SG Tebor⁵

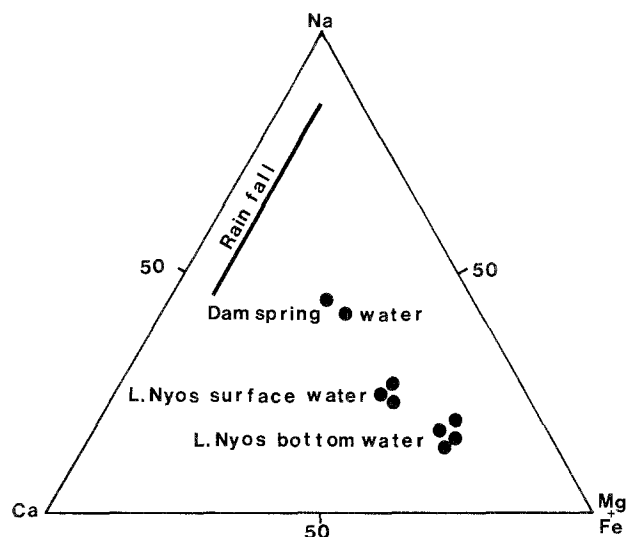
Chemical analyses of these two spring waters show similar compositions, although the lower spring contains slightly more iron. Both waters are more dilute by a factor of 2 than Lake Nyos surface waters (< 17 m), indicating an additional water source for the springs. A cation plot of deep Lake Nyos waters (> 150 m), surface waters, the two dam-face spring waters, and a range of typical rainfall compositions (Fig. 5) suggests a mixing-line relation, with one end member being deep Lake Nyos water and the other local precipi-

Fig. 5. Major cation proportions (M, molarity basis): 1) in Lake Nyos bottom waters below 150 m (average ionic strength, 0.016 M); 2) Lake Nyos surface waters above 17 m (average ionic strength, 0.0006 M); 3) dam springs (average ionic strength, 0.0003 M); 4) range for rainfall (from Eugster and Hardee 1979). Positions of dam springs shown on Fig. 3

tation. The dam spring waters probably vary along this mixing line depending on the season. During the driest part of winter the dam spring waters are presumably close to lake composition, but during the summer rainy season the springs are diluted by rainfall. The spring waters plotted in Fig. 5 were collected in March, after the summer rains had begun, and are midway between lake water and precipitation in composition.

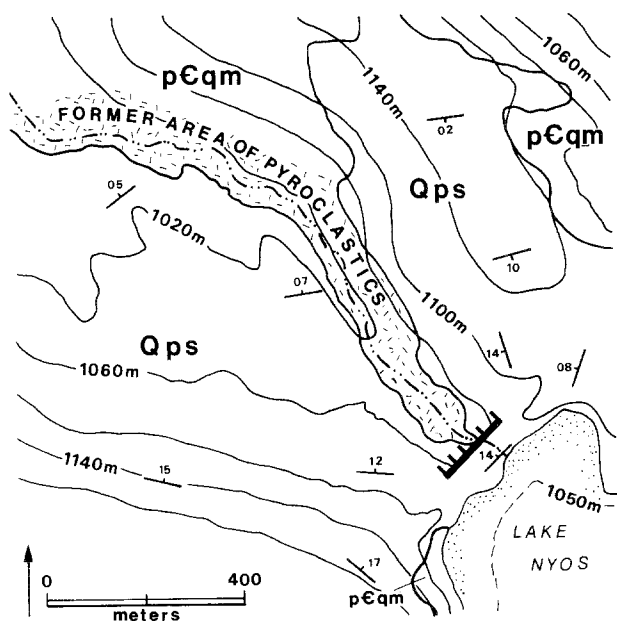
The pyroclastic rocks that form the Lake Nyos dam once extended much farther to the northwest, but erosion by the Lake Nyos outlet stream has removed all but a 45-m-wide remnant of the protective caprock at the dam's narrowest point (Figs. 6, 7). A section of pyroclastic rocks about 600 m long has been eroded away, exposing granitic bedrock along the streambed. Assuming an age of 400 years and a constant erosion rate, the natural spillway has receded at an average rate of 1.5 m/year. This high rate does not apply to the present, however, because the pyroclastic deposits

are thinner and less consolidated farther downstream, and erosion would have initially advanced upstream at a much higher than “average” rate. A slower present rate is also indicated by the vegetation on the dam face (Fig. 3). The presence of large fresh talus blocks of upper unit ash at the dam base does indicate that erosion is still proceeding. We cannot estimate the present erosion

Fig. 7. Geologic sketch map of Lake Nyos dam and adjacent areas. *Qps*, pyroclastic surge deposits; *pCqm*, Precambrian quartz monzonite. *Patterned area* denotes former extent of pyroclastic rocks, removed by stream erosion; *strike-and-dip symbols* indicate attitude of ash layering

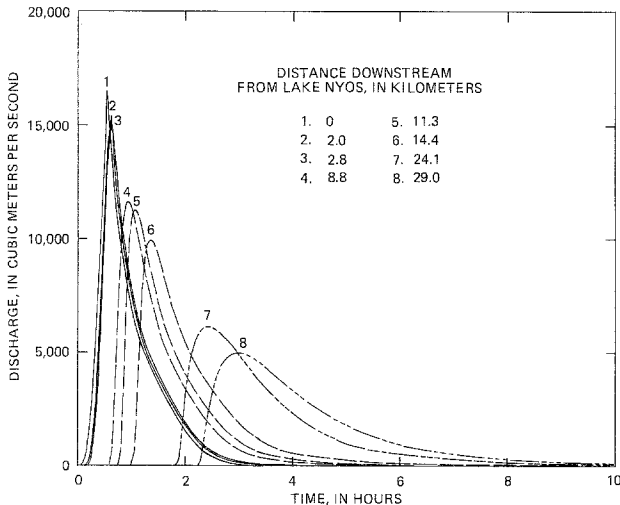
Fig. 8. Calculated hydrographs for hypothetical flood resulting from catastrophic failure of Lake Nyos dam. Individual flood-discharge curves refer to stations listed in Table 1

on differences in valley geometry. The *front* of the hypothetical flood wave would travel at speeds of 3.4–5.6 m/s and would take about 2.3 h to travel the 29 km evaluated, whereas the flood *peak* would travel between 0.94 and 3.0 m/s and would take about 3 h to travel this 29 km (Fig. 8). At this distance the flood peak would have attenuated to about 5100 m³/s.
