## LANDSLIDE DAMAGE TO THE BOAR RIVER WATER SUPPLY PIPELINE, BROMLEY HILL, JAMAICA : CASE STUDY OF A LANDSLIDE CAUSED BY HURRICANE GILBERT (1988)

Rafi AHMAD\*, Aedan H. EARLE\*, Peter HUGUES\*\*, Russell MAHARAJ\* and Edward ROBINSON\*

#### Abstract

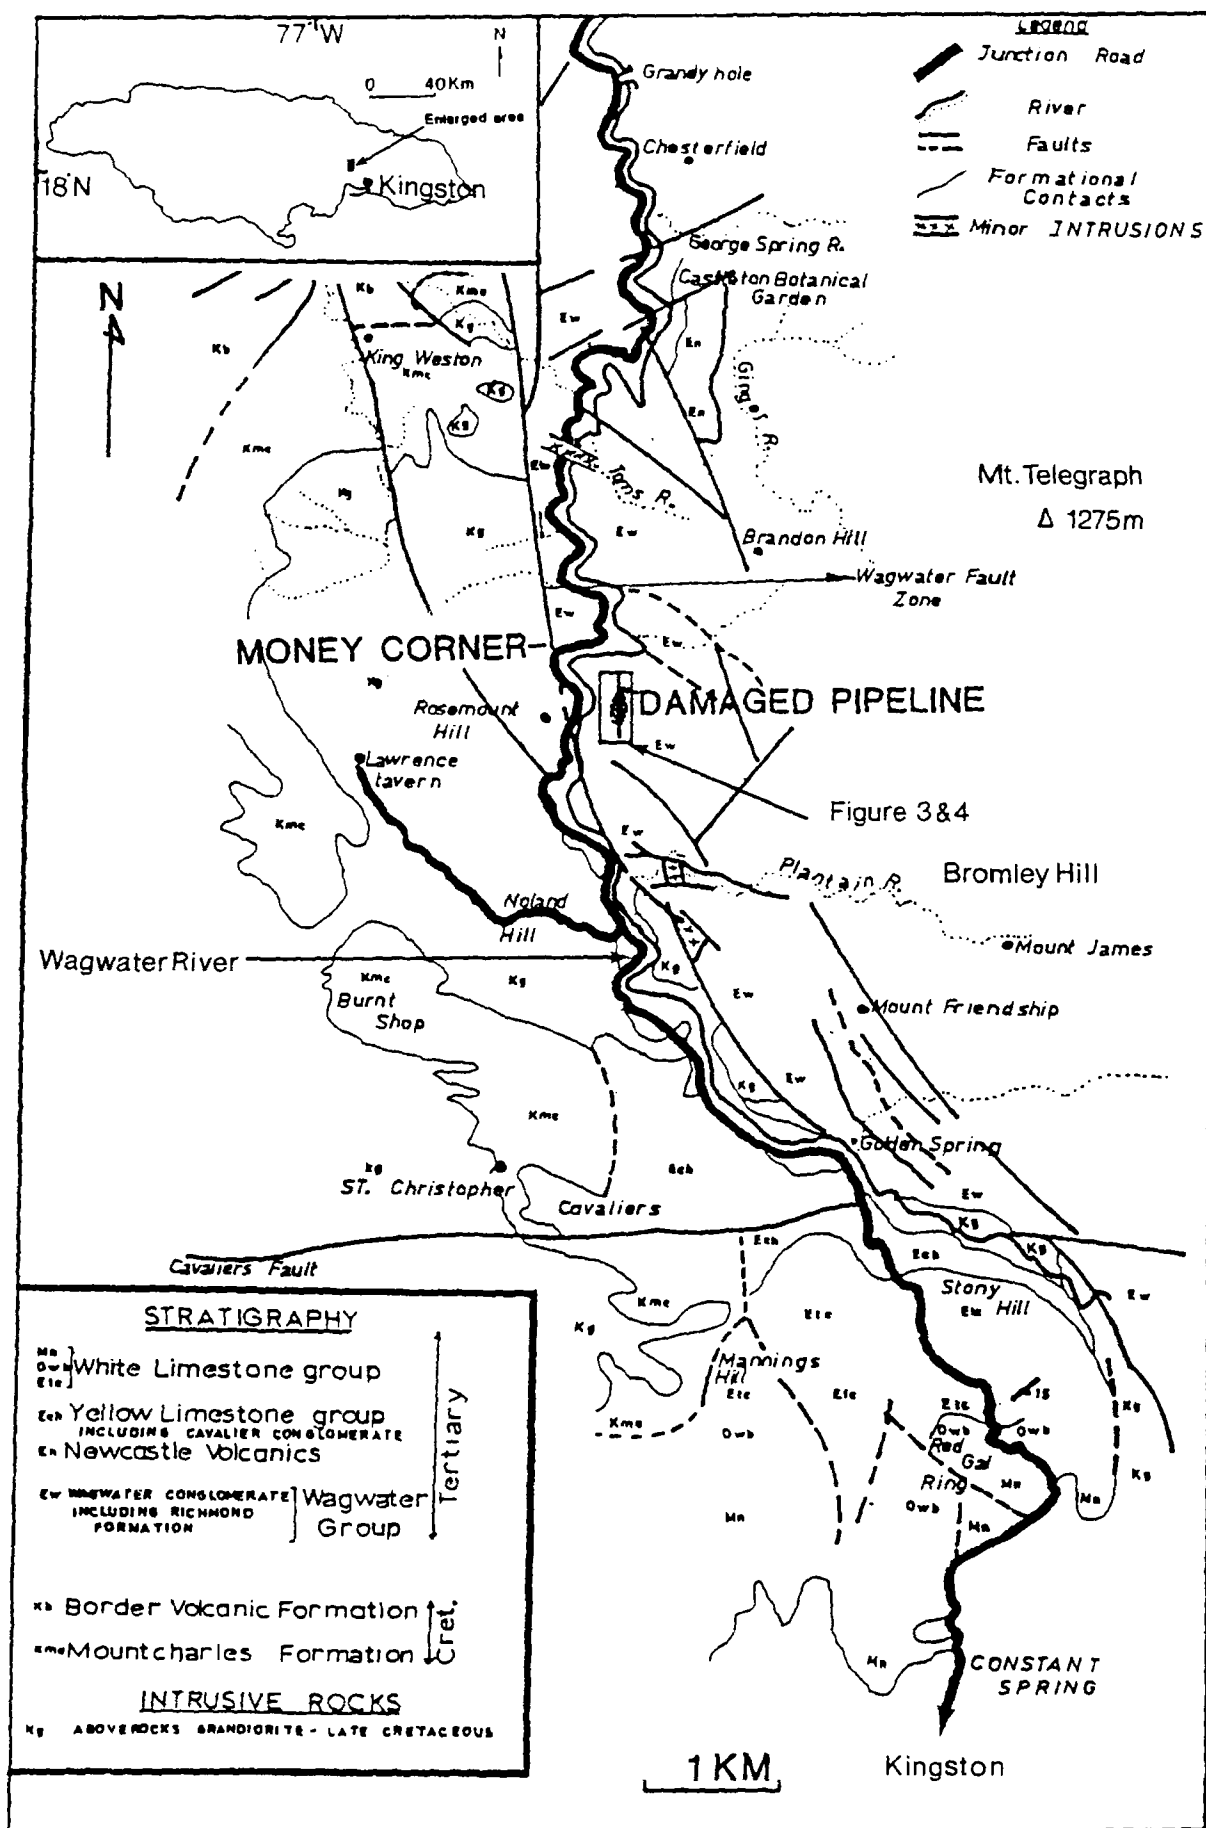
Fig. 1: Simplified geological-structural map of the western part of Wagwater Fault zone in Jamaica showing the location of the damaged pipeline at Bromley Hill. The location for Fig. 3 and 4 is marked. Geology and structure has been modified from Geological Survey Division, Geological Sheets Nos. 22 (1972), 25 (1974) and 24 (1978).

The damage site is located within the Wagwater Fault Zone (Fig. 1), which is an area of major tectonic disturbance in eastern Jamaica (Lewis and Draper, 1990). This setting has important implications for the pipeline alignment. The fault zone, over 750 m wide, has juxtaposed a sequence of interbedded conglomerates, sandstones, and shales (Wagwater Formation) against a coarse-grained, granodiorite pluton known as the Above Rocks Granodiorite. The sedimentary rocks of the Wagwater Formation are thrust over the granodiorite, a relationship which can be seen on the Junction Road (Fig. 1), where a major landslide, popularly known as Money Corner Landslide, marks the contact. Fracturing and hydrothermal alteration of the rocks of the Wagwater Formation, in and near the Fault Zone, are pervasive, and our observations suggest that sections of the pipeline route are within this zone, including the section where damage has occurred. The region is marked by a high relief and steep slopes. The major physiographic features in the area are controlled by the underlying geology and tectonic structures. High level river terraces suggest recent, probably continuing, uplift of the region. The valley slopes have been cleared for agricultural use, and this together with some degree of urbanization, has made many of the slopes unstable. Bedding discontinuities within the Wagwater Formation are subparallel to the trend of the ridges. Therefore, when slope vegetation is cleared, or interfered with, the incidence of slope instability is dramatically increased. The material underlying the slopes is deeply weathered for the most part, due to its inherent chemical composition. The depth of the weathered zone ranges up to as much as 9 m, sometimes more. Extreme climatic events, such as the passage of hurricane Gilbert have had a marked impact on the area. Landslides (debris flows and debris avalanches) were triggered along a majority of slopes by Gilbert. The debris flow which damaged the Boar River pipeline resulted from high precipitation associated with the hurricane, in an area where soil moisture was already at the saturation level.

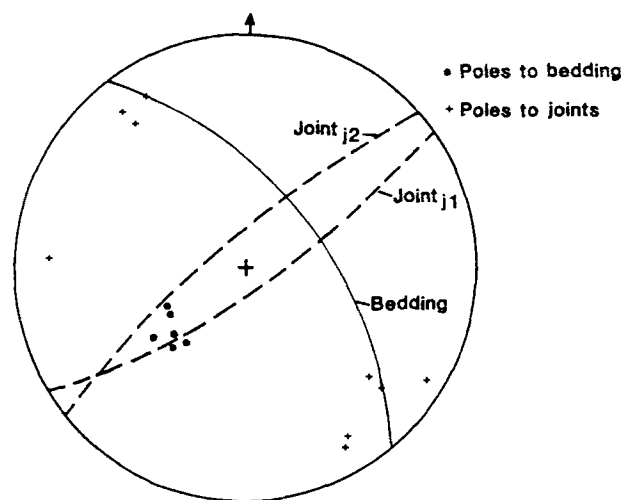
Bedding, joints, faults, and minor calcite filled extension joints are prominent in the area. Measurements of typical orientations are presented as stereographic projections in Figure 6.

Fig. 6: Equal area stereoplots of bedding and joints at localities around the damaged pipeline.

**Joints.** – Five joint directions have been identified, j1-j5, with spacing generally varying between 25 mm and 30 cm. Of these, only j1 and j2 are important and well developed, and have been included in the stereogram.
