A Fractographic Investigation of Thermal Embrittlement in Cast Duplex Stainless Steel

T. KOBAYASHI and D. A. SHOCKEY

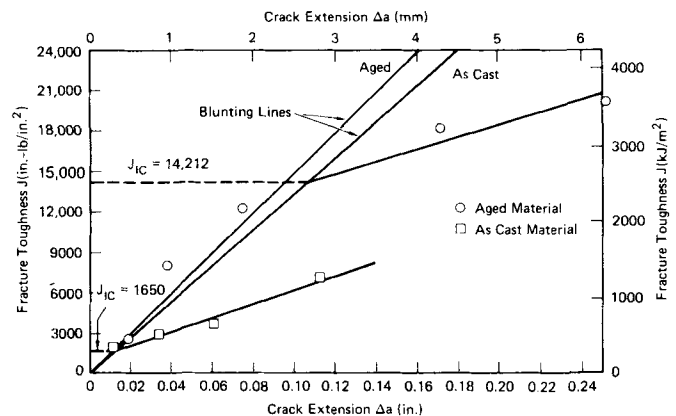
Fig. 1 — Static J-R curve for cast and aged duplex stainless steel.

The fracture resistance curves during crack extension for the as-cast and thermally embrittled material are shown in Figure 1.⁹ The tensile properties are tabulated in Table I.⁹
