The 16 September 2015 Illapel Earthquake and Tsunami: Post-Event Tsunami Inundation, Building and Infrastructure Damage Survey in Coquimbo, Chile

Abstract—The 16 September 2015 M_w 8.3 Illapel Earthquake generated a tsunami that caused severe building and infrastructure damage in Coquimbo, Chile. Initial reports indicated numerous buildings, transport, energy, water and coastal protection structures sustained varying levels of damage in response to tsunami exposure. A digital ‘census style’ survey was carried out in Coquimbo to measure and record tsunami hazard characteristics and associated buildings and infrastructure network component damage. Flow depths measured from 655 watermarks ranged from 0.1 to 4.7 m, with a 1.47 m mean and 1.02 m standard deviation. Over 3000 damage samples were recorded for tsunami exposed buildings and infrastructure components. Damage levels for 545 buildings showed most sustained partial but repairable damage at tsunami flow depths up to 2 m. A further 2544 damage samples were collected for transport, energy, water infrastructure network components and coastal protection structures. We observed undamaged infrastructure components in high proportions

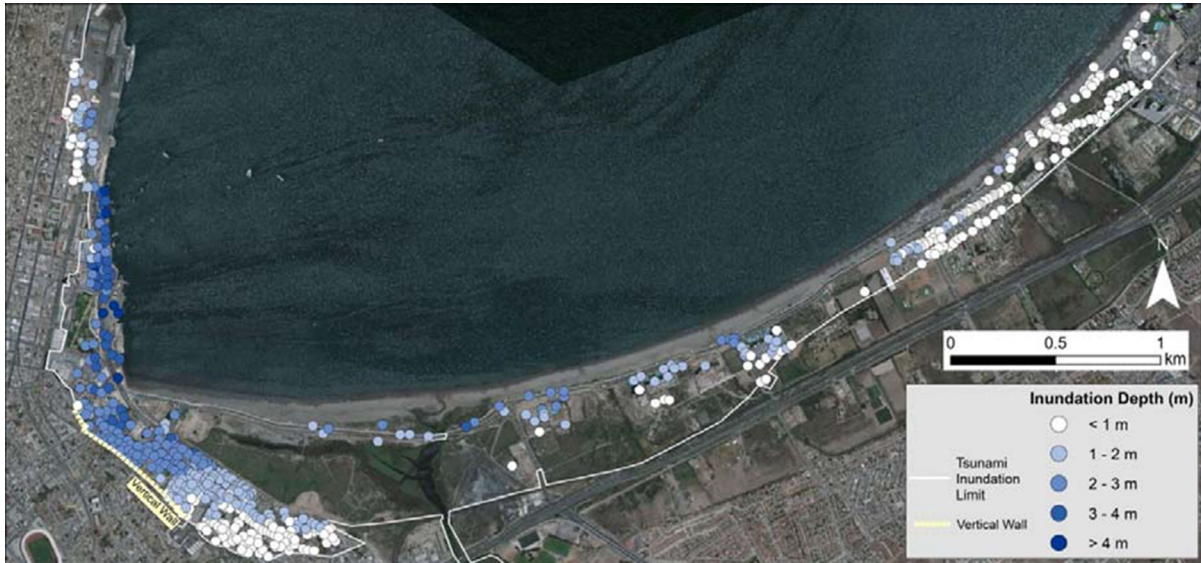
Tsunami flow depths were measured at 655 locations within the survey area. (Fig. 2). Depths ranged from 0.1 to 4.7 m with a mean and standard deviation of 1.47 m and 1.02 m. A post-event time series analysis of sea surface elevation data recorded at the Coquimbo Port tide gauge, showed a maximum amplitude of 4.97 m above the reference level, with the second wave being the largest (Aránguiz et al. 2016). Implementation of the model by Cortés et al.

The highest concentration of measured flow depths (359) was recorded from watermarks on buildings and structures in Baquedano. The mean flow depth of 1.54 m (0.9 SD) in Baquedano is nearly 1 m lower than depths measured in the Coquimbo Port, although depths at some sites exceeded 3 m. Inundation extents varied from 220 m near the southwest boundary to over 550 m toward the eastern boundary as the coastal plain widens. Notably, a vertical wall along the southwestern boundary of this survey area (Fig. 2) limited tsunami run-up. Flow depths up to 2.5 m measured on buildings within 100 m of the wall, are consistent with depths reported by Aránguiz et al. (2016). As the coastal plain toward the southeast widens, depths decrease eastward to 0.1 m to 0.15 m measured near the public park (Fig. 2). This area is afforded protection from a railway embankment located between the built-area

esplanade and built-areas near ‘Playa Changa’ beach show a gradual flow depth decrease eastward (Fig. 2). Depths ranged from 0.1 to 3.1 m, with a mean of 0.88 m (SD 0.68 m). At the western end of Avenida Costanera, flow depths up to 3 m were recorded at Condominio Altamar. Over a 4.7 km distance eastward of this location, depths decrease to 0.2 m to 0.5 m near Hotel de la Bahía. Flow depths were measured on both high and low-rise buildings, east of

Figure 2
Tsunami flow depths measured in the Coquimbo survey area
