# Weathering damage evaluation of rock properties in the Bunhwangsa temple stone pagoda, Gyeongju, Republic of Korea

**Abstract** The stone pagoda of the Bunhwangsa temple in Republic of Korea was made of piling small brick-shaped stones. The majority of stone bricks are andesitic rocks with variable geneses. Rock properties of the pagoda roof suffer partial significant deterioration, such as multiple peel-offs, exfoliation, onion-peel-like decomposition, cracks forming round lines and falling-off stone pieces. The stylobates and tabernacles at the four corners are composed of granitic rocks, which are heavily contaminated by lichens and mosses. Some of these contamination marks show dark black or yellowish brown colors by inorganic secondary hydrates. The four tabernacles and northern face of the pagoda body have been exposed to relatively high humidity, which causes light gray efflorescence as stalactites between the northern and western sides of the body. The efflorescences are composed of calcite, gypsum and clay minerals. The stone lion statues at the southeast and northeast corners are made of alkali granite, while the others are lithic tuff. Total rock properties of the pag

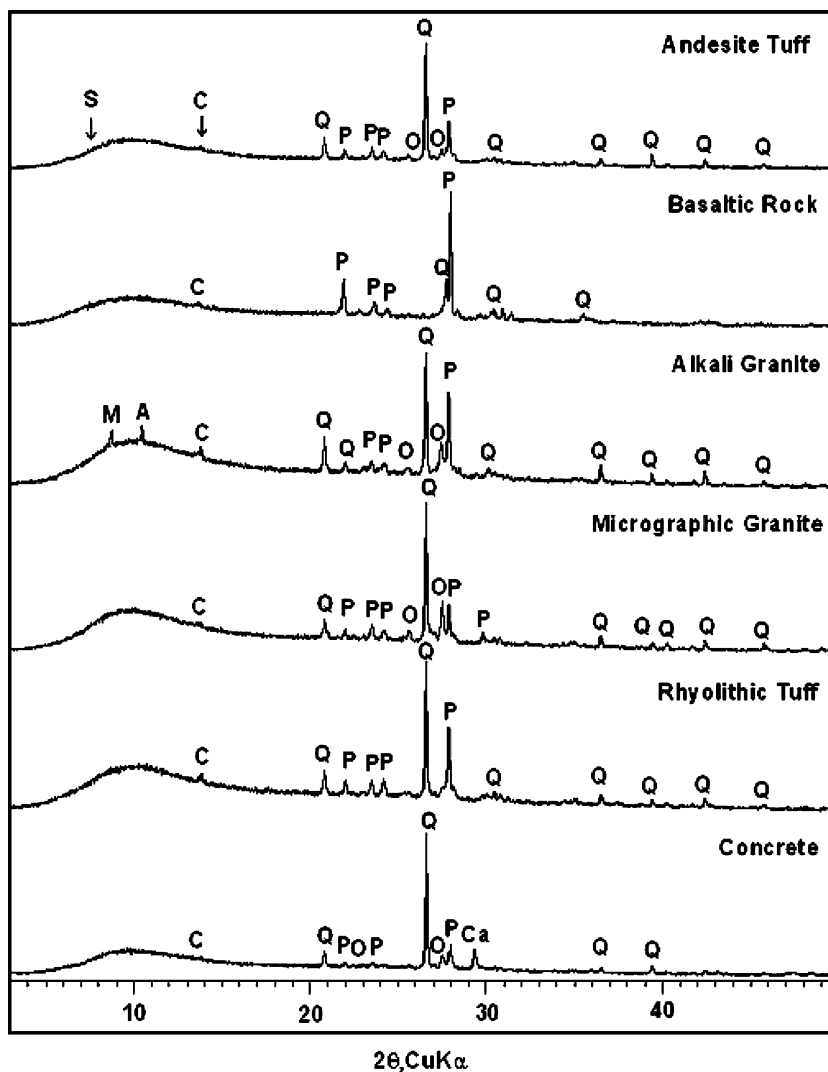
basalt. The X-ray diffraction analysis also identified a small amount of quartz and orthoclase along with the major mineral component of plagioclase. There were also traces of minerals such as smectite and chlorite. The alkali and micrographic granites usually were composed of quartz, orthoclase, plagioclase, and biotite, with traces of hornblende and chlorite (Fig. 5). The rhyolite tuff of the stone lion statues contains quartz, plagioclase, and chlorite. The concretes using materials for emergency treatment in 1915 were formed of calcite, quartz, plagioclase, and orthoclase added to cement.

**Fig. 5** X-ray powder diffraction patterns showing host rocks of the stone pagoda in the Bunhwangsa temple. (C chlorite, A amphibole, Q quartz, P plagioclase, M mica, O orthoclase, S smectite, Ca calcite)

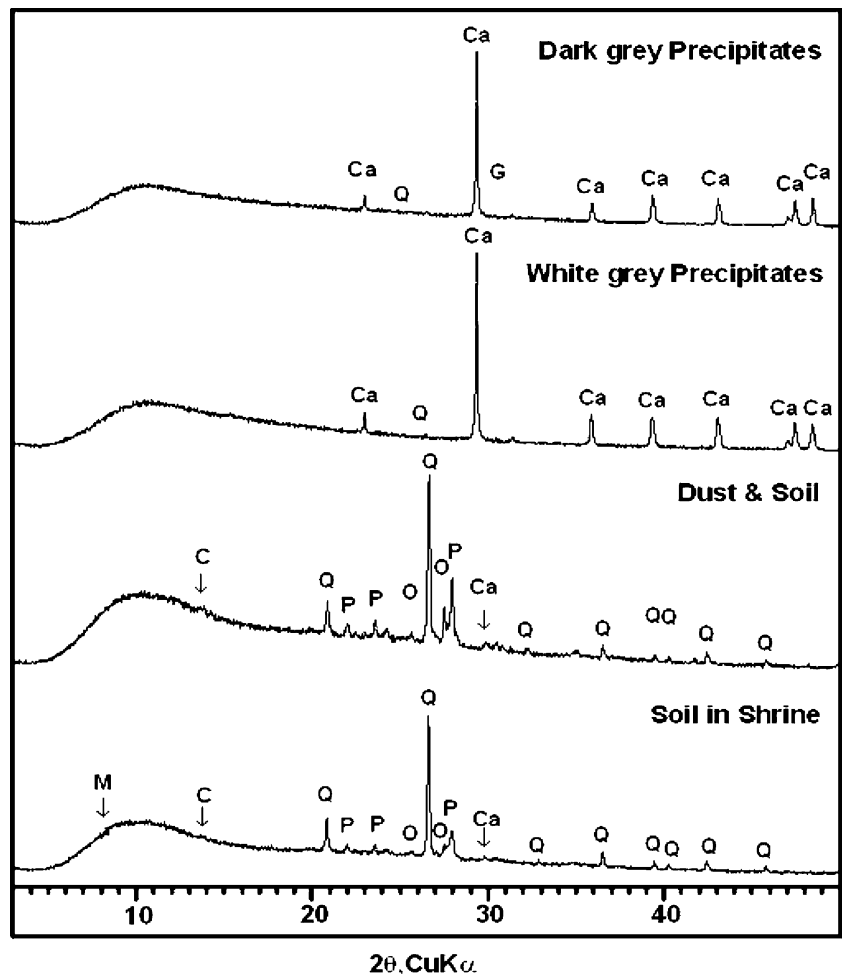
X-ray powder diffraction analysis was conducted for the mineral assemblages of the grayish white precipitates. As a result, the major mineral was calcite with trace of gypsum regardless of different peaks (Fig. 9), which was also confirmed by SEM. The authors observed authigenic kaolinite inside alkali granites formed during weathering processes (Fig. 10a). Clay minerals were also observed, which were created from plagioclase and biotite within the weathered andesites (Fig. 10b).

**Fig. 9** X-ray powder diffraction patterns showing secondary contaminants of the stone pagoda in the Bunhwangsa temple. *M* mica, *C* chlorite, *Q* quartz, *Ca* calcite, *G* gypsum, *P* plagioclase, *O* orthoclase
