Remediation and analysis of kinematic behaviour of a roadway landslide in the upper Minjiang River, Southwest China

Yu Ding · Quancai Wang

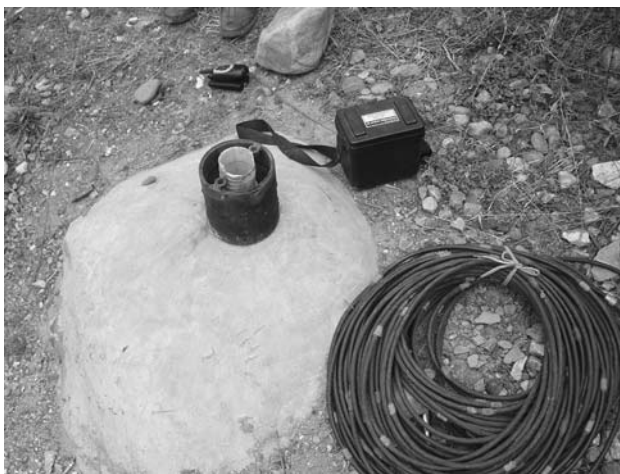
Fig. 6 Photograph of field monitoring

A SINCO Inclinometer (Inclinometer Probe: 50302510) was applied to detect zones of movement and the evolving spatial and temporal movement (Fig. 6). The monitoring in this study had three aims: (1) to determine the kinematic variations in the progress of engineering construction and post-remediation, (2) to investigate tridimensional features of the slide and determine the amount of sliding surface and its depths, and (3) to analyze the potential influence of the landslide on the roadway and carry out the back analysis of the remedial engineering.
