Hydrogeological and geotechnical assessments of the Kadifekale landslide area, İzmir, Turkey

G. Tarcan · M.Y. Koca

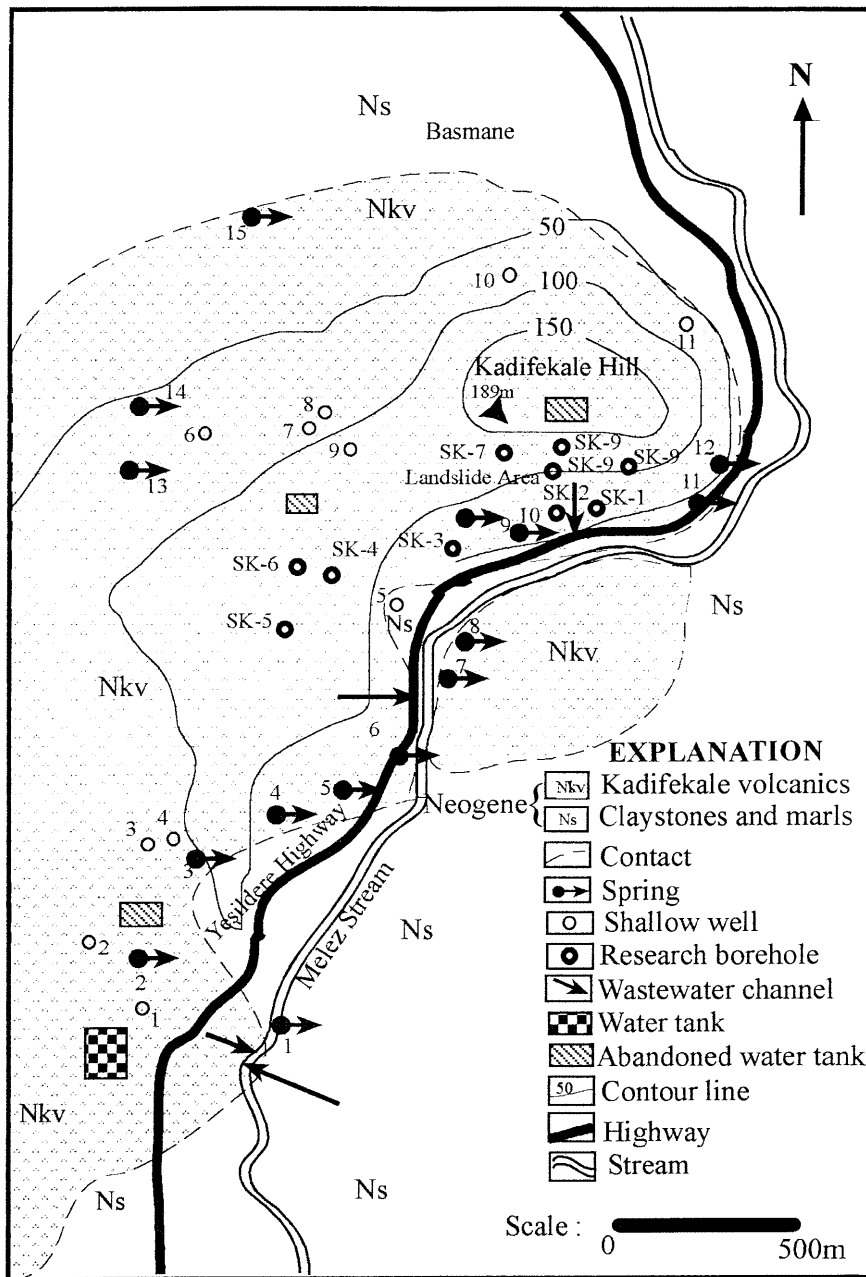
Fig. 4 Geological map of the study area and locations of the water points

The clayey and marly levels of these Neogene sediments mentioned above are found in the bottom of the Kadifekale area, south of İzmir bay. Neogene andesitic volcanics, known as Kadifekale volcanics, overlie the clayey and marly levels of sedimentary rocks. These volcanics generally have tuffs at the base and are continuous with agglomerates and andesitic lavas, in that order. When preparing the geological map of the study area the geological structure was simplified and some units, e.g. alluviums, colluvium, etc., were neglected (Fig. 4).
