# Some problems associated with past mining at a mine in the Witbank coalfield, South Africa

S. E. T. Bullock · F. G. Bell

**Key words** Pillar failure · Void migration · Burning coal seams · Spoil heaps · Acid mine drainage

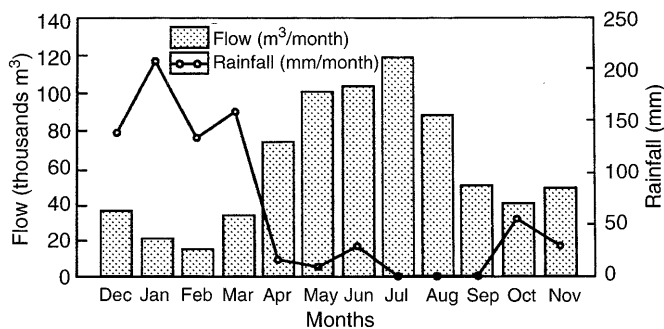
**Fig. 8**

the coal sub-outcrop pillar along the eastern boundary of the working was mined, groundwater, which previously had been retained behind the pillar, began to seep from the workings. This seepage water flows overland in a series of springs, before merging to enter the nearby stream. A V-notch flume was installed to measure flow on the stream. Weekly flow readings were recorded for a 1-year period from December 1994 to November 1995. The total annual volume of water collecting over the mine site catchment area was derived from the rainfall data. The estimated recharge to the coal seam would appear to be around 50% of the volume of rain which falls (Table 3). Figure 8 suggests that there is a time-lag between the heaviest rainfall (January) and maximum flow over the V-notch (August).

Monthly rainfall figures compared with seepage flow over the V-notch

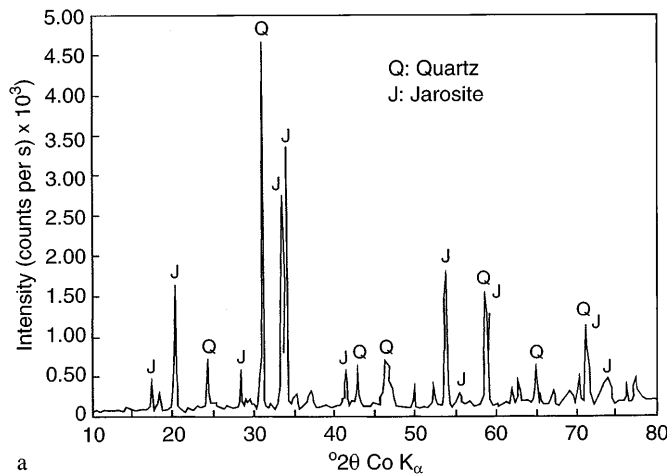
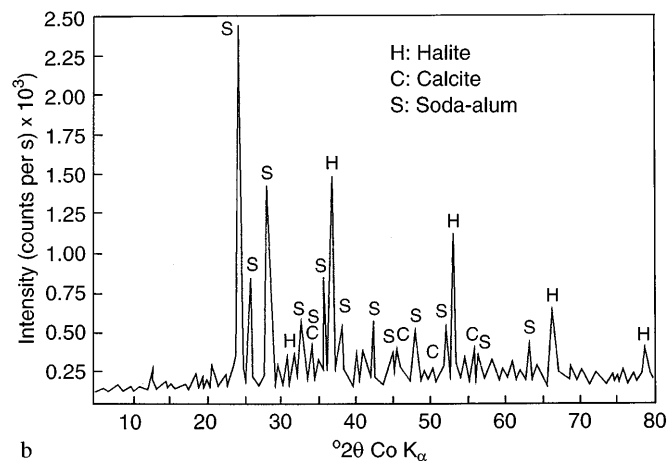
Evaporation of acid mine drainage leads to the precipitation of various salts on and in the uppermost layers of the soil (Fig. 9). X-ray diffraction analysis of such salts indicated the presence of halite NaCl, soda-alum, NaAl(SO<sub>4</sub>)<sub>2</sub>·12H<sub>2</sub>O, various members of the jarosite family of minerals (e.g. hydrojarosite, natrojarosite and possibly plumbojarosite), KFe<sub>3</sub>(SO<sub>4</sub>)<sub>2</sub>(OH)<sub>6</sub>, and a small amount of calcite, CaCO<sub>3</sub> (Fig. 10).

**Fig. 10**  
X-ray diffractograms of salts precipitated from acid mine drainage water
