Norman Kerle · Benjamin van Wyk de Vries ·  
Clive Oppenheimer

## New insight into the factors leading to the 1998 flank collapse and lahar disaster at Casita volcano, Nicaragua

Received: 12 December 2001 / Accepted: 18 November 2002 / Published online: 19 March 2003  
© Springer-Verlag 2003

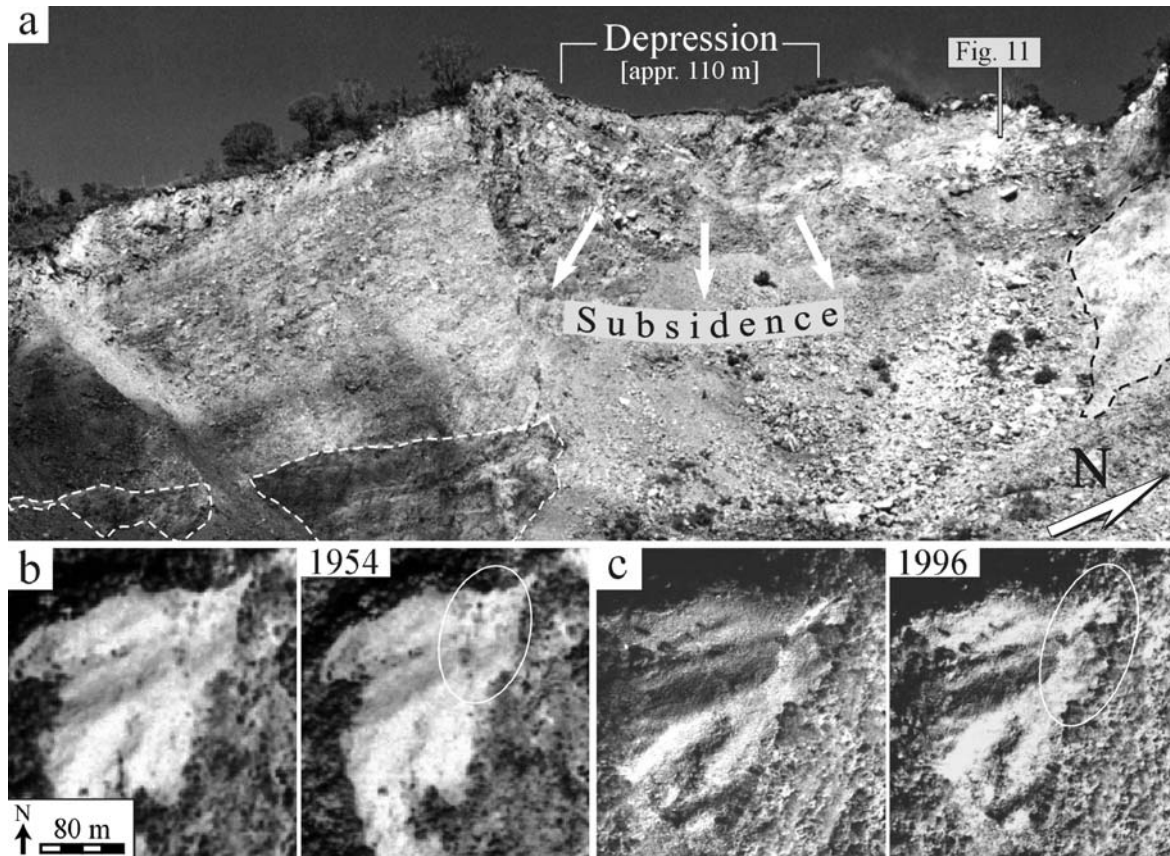
While the morphology of the western ravine shows high temporal stability, significant changes occurred near the top of the failure scarp (indicated by the solid black line in Fig. 3). The north-eastern section of the hydrothermal field contains an oval-shaped depression (D2 in Fig. 3a). In 1954 it was only faintly apparent, and had a length of approximately 60 m. By 1996 it had deepened and extended to about 110 m in length, as illustrated in the close-up stereograms shown in Fig. 5b, c. By the time of failure, the section had extended along more than a quarter of the length of the eventual failure scarp, and was entirely incorporated in the collapse material (Fig. 3c). Although the magnitude of the change in depth can not be quantified due to the aforementioned inferior quality of the 1954 photos and lack of camera information, the increase in size in all three dimensions is clear. The depression further corresponds precisely to an area of highly fractured and brecciated lava and tephra, strongly hydrothermally altered, and with clear signs of subsidence (Fig. 5a). The area is distinctly separated from a well-layered, largely undeformed and unaltered section to the south. This deformation would have fuelled further fracturing, and facilitated infiltration of meteoric water, the effects of which are discussed in more detail in a later section.

**Fig. 5** a Photograph of the 1998 failure scarp, showing a central area of subsidence, marked by heavily hydrothermally altered and brecciated material. This area corresponds to the depression

identified in Figs. 3a–c. b, c Large-scale stereograms of the depression, showing how the area has become larger and deeper between 1954 and 1996
