Damage assessment for the 2018 lower East Rift Zone lava flows of Kīlauea volcano, Hawai‘i

Elinor S. Meredith^{1,2} · Susanna F. Jenkins^{1,2} · Josh L. Hayes^{1,3} · Natalia Irma Deligne^{3,4} · David Lallemand^{1,2} · Matthew Patrick⁴ · Christina Neal^{4,5}

Received: 14 June 2021 / Accepted: 27 April 2022 / Published online: 6 June 2022
© The Author(s) 2022

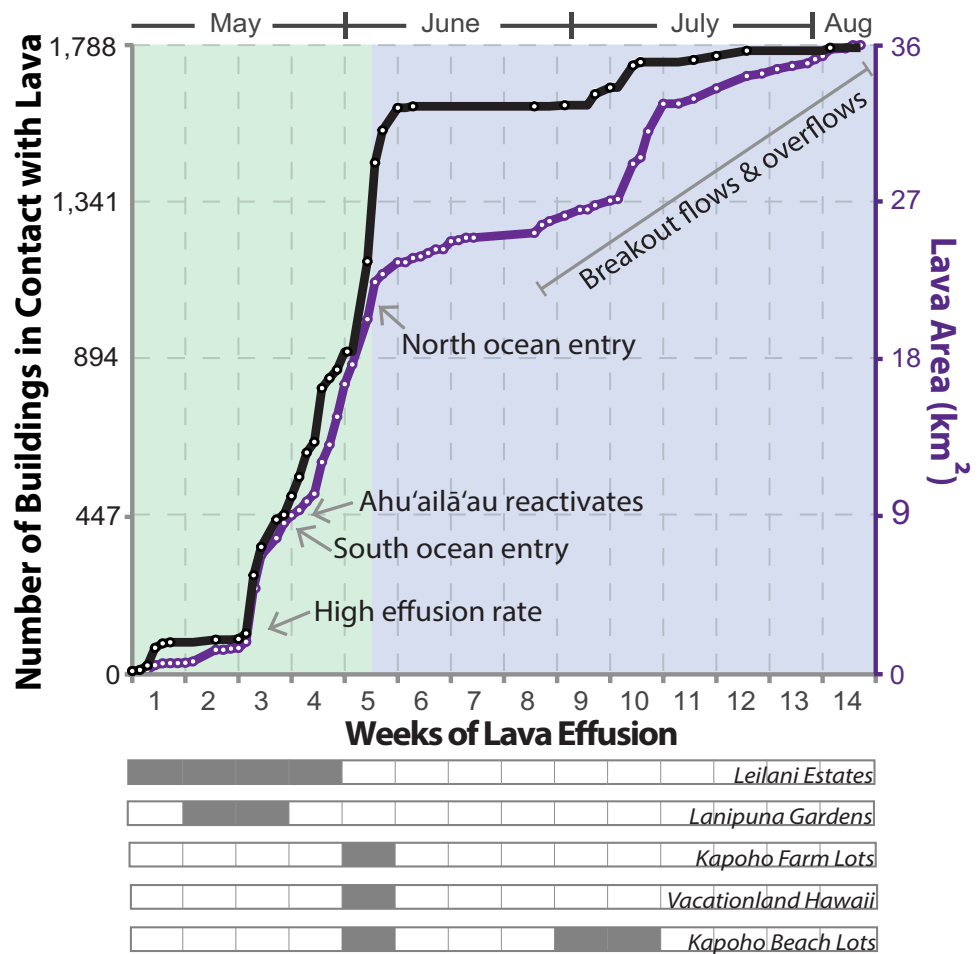
Fig. 4 The cumulative number of buildings in contact with lava (black line) and the cumulative area lava (km²) (purple line), across the weeks of lava effusion. The green background on the left indicates the weeks of predominantly channel emplacement; the blue background on the right indicates the weeks of breakout flows and overflows. By the end of the fourth week of lava effusion, 50% ($n = 894$) of the total number of buildings in contact with the lava were impacted. Below the plot indicates the weeks of most destruction for each of the main residential subdivisions

structures were buried or swept away by direct impact with the lava flows (DS5) and there was no evidence of the structures in post-eruption imagery. Of the total structures in contact with the flow, 1206 (68%) were damaged or destroyed within the first 5 weeks of the eruption, when the parent channels were being emplaced (Fig. 4). After the emplacement of the parent channels, ‘a‘ā lava destroyed structures as lateral breakout flows at the distal end of the flow. ‘A‘ā lava has a greater initial thickness and velocity than pāhoehoe flows (Kilburn 2015). This ‘a‘ā lava destroyed structures at Vacationland, Kapoho Farm Lots, and Kapoho Beach Lots (Figs. 3 and 4).

Of total structures in contact with the flow, 580 structures (32%) were damaged or destroyed after the channel reached the ocean on 5 June, when the distal flow region widened by ‘a‘ā breakout flows or by pāhoehoe overflows (Fig. 4). Lava breakout flows and overflows are inherently difficult to model and are not captured in lava flow forecast models (e.g., Harris and Rowland 2001; Favalli et al. 2005; Del Negro et al. 2005), and so a buffer of potential impact wider than the modelled lava flow channel footprint might be appropriate.

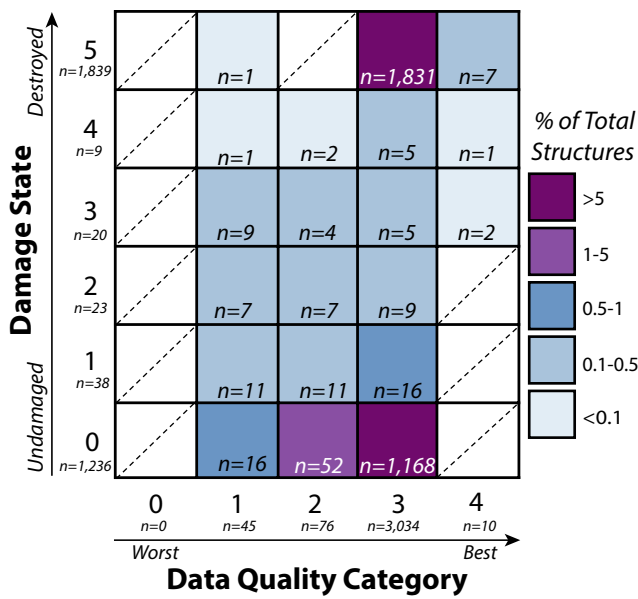
The large majority of structures (96%; 3044) were assigned a data quality category of “satisfactory” (DQ3) or “best” (DQ4) (Fig. 6). This high data quality was because 83% of the photographs ($n=6867$) used in the assessment were taken post-eruption and the majority (95%) of structures ($n=2992$) had the total footprint or structure visible in the imagery. There were 1566 structures (49%) that were clearly seen in the satellite imagery as destroyed by lava flow inundation and assigned DQ3. Structures that were damaged or destroyed (DS1–DS5) and with high data quality categories (DQ3–DQ4) likely had high quality data due to photographers focussing on damaged structures when gathering images on foot. The relatively lower data quality categories (DQ1–DQ2) assigned to 4% of structures ($n=121$; Fig. 6)

Fig. 6 Each structure within the damage assessment classified by Damage State (DS) and Data Quality (DQ) category. The colour of the boxes reflects the % of structures within that DS-DQ combination, with the number of structures shown in the box (total number of structures = 3165). There are no structures classified as DQ0

were due to either: (1) the images ($n = 1389$) used in the assessment being taken during the eruption, limiting our ability to reliably assign a final damage state as further damage may have happened after the photograph was taken and/or (2) less than half of the structure being visible in imagery ($n = 61$), limiting our ability to assess the total structure.

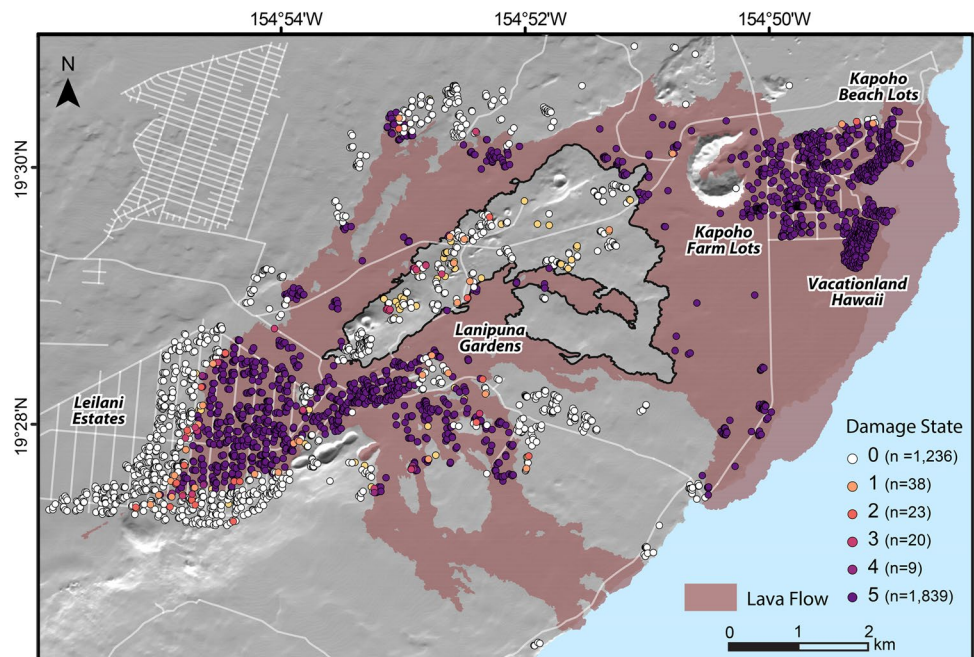
Fig. 7 Map showing the 3165 assessed structures with their assigned damage states: DS0 (white dot), DS1 (light orange dot), DS2 (dark orange), DS3 (magenta dot), DS4 (purple dot), and DS5 (dark purple dot). The central kīpuka is outlined in black. The majority of destroyed (DS5) structures are within the flow footprint, with a range of damage states (DS0–DS5) presented at the lava flow margin and farther away from the flow margin

Ahu‘ailā‘au (originally fissure 8) destroyed 1.88 km² of farmland (54% of the destroyed farmland). The 2018 LERZ eruption destroyed the entirety of Vacationland Hawai‘i and Kapoho Farm Lots, large parts of Leilani Estates, as well as the majority of Kapoho Beach Lots, and Lanipuna Gardens (Figs. 3 and 7). Relatively few recent lava flow events have destroyed such a large proportion of multiple communities (75% of two villages in the 2014–2015 eruption of Fogo, Cape Verde: Jenkins et al. 2017).

Damage associated with the 2018 LERZ lava flow event is near binary (Fig. 8), with a range of damage states along the flow margin (Fig. 7). Of the 1929 structures that showed signs of damage or that were destroyed (DS1–DS5), the large majority ($n = 1839$; 95%) were destroyed (DS5); of these, 1767 were in contact with lava and 72 were not in contact with lava (Fig. 8). However, the remaining structures (5%, $n = 90$) were classified as damaged but not destroyed (see DS1–DS4 in Fig. 7); of these, 19 were in contact with lava (found up to 17 m from the flow margin), and 71 were not in contact with lava (Fig. 7). This range of damage shown in Fig. 8 contradicts the common assumption that damage from lava flows is binary with contact with lava leading to destruction and no contact with lava leading to no damage.

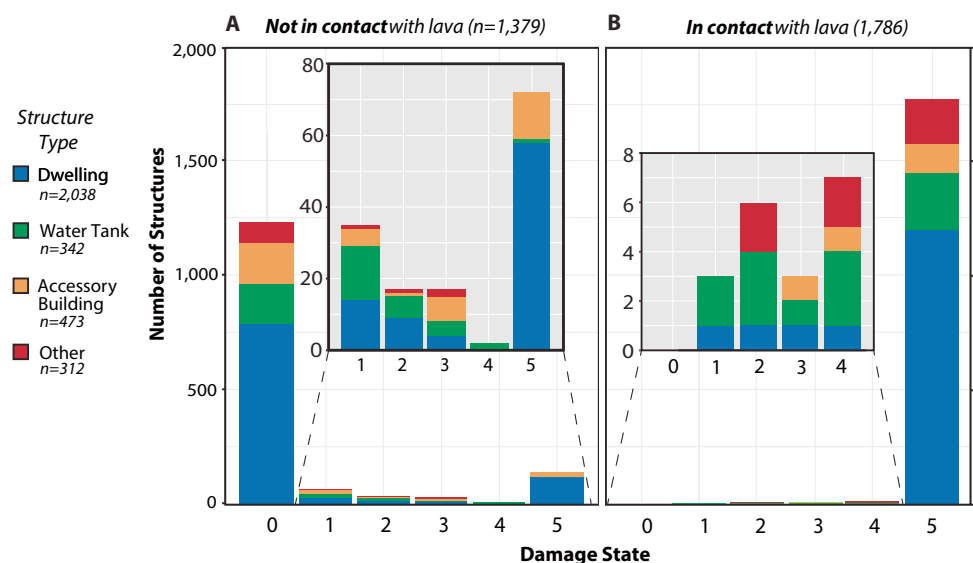
Fig. 8 Number of structures of each damage state classified by structure type for structures **a** not in contact with lava and **b** in contact with lava. There were no structures in contact with the lava that remained undamaged (DS0), meaning that all structures in contact with lava sustained some level of damage

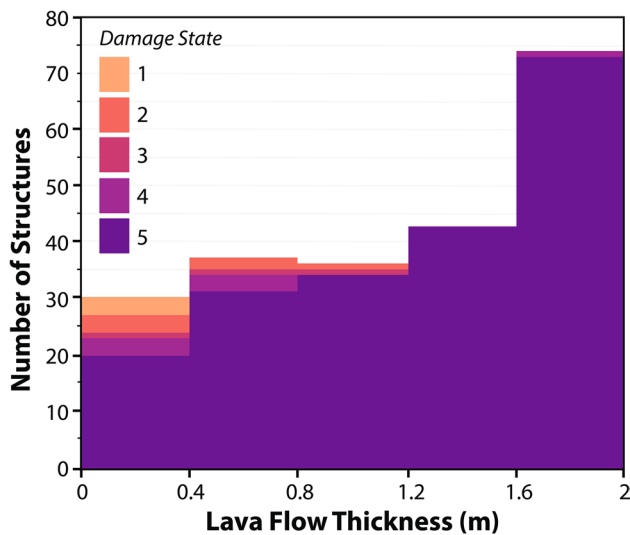
At shallow thicknesses (<2 m), structures exhibited a range of damage, from DS1–5 ($n = 220$) (Fig. 9). When overlaying the flow thickness map onto the lava flow chronology map in Fig. 3, the shallow lava (<2 m) correlates to the southern flows, along the flow margins and also to where there are overflows from the channel of pāhoehoe style lava, after the emplacement of the parent channels (Fig. 10a). Pāhoehoe lava initially is emplaced as thin lobes and inflates to a greater final thickness (Kilburn 2015). Approximately 32% (10.3 km²) of the lava flows are <2 m thick, predominantly along the flow margins. There were <2-m overflows that occurred during weeks 6 and 10–11 of the eruption close to the fissures in Leilani Estates, ~1–2 weeks after the parent channel had been established (Fig. 3). They also occurred during the final two weeks (13 and 14) of the eruption, ~8 weeks after the Ahu‘ailā‘au lava flow channel had been established, in the north of the lava flow field (Figs. 3 and 10a). The lowest damage (DS1) was only obtained by structures where lava contacted the building at <0.4 m (Fig. 9). In some cases ($n = 36$), structures were not totally surrounded by the lava but lava-triggered fires resulted in complete destruction (DS5). In one case, a metal structure of DS3 in contact with the lava flow triggered a fire by heating

Fig. 9 The number of structures in contact with lava < 2 m thick ($n=220$) categorised by damage state: DS1 ($n=3$), DS2 ($n=6$), DS3 ($n=3$), DS4 ($n=7$), and DS5 ($n=201$). All remaining structures ($n=1565$) in contact with lava flow of > 2-m thickness were destroyed (DS5). No structures in contact with the lava flow were undamaged (DS0)

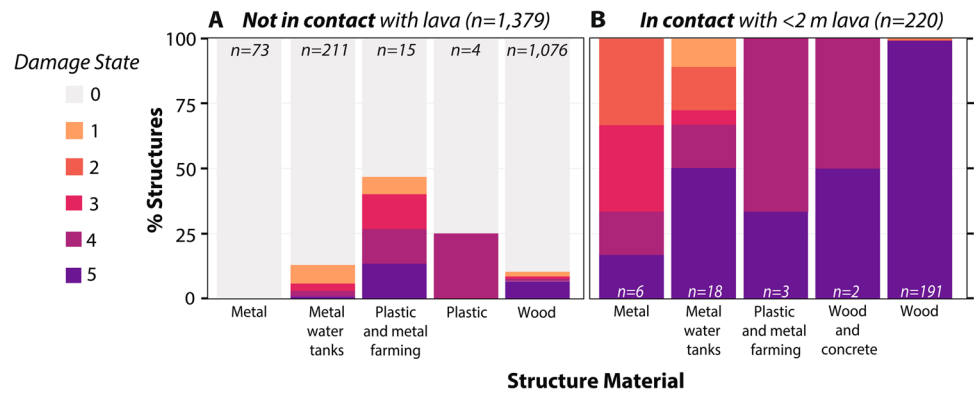
The damage states appear to be dependent on the structure material and shape. Metal structures demonstrated resistance to direct and indirect lava flow effects whilst structures made from wood or plastic were particularly vulnerable and destroyed (DS5) if in contact with the flows (Fig. 11). For example, of the 18 cylindrical metal water tanks in contact with lava < 2 m thick, 50% ($n=9$) were destroyed (DS5) and 50% ($n=9$) were damaged (DS1–DS4) compared to over

Fig. 11 Percentage of each structure material classified by damage state for structures **a** not in contact with lava and **b** in contact with lava < 2 m thick. All structures in contact with lava > 2 m thick were destroyed (DS5) and not included here, and no structures in contact with lava were undamaged

99% of wooden structures destroyed (DS5) in contact with lava (Fig. 11). Cylindrical masonry buildings during the Fogo lava flows were also resistant to thin flows (Jenkins et al. 2017). Potentially, the resilience of circular structures could be due to the strength of a convex wall placed into compression under the static or dynamic pressure of the lava (Jenkins et al. 2017), information that could be valuable in planning more resistant structures, for example those housing critical infrastructure.

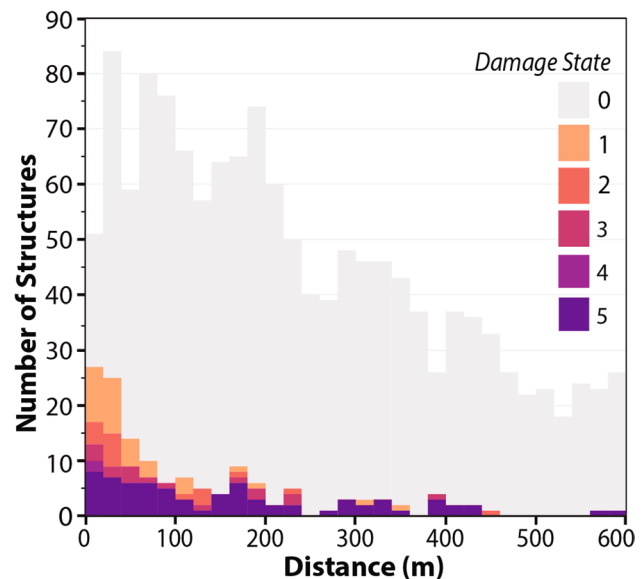
Of the 1379 structures that were not in direct contact with lava but were within 600 m of the lava flow margin, 10% ($n=143$) were damaged or destroyed (Fig. 12). Half of the structures that were within 20 m of the lava flow margin were damaged or destroyed (Fig. 12). Thermal effects from the lava and fire, as well as tephra, resulted in a range of damage states, as opposed to complete destruction. For example, 15 structures experienced melting of plastic cladding or covering, but no other damage to the structure (Fig. 13a). Video footage from the eruption showed, in some cases, that wooden structures close to the lava flow did not ignite until the lava was in contact with the structures. This delayed ignition may be due to differing moisture content and wood thickness, which plays a large role in ignitability (Jenkins et al. 2013), or differing lava flow crust thickness that affects the efficiency of thermal conductivity (Blong 1984). As a result, indirect thermal and fire damage extends the range of potential damage from a lava flow beyond the lava flow footprint, but the relationship is not simple (Figs. 12 and 13).

Lava-induced fires were a prevalent cause of damage, with damage to structures up to 595 m from the lava flow margin (Figs. 12 and 13). Fire damage was observed predominantly in the southwest direction away from the lava flow, in the downwind direction of prevailing trade wind; we hypothesise that fire spread due to volcanic gases downwind from the vents, ocean entry, or the flow itself, killing and drying vegetation in this direction (Fig. 13c). Footage also

Fig. 12 The number of structures ($n=1379$) observed at distance (m) from the lava flow margin categorised by damage state: DS0 ($n=1239$), DS1 ($n=35$), DS2 ($n=17$), DS3 ($n=17$), DS4 ($n=2$), and DS5 ($n=72$). Damage was observed up to 595 m from the lava flow
