# An Integrated Geomechanical Investigation, Multi-Parameter Monitoring and Analyses of Babadağ-Gündoğdu Creep-like Landslide

Halil Kumsar<sup>1</sup> · Ömer Aydan<sup>2</sup> · Hisataka Tano<sup>3</sup> · Sefer Beran Çelik<sup>1</sup> · Reşat Ulusay<sup>4</sup>

Received: 28 February 2015 / Accepted: 19 August 2015 / Published online: 1 September 2015  
© Springer-Verlag Wien 2015

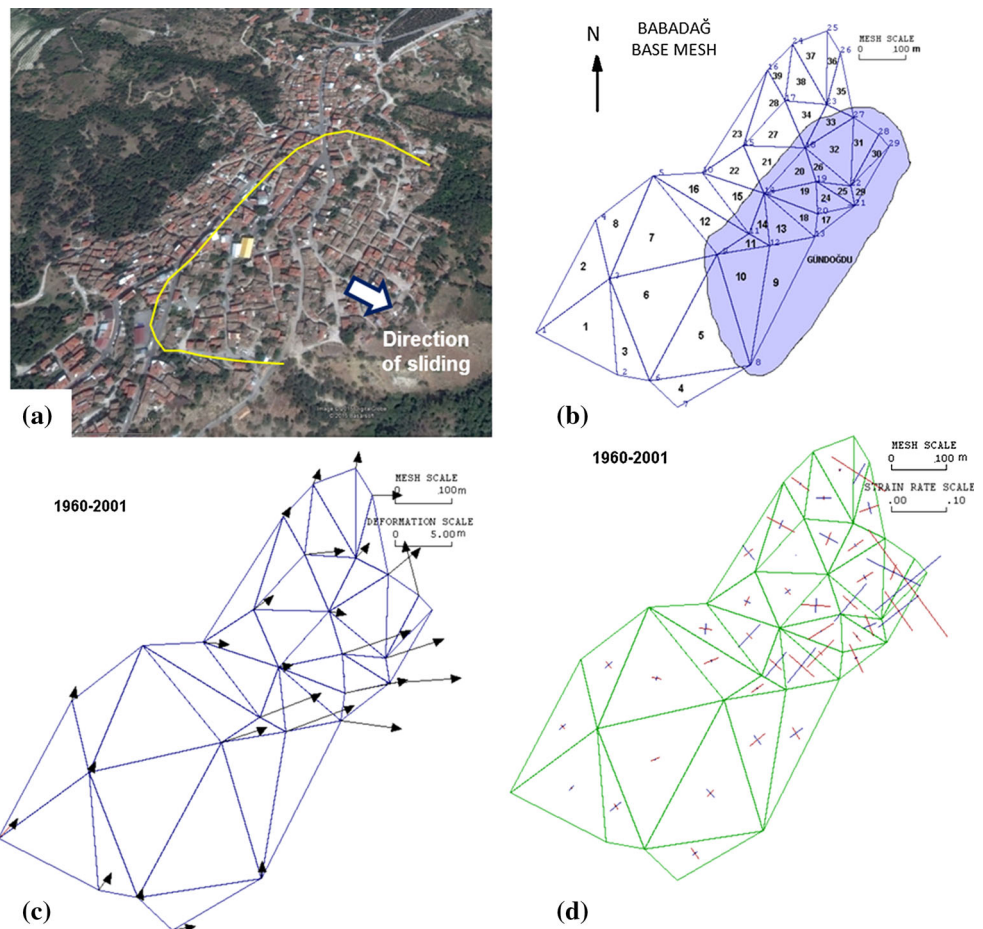
**Fig. 8** **a** The absolute horizontal displacement of some selected points, **b** tensile strain rates of some selected elements

it seems increased when compared to the other date intervals of the measurement (Fig. 8a). The computed tensile strains (Fig. 8a) are consistent with ground cracks and damages of the houses in the Gündoğdu district. Some compressive and tensile strains are developed within the landslide area that tends to rotate clockwise (Fig. 8b) (Atak et al. 2003; Kumsar et al. 2004; Tano et al. 2006a). Although the deformation is within the accelerated creep stage, general tendency of the points 12 and 29 is alarming. The overall deformation rate ranges between 40 mm/year and 160 mm/year which are quite consistent with the deformation measurements discussed in Sect. 4.4.1.

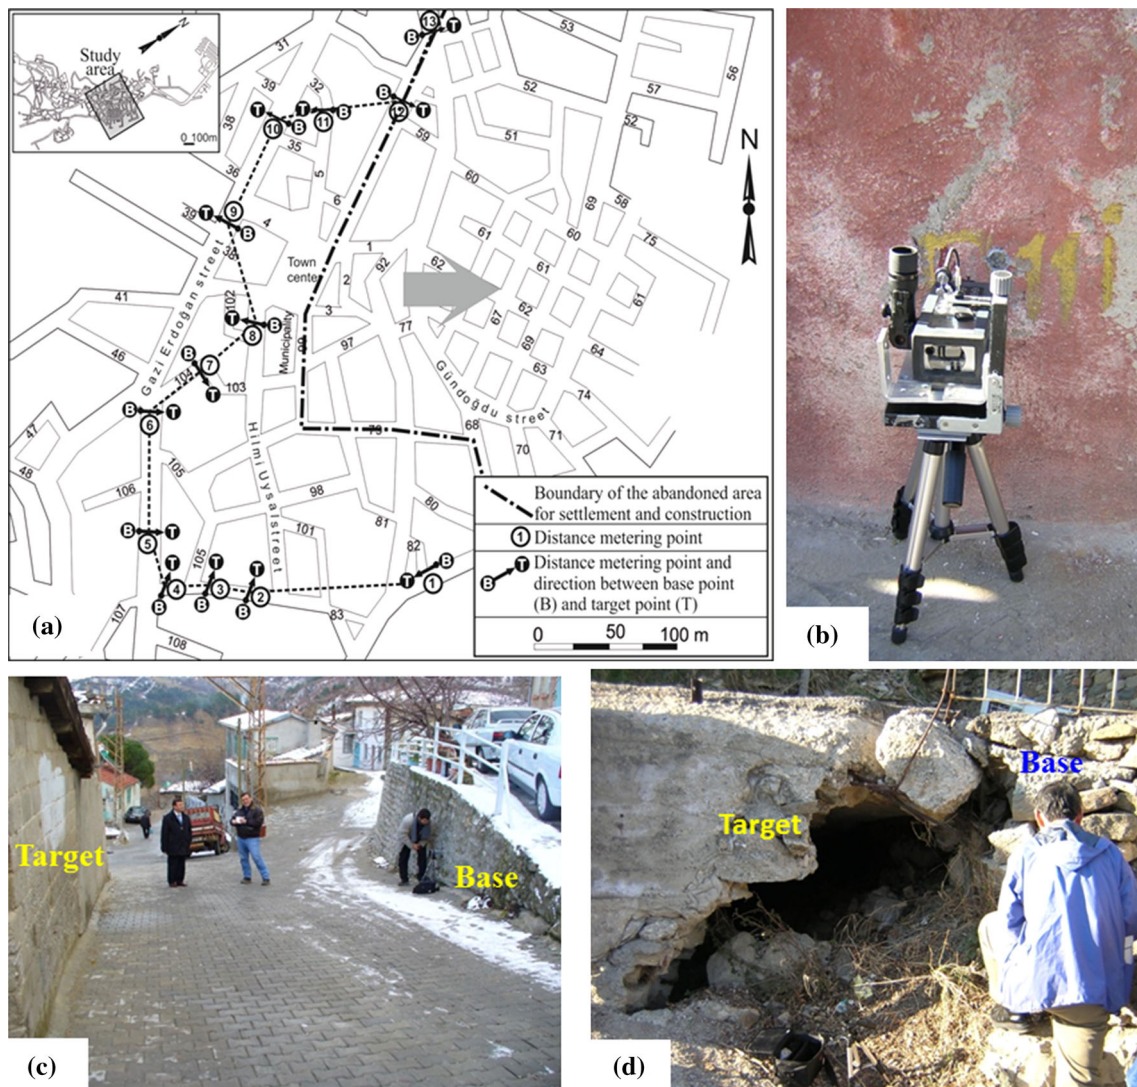
**Fig. 10** Layout of the relative displacement measurement system in the Gündoğdu landslide area

respectively (Fig. 10), and three target points were marked at each base point.

The ground surface of Babadağ is covered by different pavement materials, and therefore, direct observations on the ground surface are difficult. The measurements by laser metre were taken at 30 locations (Fig. 10) between a base point to three target points, which were marked with water-resistant painting and fixed to a metal plate. Sometimes these points were destroyed by humans mistakenly due to renovation works for the houses. The measurements were taken between 2005 and 2012 at six-month intervals (Kumsar et al. 2004).

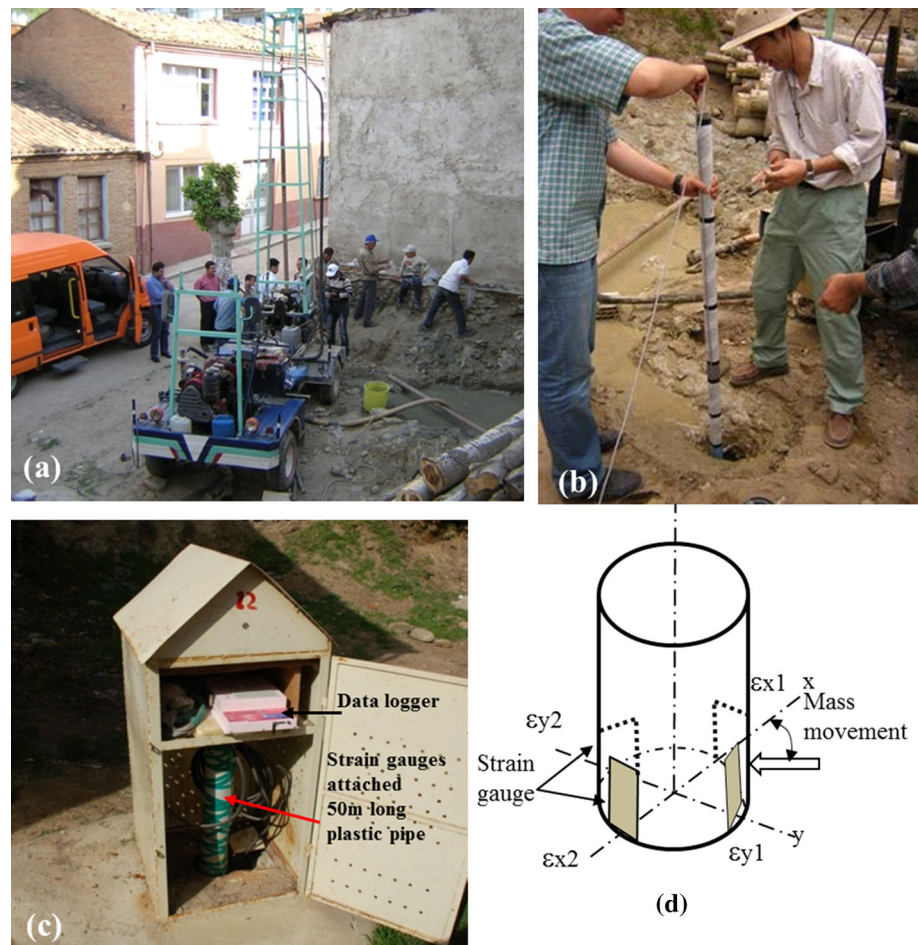
**Fig. 13** **a** Drilling of 50 m deep borehole SK4, **b** installation of pipes on which strain gauges were attached, **c** view of the station after construction, **d** locations of the strain gauges attached on the plastic pipe (Tano et al. 2006a; Çelik 2012; Kumsar et al. 2012)

far from borehole SK3 in the unstable area of the Gündoğdu landslide (Fig. 13a)

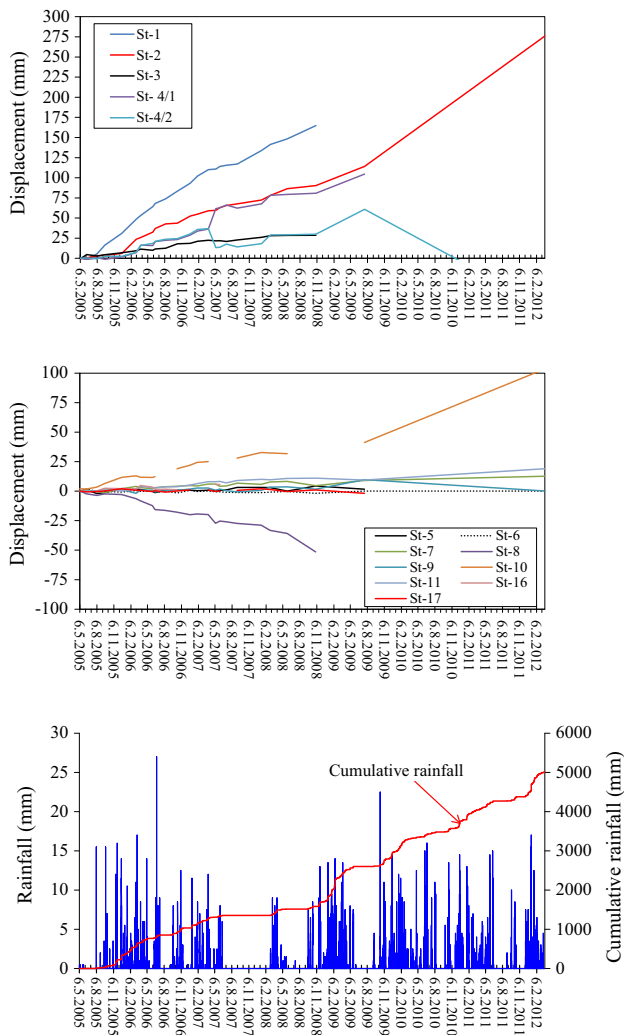
**Fig. 15** Relation between the relative displacement measurements and rainfall data

The evaluation of the relative displacement measurements at the boundary between the stable and unstable parts in the Gündoğdu could not fully be carried out during the monitoring period due to the renovation and/or repair of the houses in the district between 2005 and 2012 is shown in Fig. 15. There is a divergence at stations 1, 2, 3, 4/1 and 4/2 between 2005 and 2008. The maximum divergence of 180 mm was measured at Station 1 where there was a separation crack at the boundary. In the same period, Station 8 had a 50 mm convergence. This implies that there was a backward tilting of the buildings at this locality. Stations 2, 7, 9 and 11 were monitored for a period of 7 years and the Station 2 had a 250 mm divergence, while the others had a divergence less than 20 mm (Fig. 15). As seen from the rainfall data, the separation of the landslide from the stable part of the slope increased under the influence of increasing rainfall in Babadağ (Fig. 15).

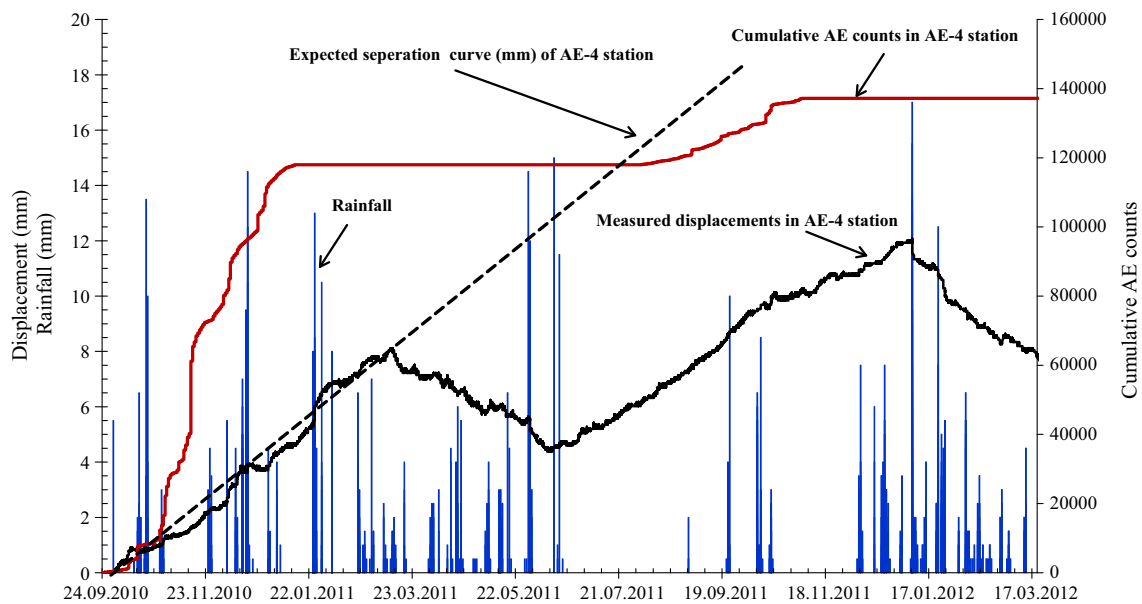
Fig. 16 Comparison of AE counts, gap measurements and rainfall data monitored at station AE4 (after Çelik 2012)

Since Station 1 is located at the boundary line between the unstable and the stable parts (next to Station AE4, see Fig. 12c), a gap measurement system was set up and measurements were taken at an interval of 1 h. At this station, AE measurement station AE4 was set up on 31 August 2007. The station, which was covered by a metal safety box, was distorted and damaged throughout the monitoring period between 2007 and 2012. 6 and 10 cm of horizontal and vertical separations, respectively, were observed at this station.

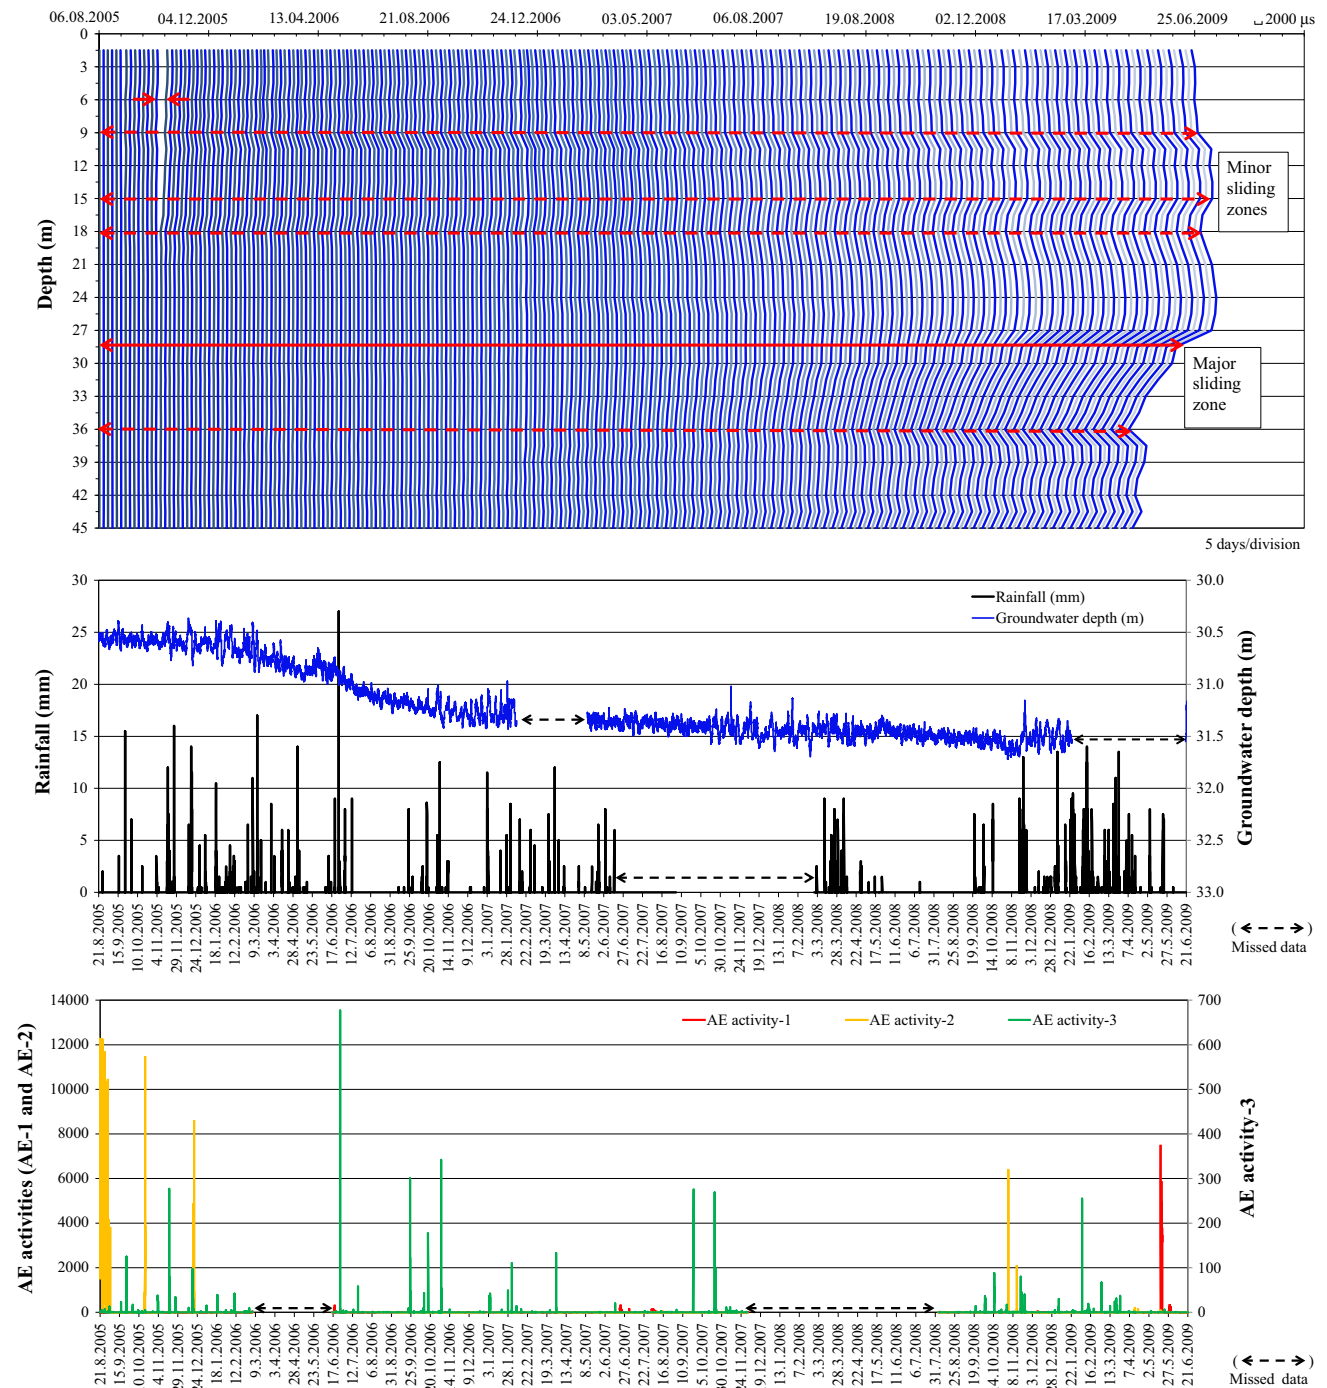
**Fig. 17** Relation between AE numbers, groundwater, rainfall and pipe strain data during the monitoring period between 21 August 2005 and 21 June 2009

The monitoring data, representing the period of monitoring between 06 August 2005 and 7 May 2009, from the pipe strain, groundwater level fluctuation, rainfall, AE1, AE2 and AE3 stations were compiled and shown in Fig. 17. As noted from the figure, there is a notable deformation at 9 and 18 m below the ground surface until 2 December 2007, while there is a decrease in the groundwater level below the ground surface from 30.5 to 31.25 m between 6 August 2005 and 24 September 2006. When a rainy season started at the end of September 2005, the groundwater level increased to 30.75 m below the ground surface. In this period, AE counts were observed mainly at stations AE1 and AE3, which are located in the active part of the landslide. Station AE2 is located in the stable part of the Gündoğdu region and the AE counts recorded at this station were mainly due to the fall of marl

Displacements at the levels of 15 and 36 m in the borehole SK4 started to increase during the period between 4 January 2007 and 2 December 2007. There were no data for the groundwater level measurement and rainfall between 13 February 2005 and 10 May 2005, and 20 June 2007 and 15 December 2007, respectively. During this period, the AE counts of AE1 station varied from 10 to 345 from 24 May 2007 to 6 February 2007, respectively. At Station AE3 also AE counts ranging between 10 and 270 were recorded during the measurement period. The AE counts recorded at Station AE2 were less than 75 since the station is located in the stable part of the slope.

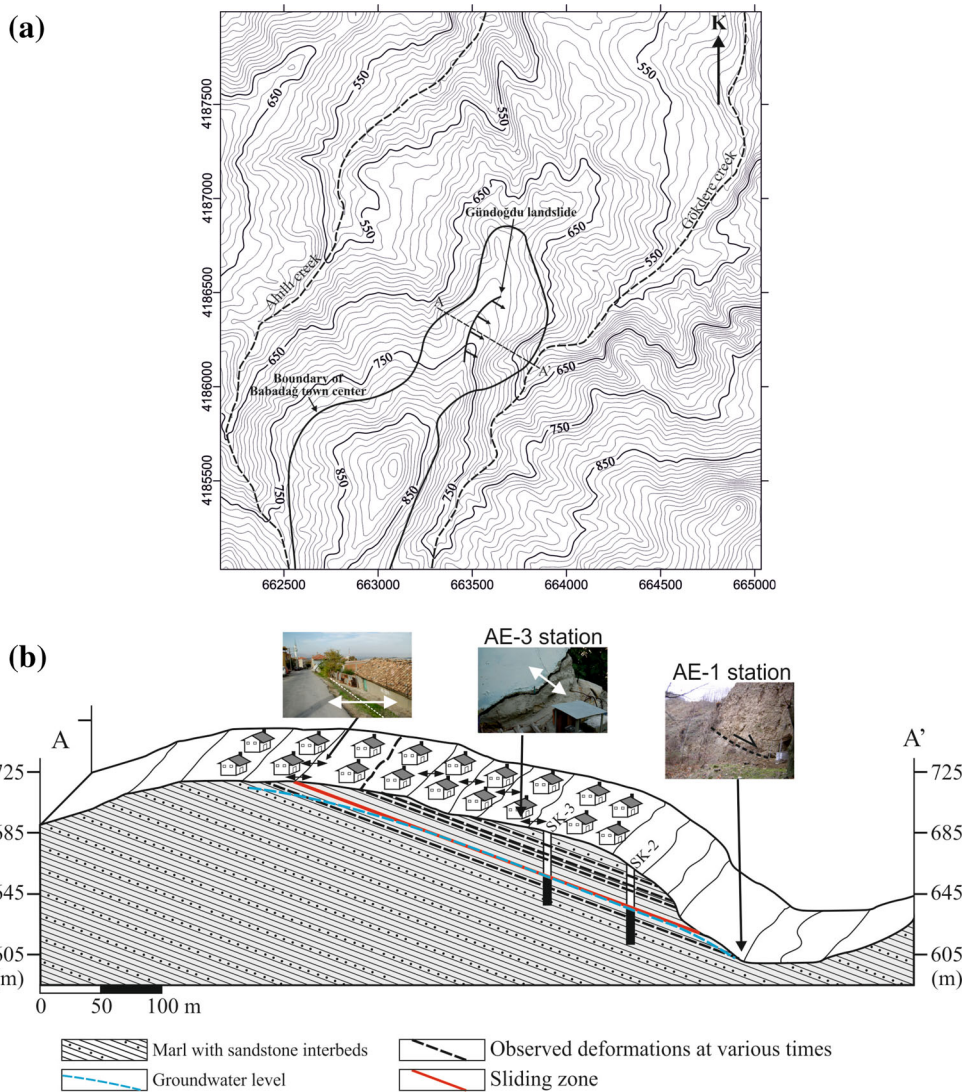
**Fig. 18** **a** Topographic map of Babadağ and cross-section line along the Gündoğdu landslide, **b** inferred failure surfaces on section A–A’ determined from the pipe strain and surface deformation monitoring data

Topographic map of Babadağ (Fig. 18a) was digitised and loaded to SLOPAC2D software developed by Kumsar (1993) and a topographic cross section was constructed showing the failure surface (Fig. 18b) by using pipe strain and surface deformation monitoring data. The dip of the failure surface was determined as 17° to SE. On the basis of numerous direct shear tests on interfaces between sandstone and marl units under both dry and saturated conditions (Çelik 2012), the cohesion and friction angle based on linear Mohr–Coulomb failure criterion were
