TECHNICAL NOTE

Microseismic Monitoring of the Left Bank Slope at the Baihetan Hydropower Station, China

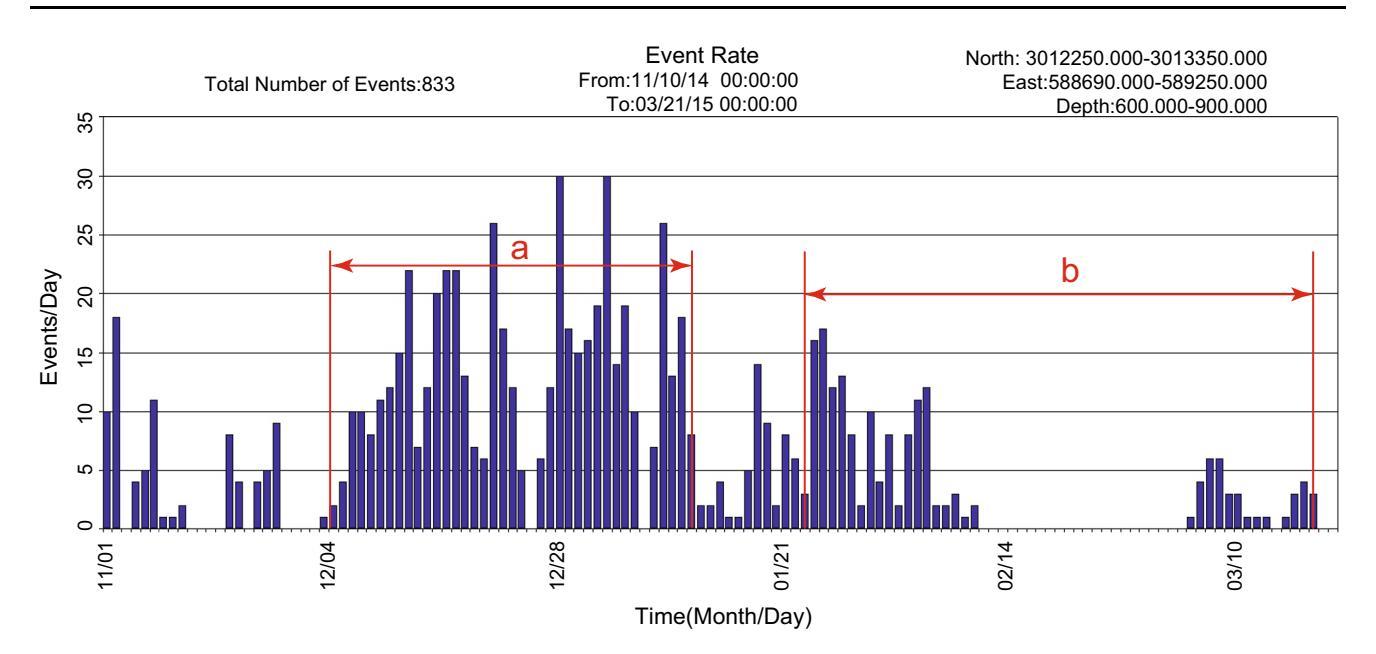
After filtering out the noisy events, 833 MS events were recorded within a given volume of interest during the selected period from November 10, 2014, to March 20, 2015. A plot of the cumulative number of MS events recorded during the selected period shows one period of increased MS activity, namely December 5, 2014, to January 10, 2015, as illustrated in stage "a" of Fig. 2. During stage "a", there were approximately 13 MS events per day. This graph can be compared to the time history of excavated rock mass at the left bank slope (Fig. 1a). The graph shows that the curve of cumulative MS events in Fig. 2 exhibits almost the same tendency as the scheme of the excavated volume of rock mass (volume blasted) in Fig. 1a. According to on-site observations, the dam foundation slope, the drainage tunnel PSL4 and the curtain grouting tunnel WML4 at an elevation of 750 m were being excavated during this period. These excavation activities strongly contributed to the clustering of MS events in the time series. This is a good correlation and illustrates the strong consistency between the volume of rock mass being excavated and the total number of MS events. Therefore, excavation activities play a significant role in the levels of extension fracturing within a rock slope-the deeper the slope is, the more stressed it is and thus the more it fractures after being unloaded due to excavation (Xu et al. 2012). Another interesting phenomenon is that although excavation activities of the dam foundation slope were suspended on December 29, 2014, a number of MS events continued to occur in the rock slope between January 23 and March 20, 2015, as shown in stage "b" of Fig. 2. The following spatial distribution of MS events can be used to interpret the phenomenon.

Fig. 2 Temporal distribution of MS events during the selected period between November 10, 2014, and March 20, 2015

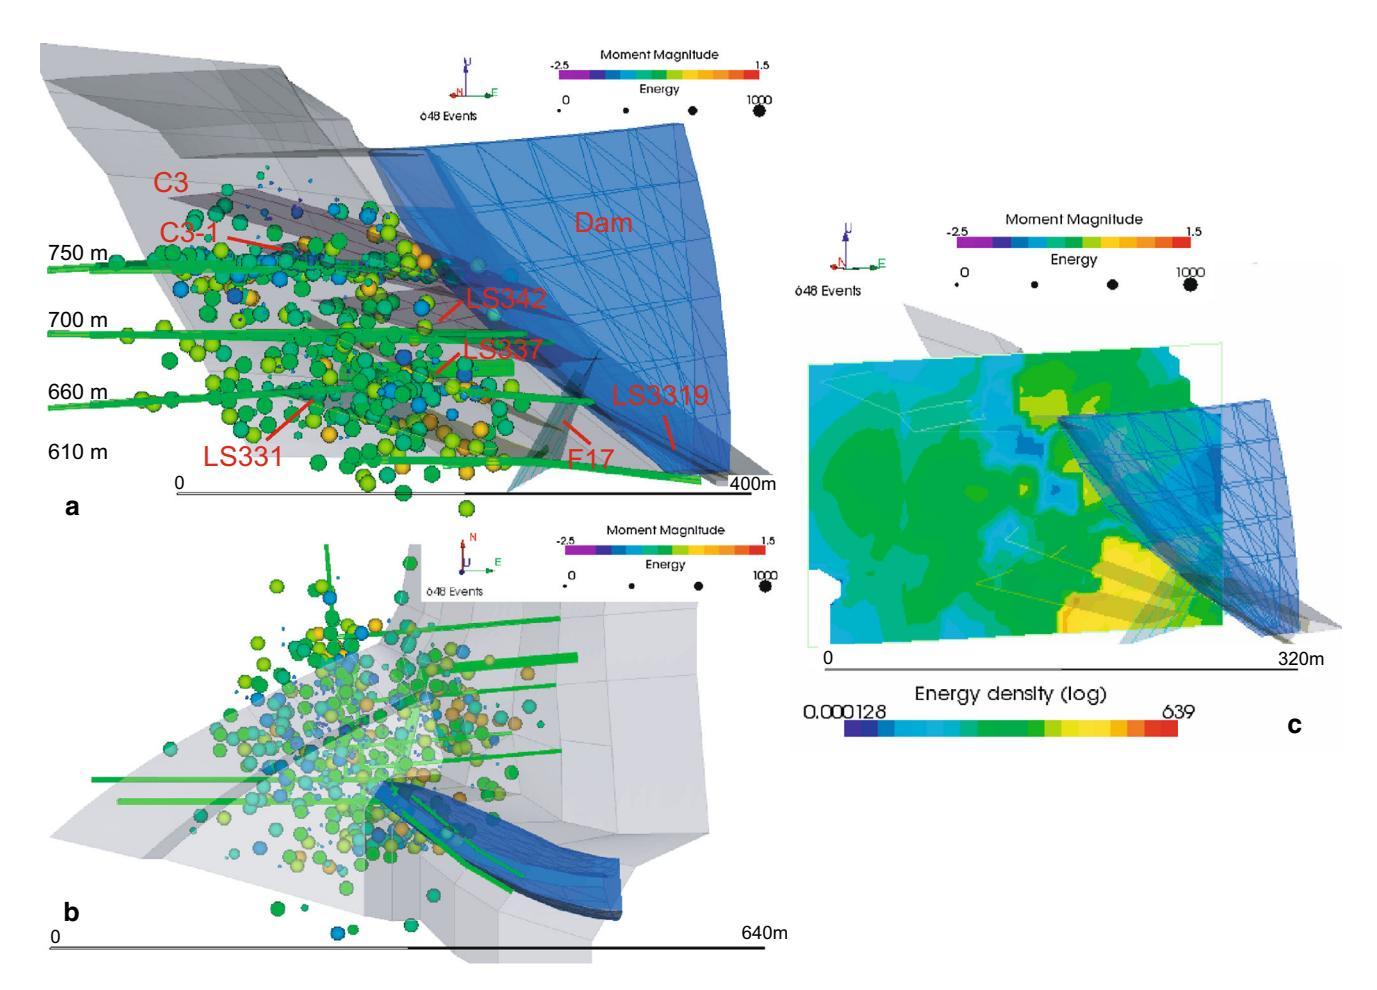
ranging from 610 to 700 m. The aerial view in Fig. 3b shows that MS events were being recorded at significant depths into the slope. However, a small number of MS events occurred at the top of the rock slope. This may be partly attributed to residual movements in the rock slope at high elevations and/or the excavation of shear-resistance tunnels. On the other hand, it may also be partly due to stress concentrations resulting from slope geometry. In addition, to highlight the relationship between the spatial distribution of MS events and the geological structure elements, Fig. 3c shows the released energy density

Fig. 3 Spatial distribution of MS events during the selected period between November 10, 2014, and January 23, 2015. **a** Front view, **b** aerial view and **c** energy density contour of MS events. The *colors*

of the spheres in the figures indicate different moment magnitudes, and the sphere size is proportional to the energy scale (colour figure online) contours of seismic source locations. MS events show a strong correlation with structural elements on-site, particularly with LS331, LS337 and fault F17. Thus, the potential risky regions in the left bank slope, where microseismicity is active or inactive, can be identified.

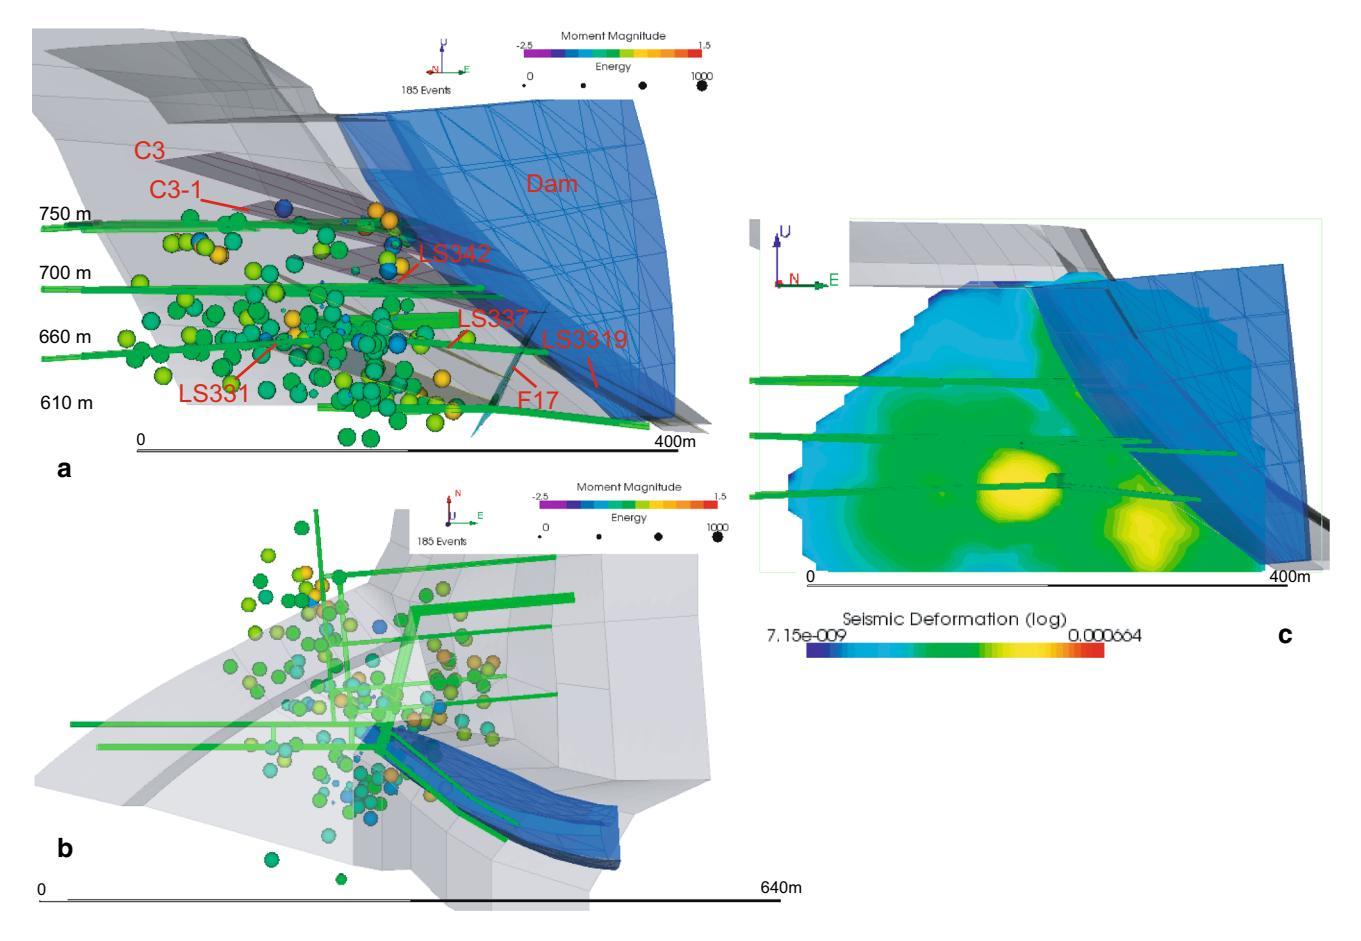
Further, Fig. 4 shows the spatial distribution of MS events that occurred in the rock slope during the selected period between January 24 and March 20, 2015. A number of MS events remained concentrated along LS331 and LS337 even though the excavation activity of the dam foundation slope was suspended on December 29, 2014. Similarly, Fig. 4c shows the seismic deformation contours of MS events, therein highlighting the correlation between microseismicity and structure elements (i.e., LS331 and F17). According to construction activities and field observations, this clustering was mainly caused by the combined actions of the shear deformation of the intraformational faulted zones (i.e., LS331 and LS337) and the expansion deformation of fault F17 after the latter was exposed at the toe of the dam foundation slope. The evolutionary characteristic of MS events in the rock slope is acted on by both external and internal sources. The former is the excavationinduced unloading effect, and the latter consists of preexisting weak structural planes.

Fig. 4 Spatial distribution of MS events during the selected period between January 24 and March 20, 2015. a Cross-section looking along the east-north projection, \mathbf{b} top view and \mathbf{c} seismic deformation contour of MS events from south-north vertical cross-section looking east

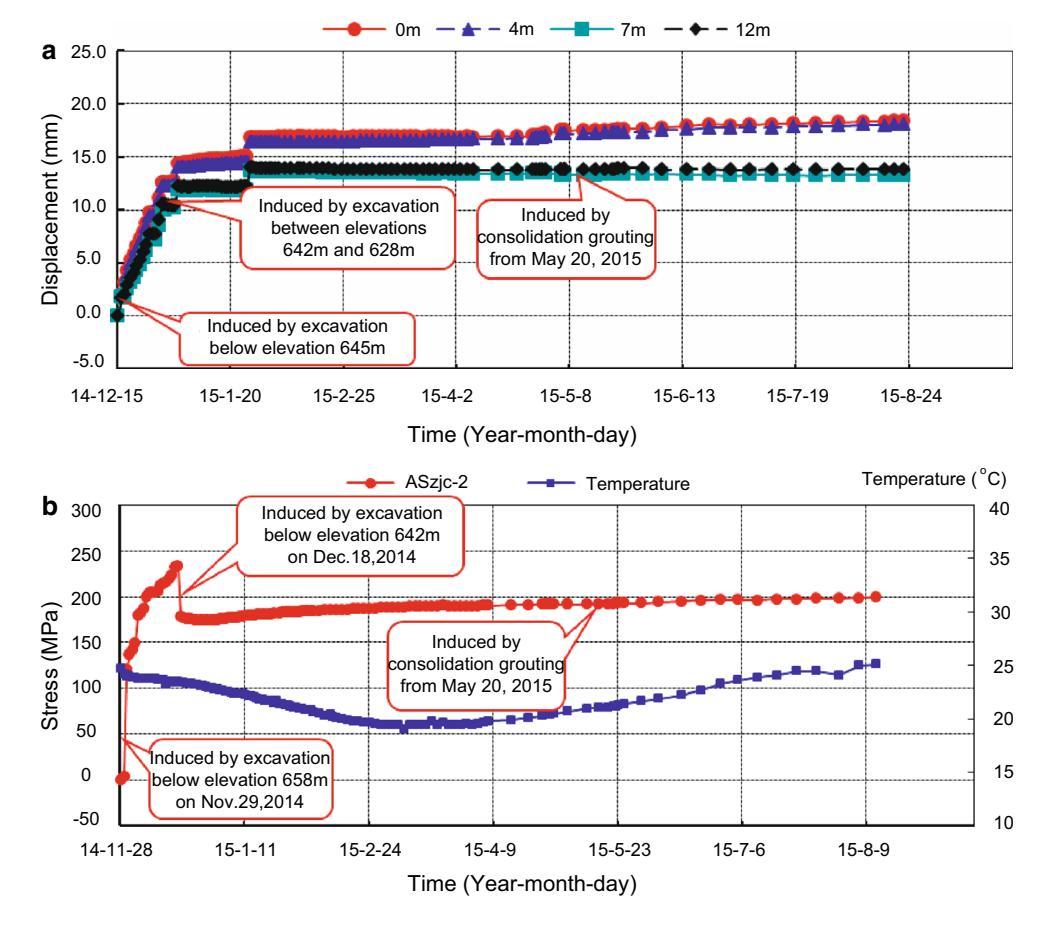
Fig. 5 a Absolute displacement process graph of the Mzjc-3 multi-point extensometer in the experimental zone of the columnar jointing at the dam foundation at an elevation of 654.53 m and **b** stress process graph of the ASzjc-2 anchor stress gauge in the experimental zone of the columnar jointing at the dam foundation at an elevation of 658.55 m

December 2014, in particular at the end of the month. The same change is attributed to production blasts during excavation of the dam foundation slope according to field observations and construction notes. However, it is worth noting that only a relative displacement of 5 mm occurred somewhere between depths of 4 and 7 m from the slope surface. This is mainly attributed to the length (only 12 m) of the multi-point extensometer installed in the zone. The deformation of the deep rock mass of the left bank dam foundation slope thus cannot be obtained. In addition, to study the stress redistribution induced by excavation of the dam foundation slope, a stress process graph of the ASzjc-2 anchor stress gauge (see Fig. 1a) at an elevation of 658.55 m is shown in Fig. 5b. The graph partly reflects the stress variation in anchor bolts in the deep rock mass of the spandrel groove slope. In contrast, unlike the results shown in Fig. 5a, the data obtained by the ASzjc-2 anchor stress gauge decreased on December 18, 2014. This can be used to accurately interpret the stress release mechanism induced by energy loss from MS events concentrated in the rock slope. Thus, MS activity can be regarded as the precursor to the surface deformation and even instability failure of the rock slope. The evolution of stress variation in processes leading to potential slope instability is consistent with the tempo-spatial distribution of MS events (Xu et al. 2012).
