Shallow cover over coal mining: a case study of subsidence at Kamptee Colliery, Nagpur, India

Abstract Shallow land cover over old underground workings at Kamptee Colliery has led to the development of ground collapse, with three crown hole subsidences recorded in a 10 year period. As the land above the workings has been developed, it was considered that for safety purposes areas with less than 15 m of competent rock should be established. The paper discusses the Multi-electrode Resistivity Imaging (RI) and Ground Penetrating Radar (GPR) undertaken over an area of 800 m × 200 m, which indicated that where a competent cover was present it was very thin.

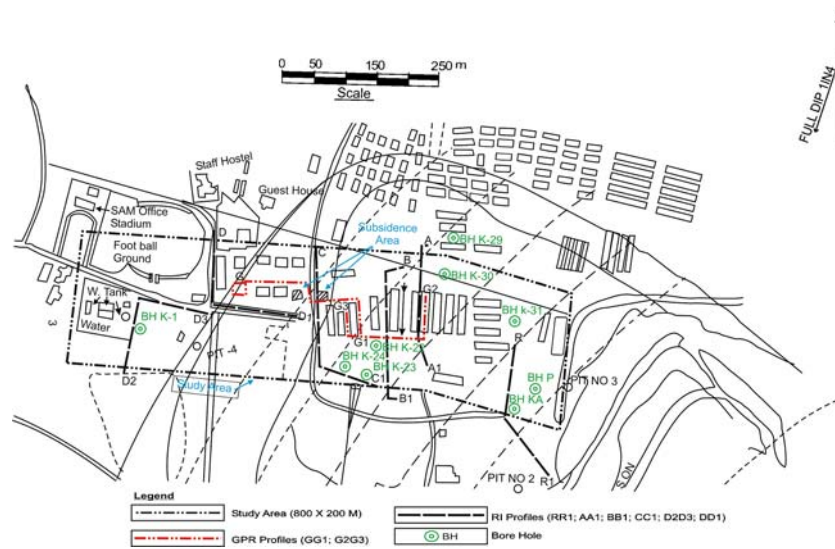
Fig. 2 RI and GPR profiles over study area (Kamptee Colliery)

Six profiles (RR1, AA1, BB1, CC1, DD1 and D2D3) were selected for the Resistivity Imaging survey and two profiles (GG1 and G2G3) for the GPR survey (Fig. 2).

Ground Penetrating Radar surveys were carried out in the subsidence areas and over the underground workings (GG1 and G2G3, Fig. 2). Traverse GG1 was 243 m long and divided into three sections: 0–80 m (the guest house), 80–160 m and 60–243 m (damage zone). As can be seen from Fig. 5, the radar signatures for section I (0–80 m) indicate the strata are disturbed to a depth of 30 m. Some cavities were indicated at a depth of 10 m at chainages 12 and 35 m. The formation of these cavities is likely to be related to the underground development of the seams shown in BH K31. The strata in this zone are very weak and friable with no hard strata present.

Traverse G2G3 (Fig. 6) starts at the colony (along line AA1 line) and ends close to a subsidence (chainage 245 m). The radar signatures show various disturbed and less disturbed strata in the first two sections (chainages 0 to 120 m). Between chainages 120–160 m the strata is relatively undisturbed to a depth of 10 m, below which it is very disturbed. Cavities are present at chainages 95, 105, 123 and 150 m, at depths varying from 5 to 8 m. This is due to void migration associated with seam III which has no competent cover (see BHs
