In situ failure investigation and time-dependent damage test for columnar jointed basalt at the Baihetan left dam foundation

Quan Jiang¹ · Bin Wang¹ · Xia-Ting Feng¹ · Qi-Xiang Fan² · Zhilin Wang² · Shufeng Pei¹ · Shan Jiang³

Received: 13 June 2018 / Accepted: 3 October 2018 / Published online: 22 October 2018
© Springer-Verlag GmbH Germany, part of Springer Nature 2018

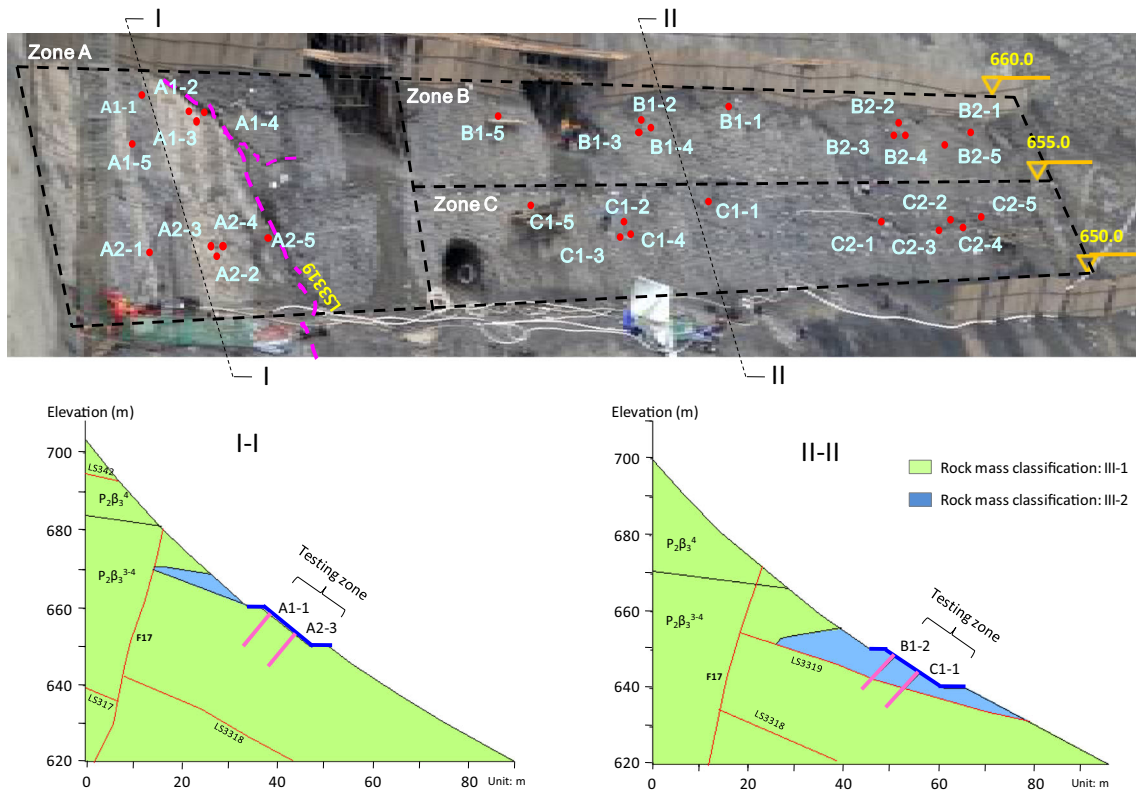
The experimental zone was entirely in the columnar jointed rock mass, and its surface was inclined to the Jinsha River with a dip angle of approximately 45°. A shearing belt with a small dip angle (approximately 15°–25°), called LS3319, ran through the testing zone and introduced differences of rock mass quality. The quality classification of the CJB mass below the shearing belt was III-1 rank, whereas the CJB quality classification above was slightly weaker, i.e., III-2, according to the Chinese national standard for engineering classification of rock masses (DB 50218 1995; Chen and Xu 2017). The experimental zone was divided into three subzones, i.e., the downside region of LS3319, subzone A; the upper region of LS3319 at EL 660–655 m, subzone B and subzone C, as shown in Fig. 8. Thus, these geological differences between subzones might affect the initial damage depth induced by the unloading excavation for the dam foundation.

Fig. 8 In situ experiment site and corresponding subzones
