Stability analyses of dams using multidisciplinary geoscience approach for water reservoir safety: case of Mpu Damsite, Southeastern Nigeria

Abstract

Keywords Damsite · Seepages · Uplift pressure · Dam foundation · Composite bedrock · Reservoir safety

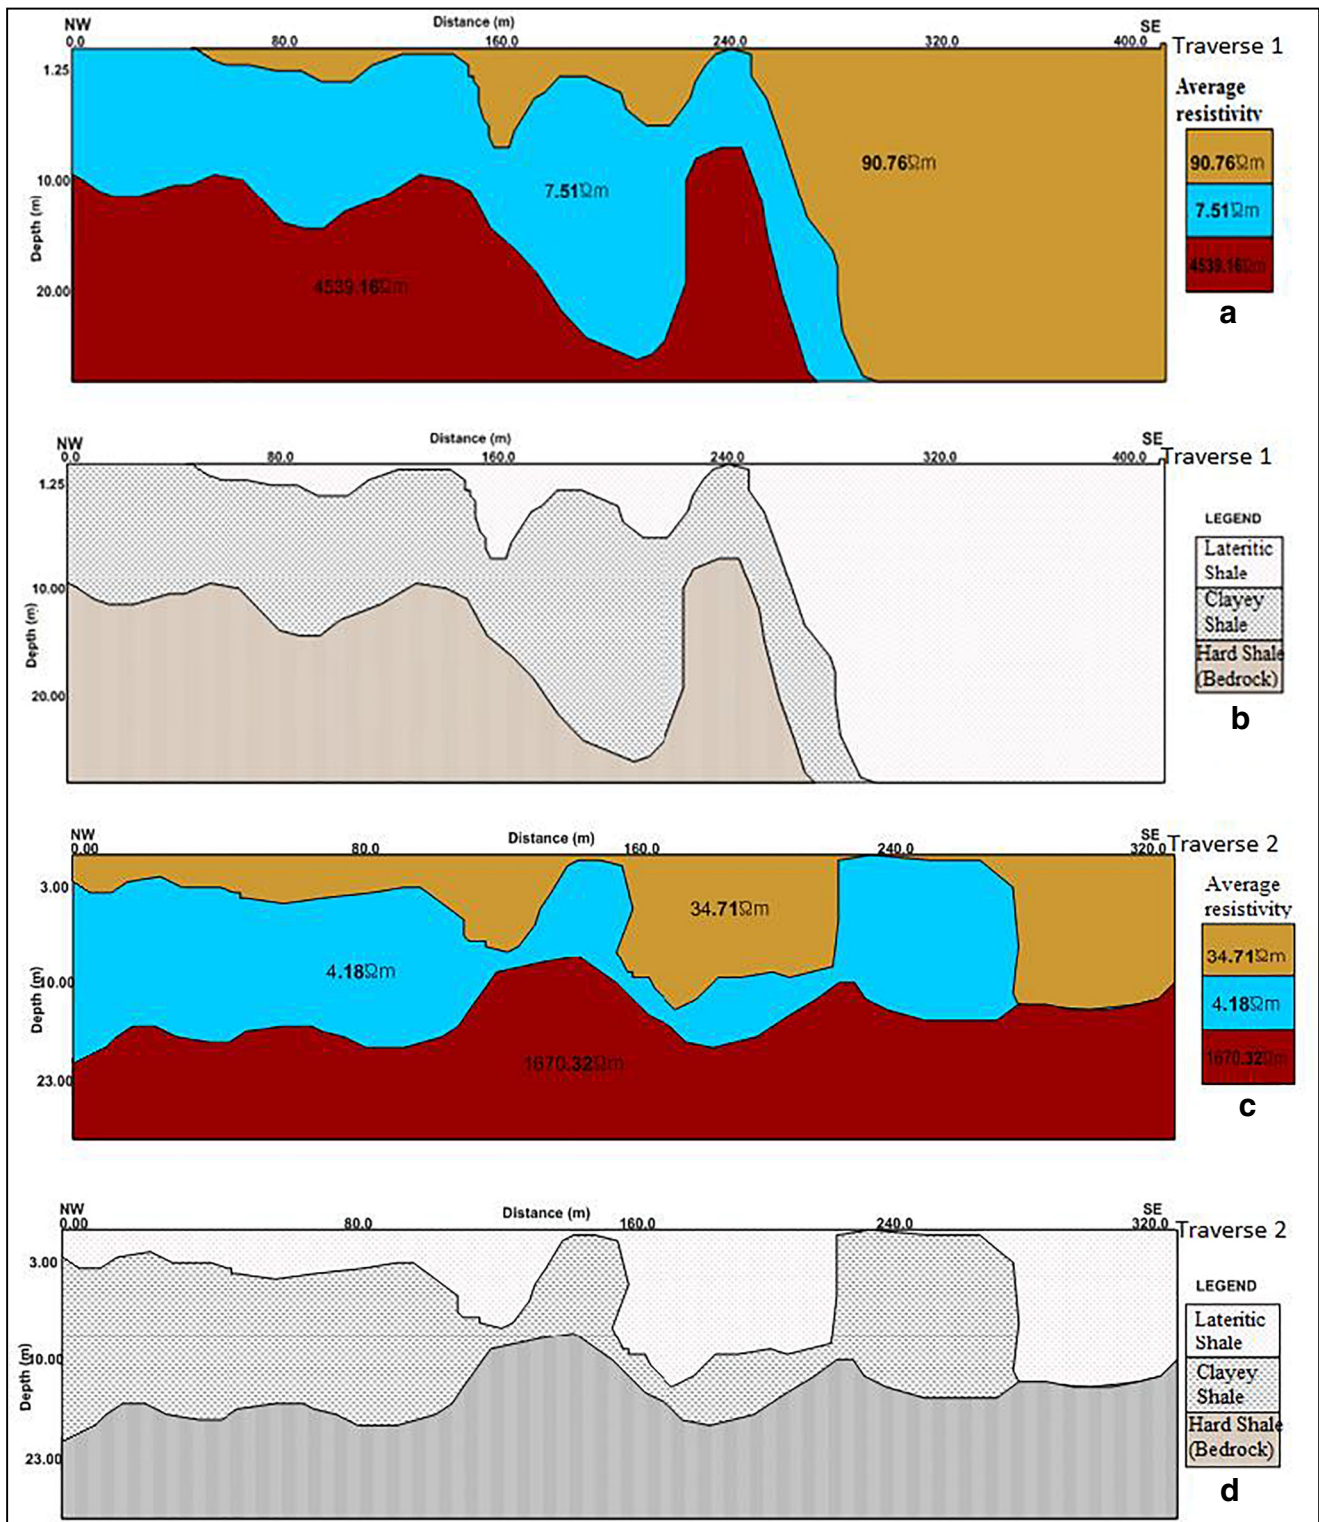
Geoelectric models (Fig. 8a and c) delineated configurations of the underlying bedrocks around the foundation zone. Observably, the dam stretched across the geologic contact (or gap) between Asu River Group which extended down-slope from the axial Abakaliki Anticlinorium, and Ezeaku Group which prograded from Afikpo sub-basin. As seen in

the models, typical rock resistivities (Loke 1999) deduced three major geoelectric units (Figs. 8b and d). Ranges of resistivities from 34.7 to 90.8 Ohm m were interpreted as weathered/ferruginized shale (see Fig. 5I) with patches of iron residues (see Fig. 6I, II, III, IV); from 4.2 to 7.5 Ohm m was interpreted as clayey layer which marked the basal limit of weathered sedimentary subgrades; and from 1670.3 to 4538.2 Ohm m as the underlying fresh bedrocks (compare [Fig. 8a and b with 8c and d]). According to Lyons and Van deCamp (1980), bedrocks reflect elevated resistivities, possibly relating to induration (i.e., hardness). Inferred depths to the bedrocks varied, but with the minimum of about 10 m (see Fig. 8). The depth increased infinitely where the Asu River Group prograded indefinitely into subsurface, particularly towards the end of traverse 1, about a distance of 240 m away from the initial line of the traverse (see Fig. 8a and b). Axis of the sedimentary progradation in the field (by latitude and longitude) was located on geologic map (see Fig. 4IV) as a boundary where Asu River Group dipped into Ezeaku Group.

Fig. 7 Geo-models. a Resistivity equivalent of (b) geologic formation in Asu River Group; (c) resistivity equivalent of (d) geologic formation in Ezeaku Group

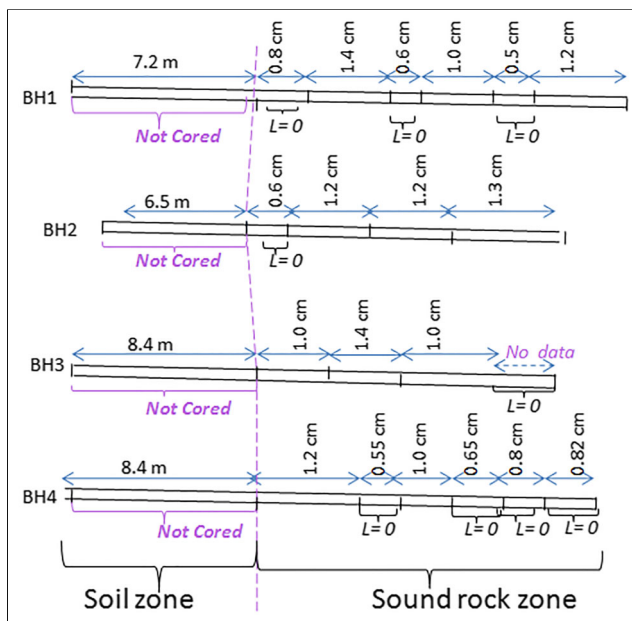
Fig. 11 Measured molds of the core sample across the Boreholes from surfacial (soil) zone to subsurfacial (fresh rock) zone

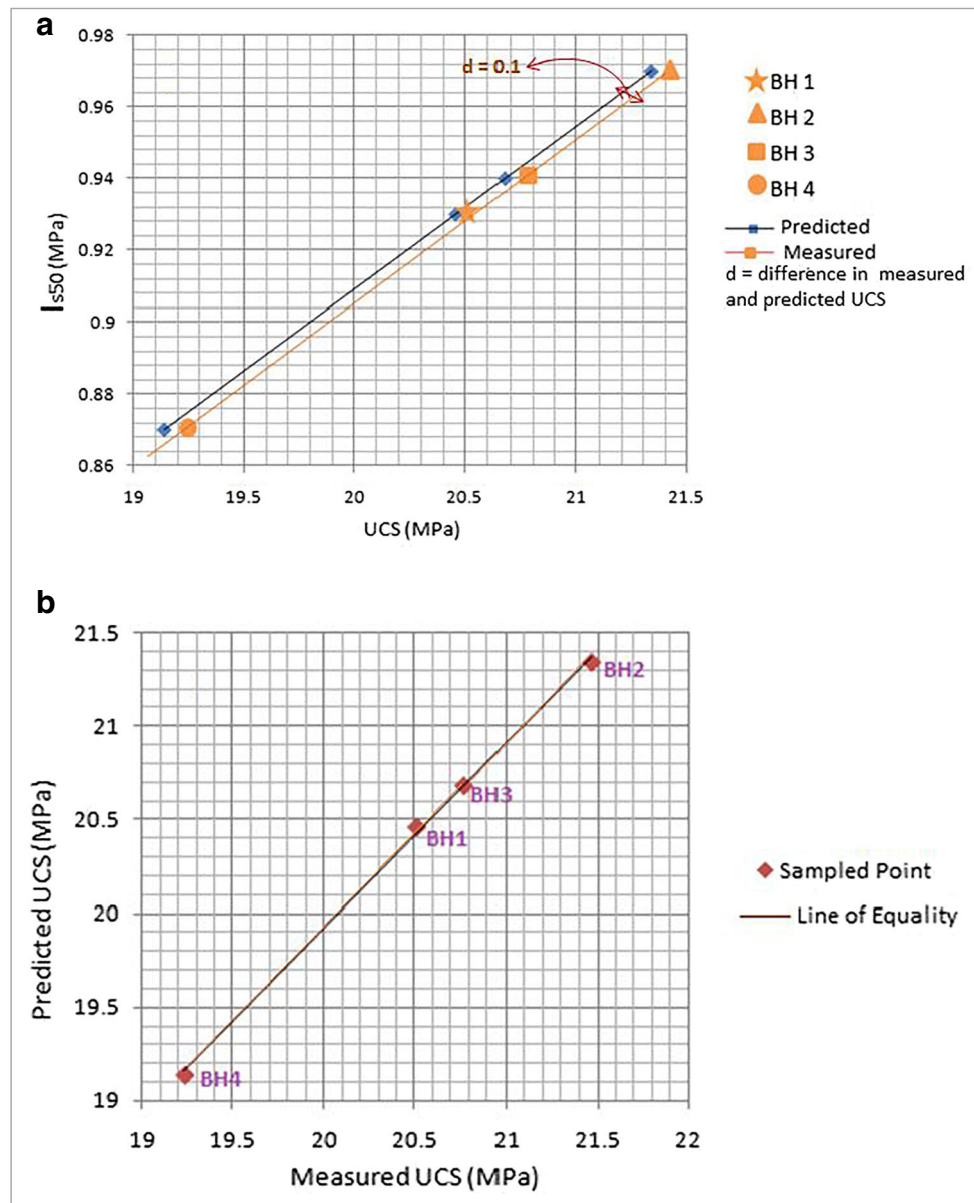
Seeing that most parts of the rock heads (bedrock columns) are somewhat unsound (see Fig. 12; Appendix 3b), ultimate bearing capacity (q_{ult}), in addition to allowable bearing capacity (see Eqs. (2) and (5)), was determined (see Appendix 4 in ESM) to check capacities for end bearing piles. Table 4 shows results of compressive strength and shear strength tests as follows: uniaxial compressive strength, UCS ranged from 19.2 to 21.5 MPa with negligible difference of about 0.1 MPa greater than predicted values, ultimate bearing capacity (q_{ult}) from 52.9 to 60.1 MPa (i.e., 539.4 to 612.8 kg/cm²), and safe or allowable bearing capacity (q_{al}) from 21 to 24 MPa (or 214.1 to 244.7 kg/cm²). Close comparison of the data in Fig. 12a showed that the UCS is linearly related with point load strength index (I_{S50}), hence indicate that one can be predicted from another as shown in Eq. (8). Precision of the measured UCS was indicated in the predicted values as both showed linear equality (Fig. 12b). The determined

Fig. 12 Graphs showing linear relationship between (a) point load index (I_{s50}) and UCS, (b) measured and predicted uniaxial compressive strength (UCS)

UCS is higher than the 18 MPa standard highlighted by Kawasaki et al. (2002). Relatively, elevated values of q_{ult} signified that the bedrocks satisfy ultimate limit (i.e., state of safety criterion) to bear load of the dam without being stressed to probable failure. The estimated q_{al} values of the end bearing bedrocks surpassed the 25.5 kg/cm^2 presumed as threshold limit by Indian Standard, IS (1987), for net allowable bearing pressure in typical hard shales. Linearly, q_{ult} and q_{al} are parallel, possibly due to common relationship with factor of safety (FS) as shown in Eq. (5). The FS was selected to about 2.5 justified as global factor of safety for deep foundation (Briaud 2013) or for normal control in permanent foundation (BNBC 2012).
