Kinematic process and mechanism of the two slope failures at Baige Village in the upper reaches of the Jinsha River, China

On Oct. 10 and Nov. 3, 2018, two landslides, i.e., the “10.10” and “11.3” rockslides, occurred successively at Baige Village, Jiangda County, Tibetan Autonomous Region, P. R. China. The two landslides are located in the upper reaches of the Jinsha River and both dammed the river. Immediately since the slides, the authors have been working on the slides and help disaster reduction. Based on the data collected by April 2020, this paper is aimed at clarifying the geological condition of the slides and at explaining why the slides occurred and what the whole sliding process was. Conclusions are summarized as follows. First, the two landslides occurred in the suture belt of the Jinsha River and the rocks are composed of tectonic *mélange* slices of mainly gneiss intermingled with carboniferous slate and marble and with intruded serpentine and granite porphyry. The gneiss generally bears a schistosity plane with an averaged attitude of N47° W/47°, dipping into the slope. Secondly, long-term geomorphological evolution of the bank slope due to river incision contribut

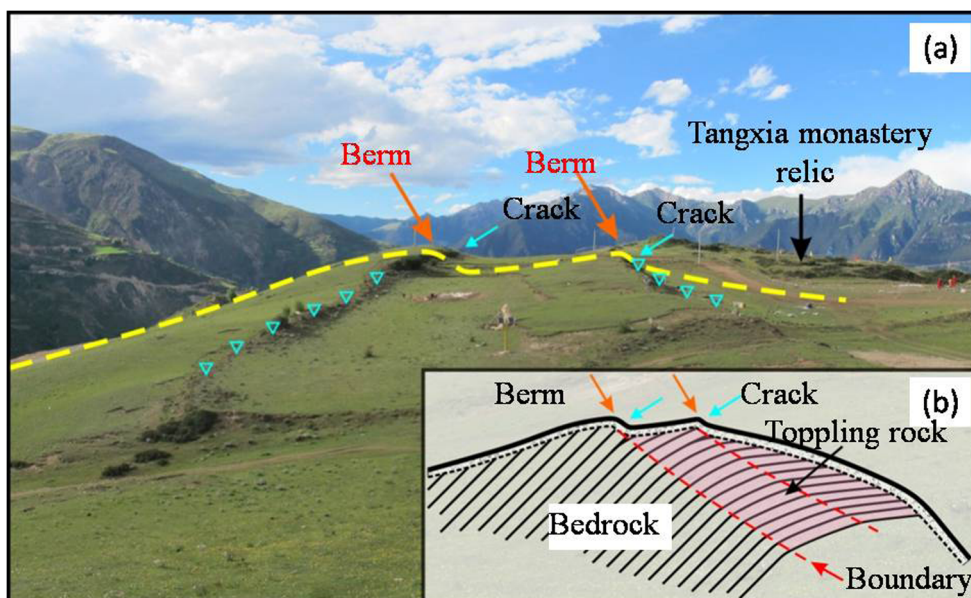
Fig. 20 Schematic view for the formation of the berms

relocation is closely related to the slope deformation. From the microtopography adjacent to the sliding area, berms are quite common and most of the sliding-induced cracks appear along the berms (Pictures P1 to P3 in Fig. 19). So the berms should be naturally formed during the long-term toppling deformation of the slope. Formation of the berms can be interpreted in Fig. 20. That is, the deformation history of the slope is quite long and may be traced back to prehistoric time, as can also be evidenced by the weathering degree of gneiss beside the berms (Picture P4 in Fig. 19). The closer to the sliding area, the heavier the weathering degree. In general, the slides are the result of long-term geomorphological evolution due to river incision.
