# Dynamic evolution mechanism and subsequent reactivated ancient landslide analyses of the "6.17" Danba sequential disasters

Nan Jiang<sup>1</sup> · Hai-bo Li<sup>2</sup> · Yu-xiang Hu<sup>1</sup> · Jie-yuan Zhang<sup>2</sup> · Wei Dai<sup>1</sup> · Cong-jiang Li<sup>2</sup> · Jia-wen Zhou<sup>1</sup>

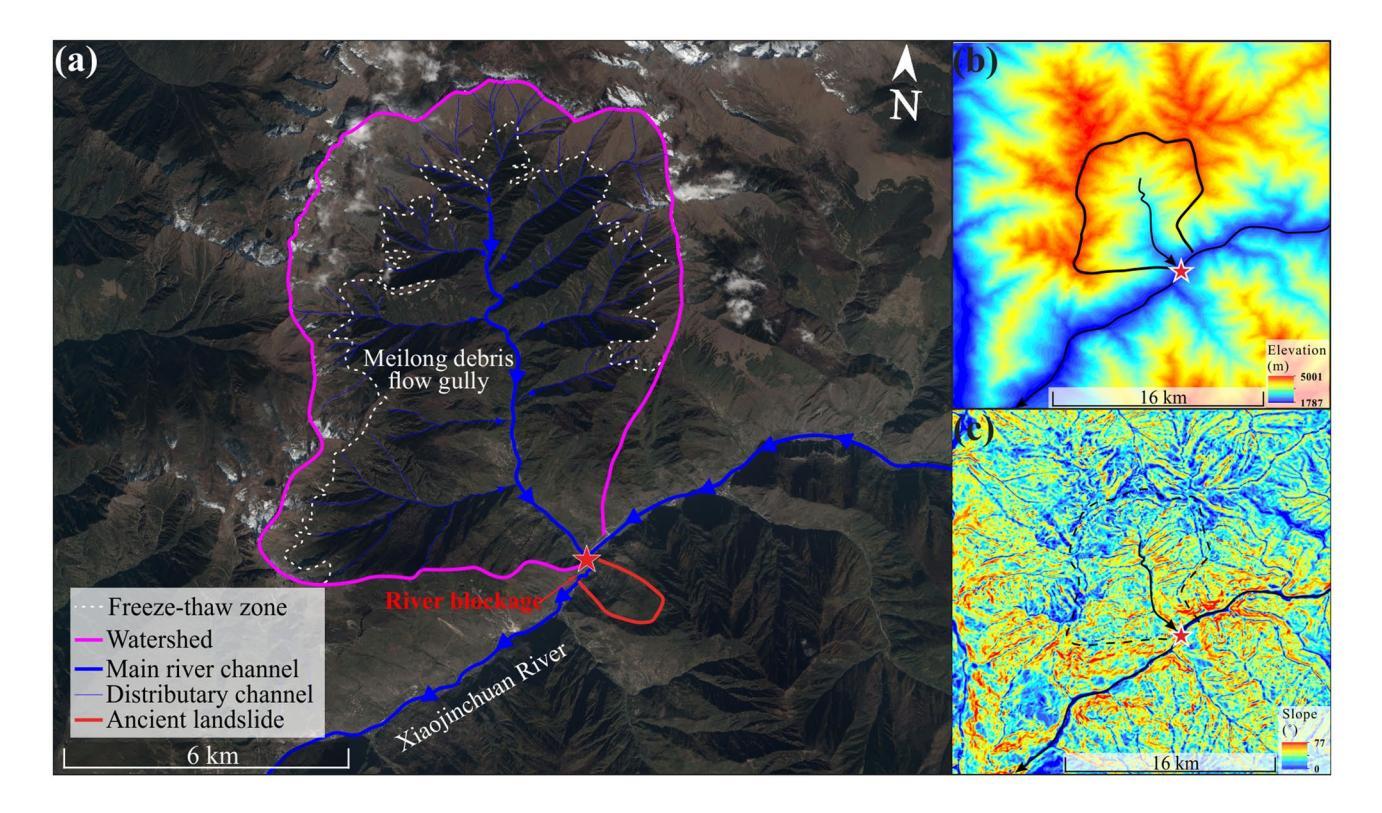
Fig.8 Topography of the Meilong gully: (a) a satellite image of the Meilong gully (from Google Earth); (b) and (c) topography of Meilong gully

The location of the Meilong debris flow is approximately 19.5 km upstream of Danba County. The rain collection range is surrounded by steep mountains on all sides and has an area of  $64.37 \text{ km}^2$  and a maximum height of 2500 m (Fig. 8). The minimum width of its outlet is only 113 m. There are freeze–thaw areas at the top of the mountain (from elevation (EL.) 4000 m to EL. 5000 m), with average slopes between 0° and 30° (Fig. 8c). The slopes below the freeze–thaw areas are relatively steep ( $30^\circ$ – $60^\circ$ ) with elevations between 2300 and 4000 m.

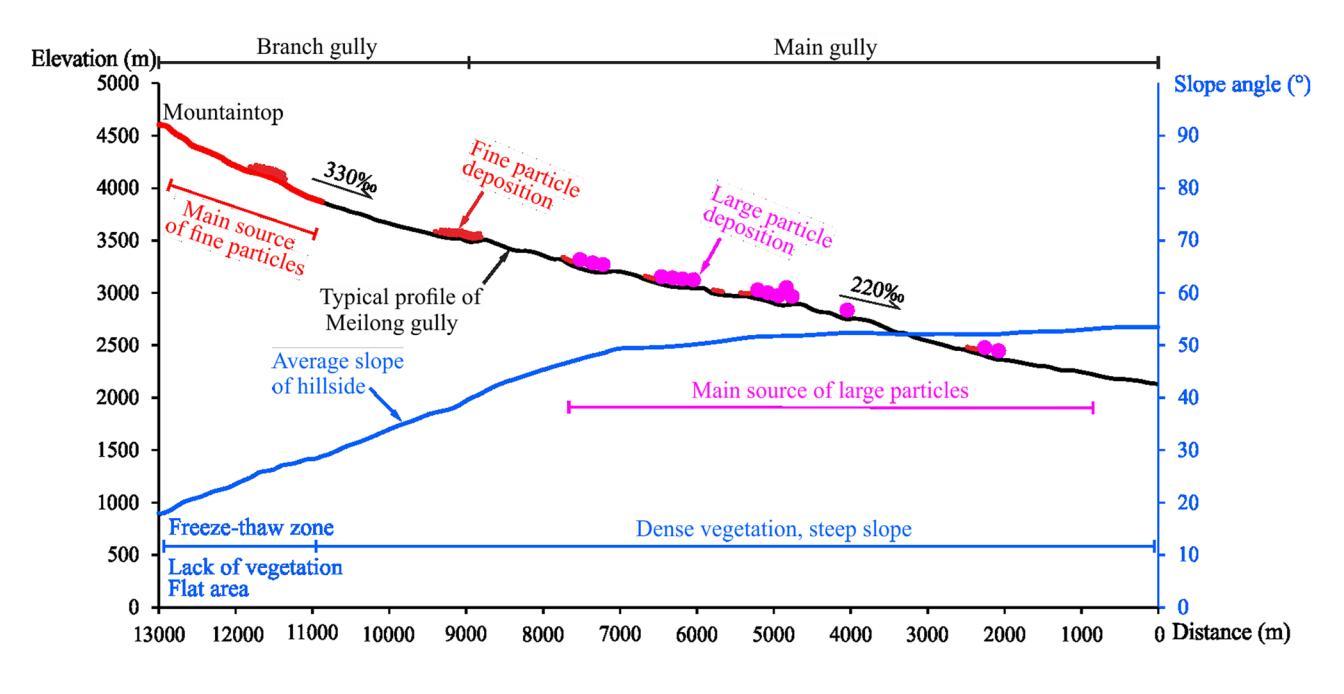
Fig. 9 Typical profile of the main Meilong gully

Figure 9 shows a typical profile of the Meilong gully and the average slope angle of the nearby hillside. The surface overburden in the freeze–thaw areas is a Quaternary deposit layer with abundant fine particles. According to a geological hazard report in 2006, the statistical relationship between the scale of the debris flow, slope of the hillside, and gradient of debris flow gullies in Danba County is shown in Table 1. This shows that giant debris flows were more likely to occur in gullies with gradients less than 240‰ and hillside slopes greater than 40°, which is consistent with the characteristics of the Meilong gully.

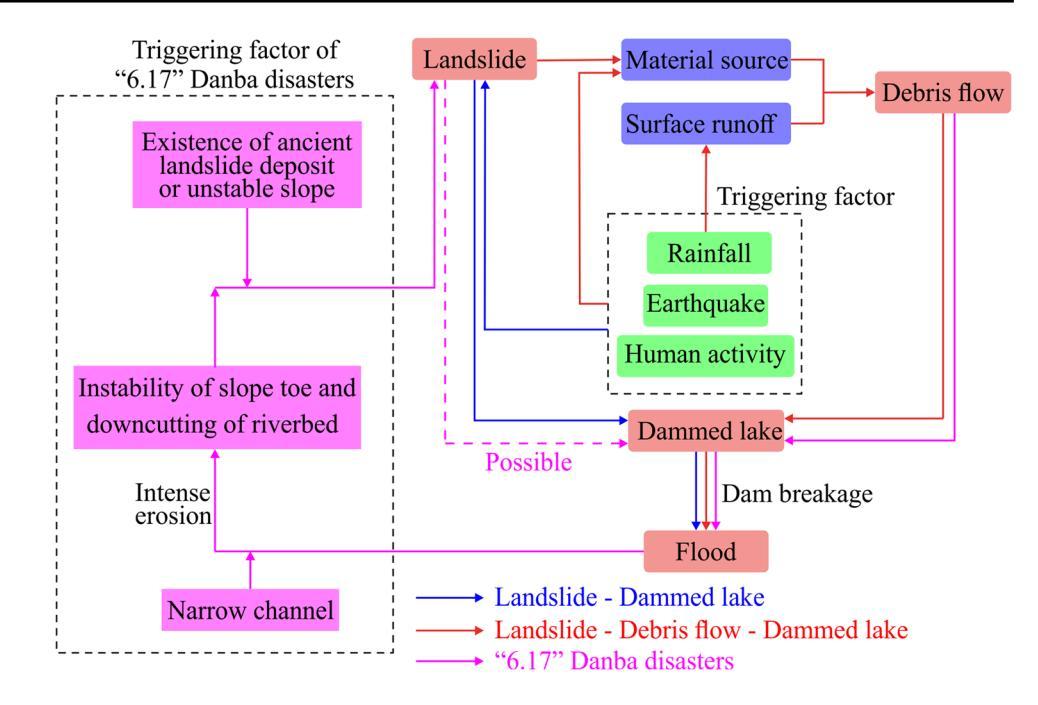
Fig. 17 Analysis of the landslide boundary: (a) determination of the range of the disturbed riverbed based on the DOO; (b)–(d) typical profiles of the riverbed Fig. 18 Schematic diagram of the mechanism of continuous disasters: landslide-dammed lake disasters (blue lines), landslide-debris flow-dammed lake disasters (red lines) and the 6.17 Danba disasters (purple lines)

Fig. 19 Potential sites similar to the 6.17 Danba sequential disasters in Danba County debris flow-dammed lake-reactivated landslide, which has a longer duration and greater potential risk than a normal dammed lake disaster (Fig. 18). The key factor in the formation of this type of sequential disaster event is the presence of an ancient landslide or unstable slope at the site of the debris flow dam. Dam failure floods may cause the instability of unstable slopes and have the potential to block river channels. According to geological surveys, there are dozens of ancient landslides or unstable slopes in Danba County. To determine whether other sequential disaster events similar to the Danba 6.17 sequential disasters could occur in these areas, we counted the locations of existing natural hazards, including debris flows, landslides, and unstable slopes, according to the detailed investigation report of geological hazards in Danba County (Fig. 19). Nine positions with ancient landslides or unstable slopes located at the outlet of debris flow gullies were highlighted. All of the positions are located near the main river channel, and the formation of a large debris flow may form such continuous disasters, seriously affecting regional safety and economic development in downstream areas.
