# Interpreting the formation mechanism of a complex landslide: a case study of a reactivated landslide of a reinforced embankment slope

Qiuxiang Huang<sup>1,2</sup> · Jialin Wang<sup>1</sup> · Pinnaduwa H.S.W. Kulatilake<sup>2</sup> · Haofeng Guo<sup>1</sup> · Jipeng Shen<sup>1</sup>

Received: 27 April 2023 / Accepted: 17 November 2023 / Published online: 1 December 2023  
© Springer-Verlag GmbH Germany, part of Springer Nature 2023

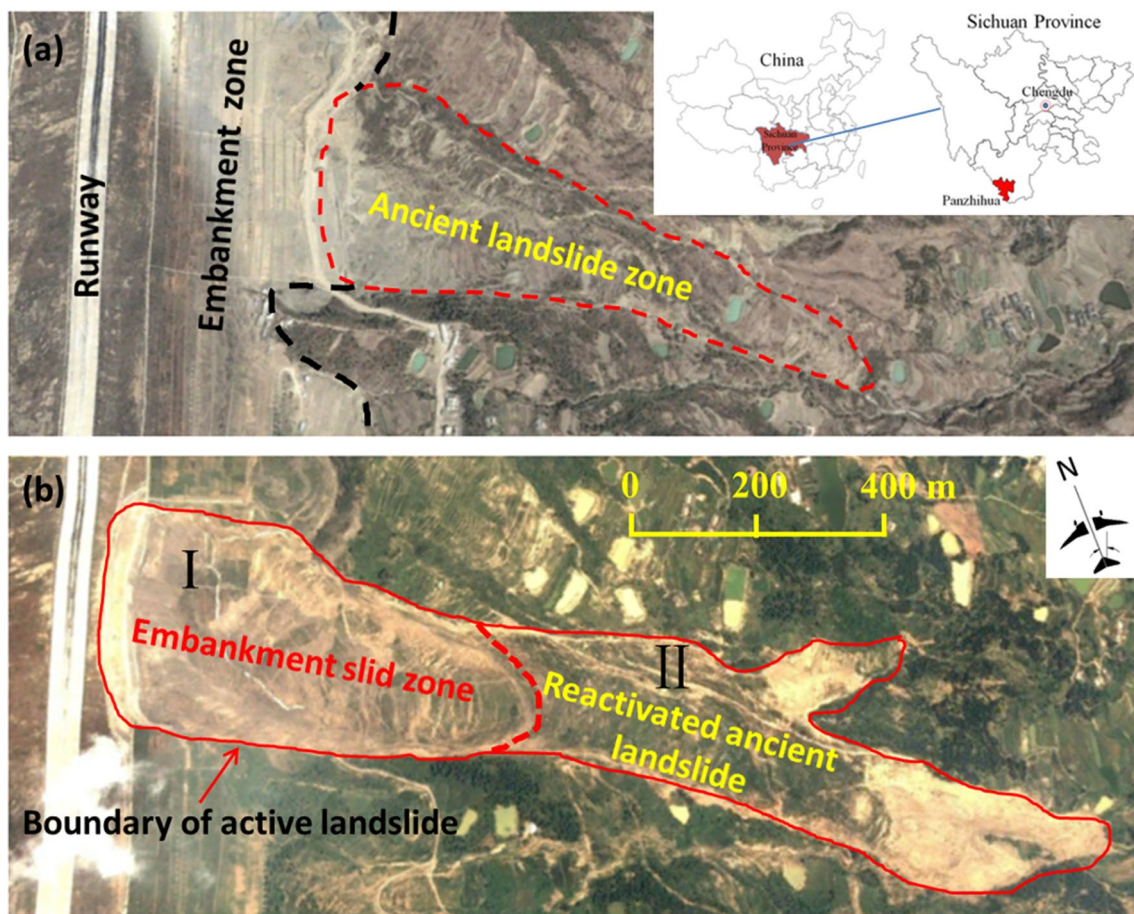
On October 3, 2009, at about 15:20, a complex landslide occurred in Panzhihua, Sichuan province of China, on the east side of the runway in Panzhihua airport (see Fig. 1). The landslide area (Fig. 1b) can be separated into two sections, the embankment slid area and the reactivated ancient landslide area located at the lower part of the embankment slope, with an estimated volume of about  $5.1 \times 10^6 \text{ m}^3$ . This failure resulted in considerable damage to the runway of the airport and led to the interruption of Panzhihua airport.

**Fig. 1** Pre- and post-failure Google images of the study area; inset maps show the general location of the landslide in China. **a** Google image of pre-failure, obtained in April 2009. **b** Google image of post-failure, obtained in Sep. 2010

After a few such movements of the filled zone, the overall instability of the embankment slope occurred on October 3, 2009, with sliding mass depositing on the upper part of the YJP landslide. This led to the reactivation of the YJP landslide. Hereafter, we refer to the two slides as zone I and zone II sections (see Fig. 1b) of the landslide, which is the research object of this paper.

The wider landslide area can be separated into two sections; the upper part is the embankment sliding zone (denoted as zone I), while the lower part is the reactivated YJP landslide (referred to as zone II), as shown in Fig. 1b. From the crown (altitude about 1975 m) to the tip (altitude about 1550 m), the total length of the slope is approximately 1800 m and the width of the displaced mass is about 200–400 m, in the shape of a long tongue. The landslide mass movement was mainly in the direction of  $125^\circ$  with a displacement of 100–300 m in this direction. When combined with the borehole results, the thickness of sliding mass ranged between 10

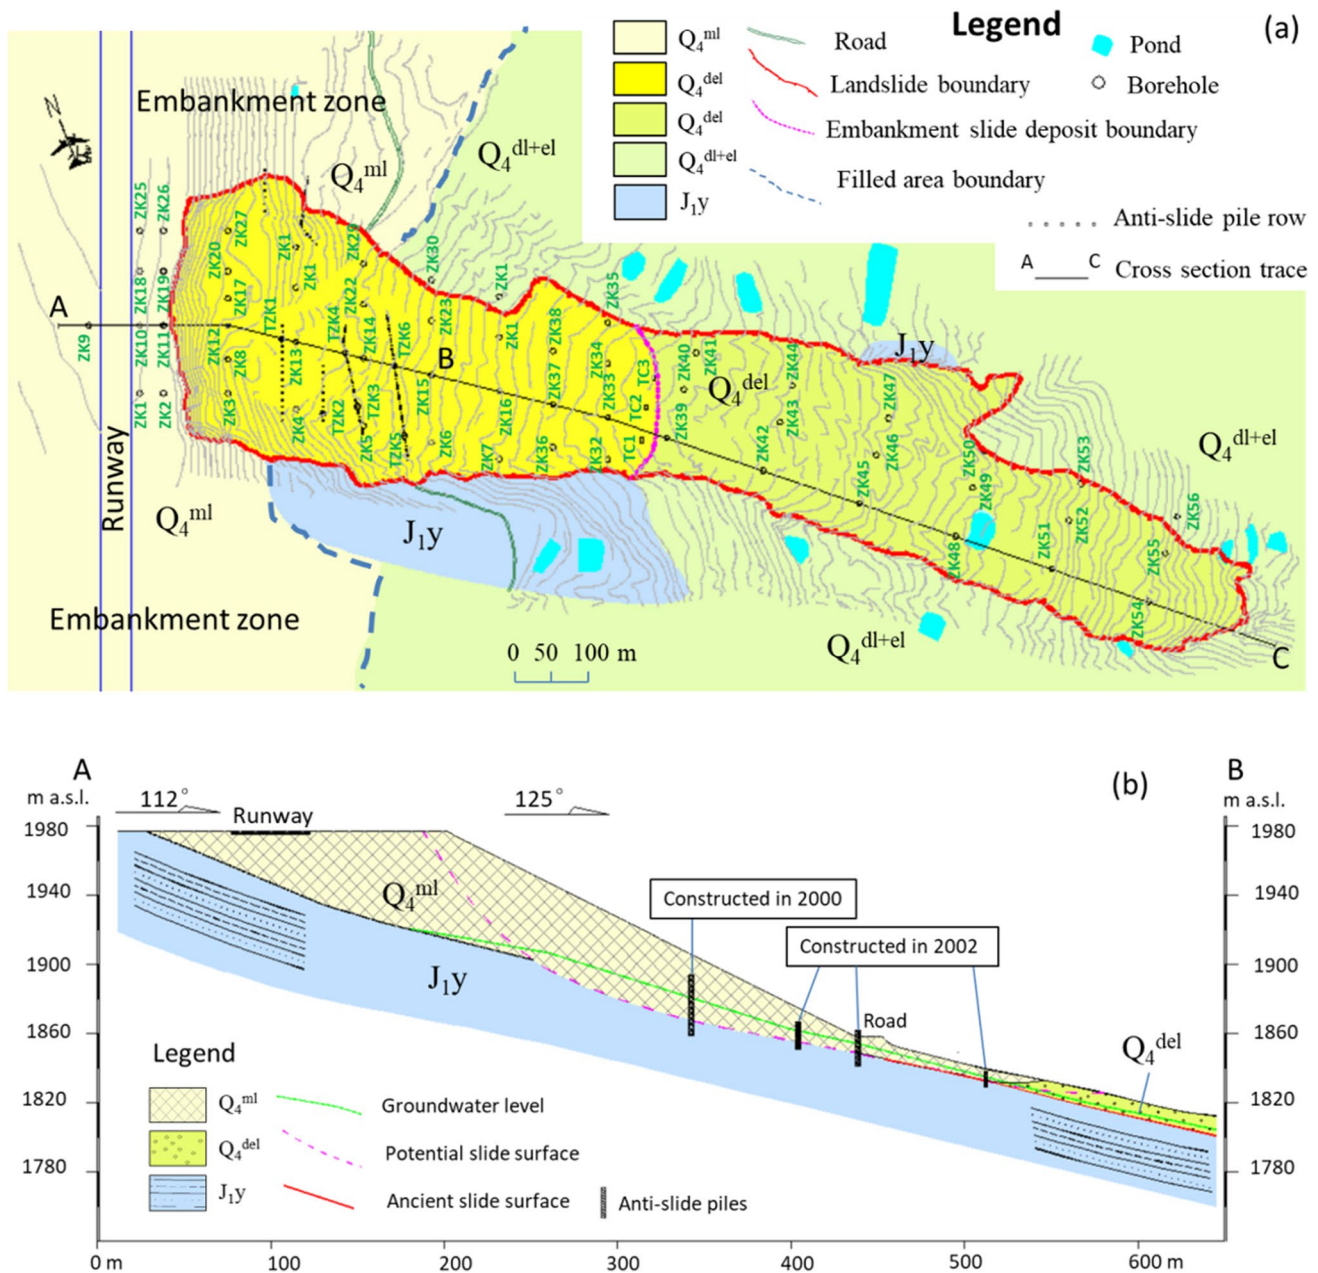
As mentioned before, the YJP landslide was in stable condition before the airport construction, with a gentle slope gradient of 8–10°. Many gullies developed on the slope body, and ponds of varied sizes were scattered in the middle and lower part of the slope (Fig. 4a). The embankment zone for the runway area construction was

located at the upper part of the ancient landslide, with a region of 3.5km length in the N-S, 0.7km width in the E-W. The runaway area was at an elevation of 1976 m, while the embankment slope was located on its east side. After the embankment construction, the gradient of this slope part turned out to be 25–26° compared to the original value of 10–18°, with a maximum thickness of filled zone up to 50 m and a slope height of 150 m (see Fig. 4b).

**Fig. 4** Geological and geotechnical setting of the study area. **a** Detailed geologic map of the study area. Also shown are the original locations of the anti-slide piles before failure and the locations of the

boreholes set for the field investigations. **b** A pre-failure cross-sectional profile of the embankment slope

The geological environment of the region is dominated by the Quaternary and the Yimen group of Lower Jurassic ( $J_{1Y}$ ), almost mantled quaternary material, as shown in Fig. 4a.

The conducted site investigations and surveys indicated that the groundwater in the landslide area was relatively developed. Several subsurface discharges of groundwater appeared on the back scarp (Fig. 6c), and water ponds in surface depressions were scattered both in and outside the sliding area (Fig. 4a). These phenomena showed that the groundwater was abundant in the areas of filled slope and the YJP landslide.

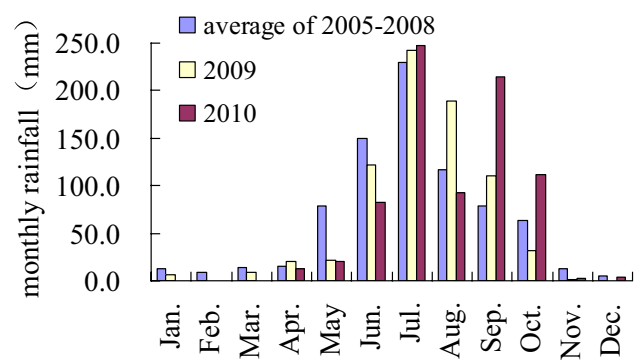
In the study area, the mean annual temperature was about  $20.9^\circ\text{C}$ . Most of the precipitation was concentrated from June to September, accounting for about 95.5% of the year. The average annual precipitation was roughly 801.6 mm, with a maximum of 1006.9 mm. Figure 5 shows the monthly precipitation data covering 6 years (2005 to 2010) taken from the Panzhihua airport gauging station. It also shows the amount of precipitation during the rainy periods in 2009 and 2010, when the landslide phenomena in the studied sites occurred.

**Fig. 5** Monthly precipitations of the years 2009 and 2010 and the mean monthly precipitation for the period 2005–2008 that were recorded at the airport gauging station

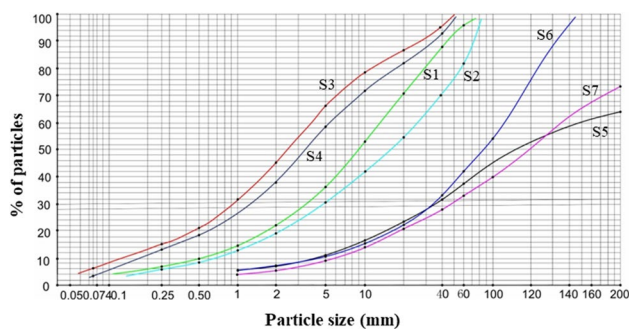
The material was composed of yellowish-brown silty clay and fragments generated from moderately-highly weathered sandstone and mudstone. According to the particle size analyses of all samples (as shown in Fig. 11), the material in the middle and lower part of the filled body was found to be mainly composed of fine particles, with the percentage of fines higher than 50% and up to 85% with grain size smaller

**Fig. 11** Grain size distributions of seven samples obtained from the embankment area, with four samples (named as S1–S4) collected from the back scarp area representing the material of the middle-lower part of the embankment and the other three samples (referred to as S5–S7) from the crown area representing the material of the upper part

than 20 mm. The percentage of fines in the upper part material of the filled body was found to be about 20–23%, which was dominated by coarse-grained soil with boulders occasionally observed in the size of 0.5–1.0 m.

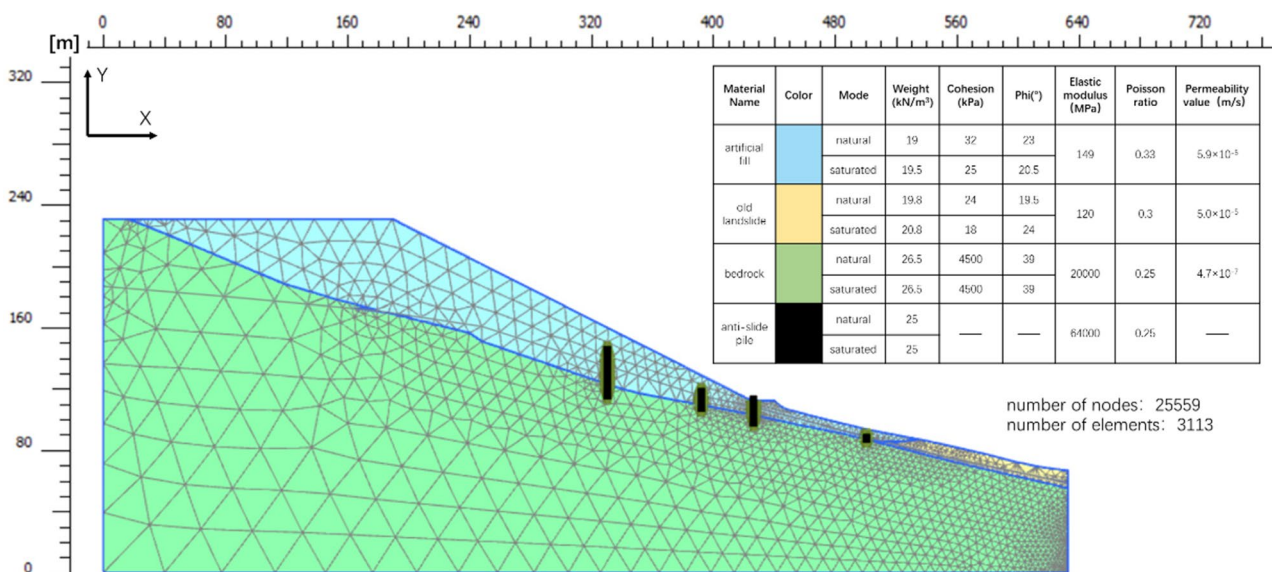
According to the principle of pile-soil interaction, the distribution form of the thrust and resistance of the piles can be calculated, and the landslide thrust borne by the piles can be obtained by integrating the thrust and resistance. The calculation model is shown in Fig. 12. Horizontal constraints are applied to the left and right boundaries, and fixed constraints are applied to the bottom. In the simulation analysis, two phases, solid and liquid, were used, and the fluid-solid coupling analysis was carried out based on Biot’s consolidation theory. The Mohr-Coulomb constitutive model was selected to represent the strength of different materials used in Fig. 12, and the seepage function and soil-water characteristic curve of rock and soil were fitted by Van Genuchten equation.

Both natural conditions and rainfall conditions were considered in the calculations, and the rainfall conditions were divided into two cases: effective drainage and poor drainage.

Fig. 12 The model adopted for stability analyses in PLAXIS software

Here, whether the drainage system is effective is defined in terms of the drainage effect obtained. Effective drainage means that the drainage is so effective that the groundwater level does not rise even when heavy rainfall occurs. Poor drainage means that the drainage effect is not good, and the groundwater level rises after the rainfall occurs.
