Remedial measures to control seepage problems in the Kafrein dam, Jordan

Osama K. Nusier · Ahmed Shlash Alawneh · Abdallah I. Husein Malkawi

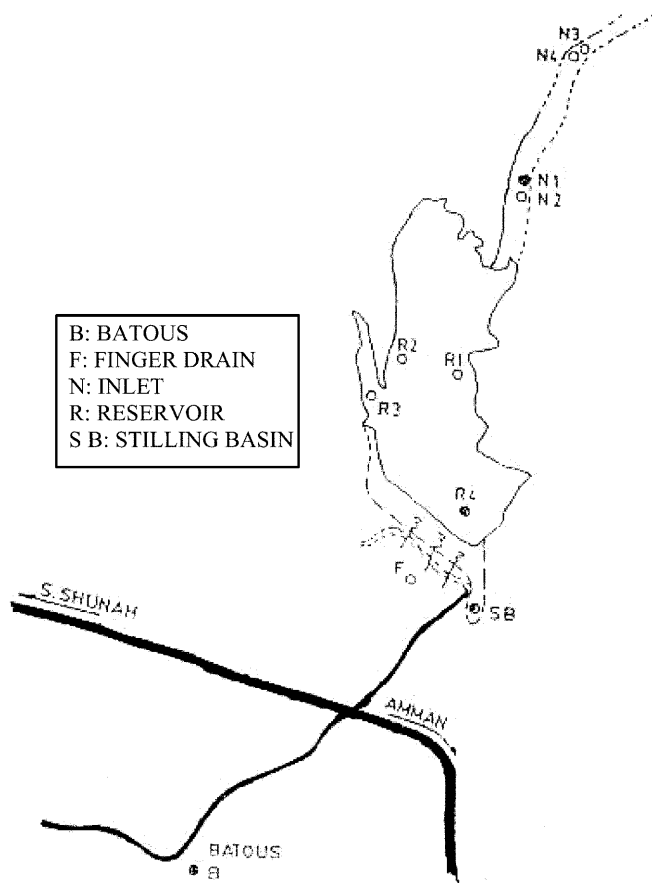
Fig. 4
Sampling locations

The study programme was initiated in order to monitor the behaviour of the dam in general and specifically the seepage, and included piezometer readings, relief wells and readings of the reservoir levels, measurement of the volume of water collected at Batous and determination of the water quality at various locations (Fig. 4). Examples of these data are presented in Tables 2, 3 and 4.
