## Slope failure in stratified rocks: a case from NE Himalaya, India

**Abstract** Mountainous regions of India experience recurrent slope failures due to rapid urbanization. The main causes of slope failure are high precipitation aided by unplanned construction of cut slopes. Such slope failures are further aggravated because of the presence of low strength, highly jointed, stratified rocks rich in clay minerals. In general, effect of weathering is more pronounced in these rocks, which causes long-term time-dependent deterioration of the rocks as well as joint strength. In this regard, the present investigation deals with the causes, behavior, and mechanism of slope failure by examining a section in the North Eastern Himalayas. A detailed field investigation was carried out for examining the existing condition of slope, slope material, and joint parameters. Laboratory experiments like compressive and tensile strength tests along and across the lamination planes along with slake durability index tests were conducted to characterize the material and investigate the role of weathering in strength degradation. Later, numerical simulation was performed employing distinct element method

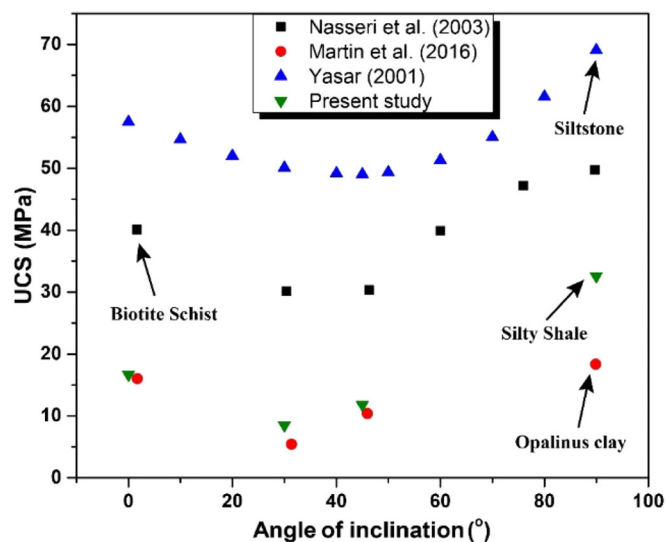
The low value of UCS for both exposed and failed mass is an indication to the continued effect of weathering. Moreover, a sharp decrease in the strength of the samples loaded in perpendicular and parallel to lamination is another factor that decreases the load-bearing capacity and promotes kinematic release of blocks. A better understanding of strength anisotropy is made from Fig. 8, where UCS and angle of lamination are plotted on ordinate and abscissa, respectively. The graph compares the result of four different laminated rocks including one from present study. The trend of all the rocks is almost similar with the minimum strength value somewhere around  $30^\circ$ – $45^\circ$ . Silty shale samples from present study follow the trend of Opalinus clay samples tested by Martin et al. (2016). Laminated siltstone samples tested by Yaşar (2001) show highest strength followed by biotite schist samples (Nasseri et al. 2003). It is interesting to correlate the findings from Fig. 8 with the stratification observed in the cut slope face in the present study. The bedding parallel joint dips toward slope face with an amount of  $45^\circ$  which indicates that the rock mass is likely to show least strength when the slope is loaded from the top. This important parameter is generally ignored while construction of houses which ultimately leads to failure of cut slope.

**Fig. 8** Comparison of UCS for different laminated rocks with angle of bedding
