Landslides (2018) 15:1233–1251
 DOI 10.1007/s10346-018-0973-5
 Received: 4 December 2017
 Accepted: 26 February 2018
 Published online: 13 March 2018
 © Springer-Verlag GmbH Germany,
 part of Springer Nature 2018

Multidisciplinary research of landslide at UNESCO site of Lower Hodruša mining water reservoir

Keywords Banská Štiavnica · Landslide · Lower Hodruša mining water reservoir

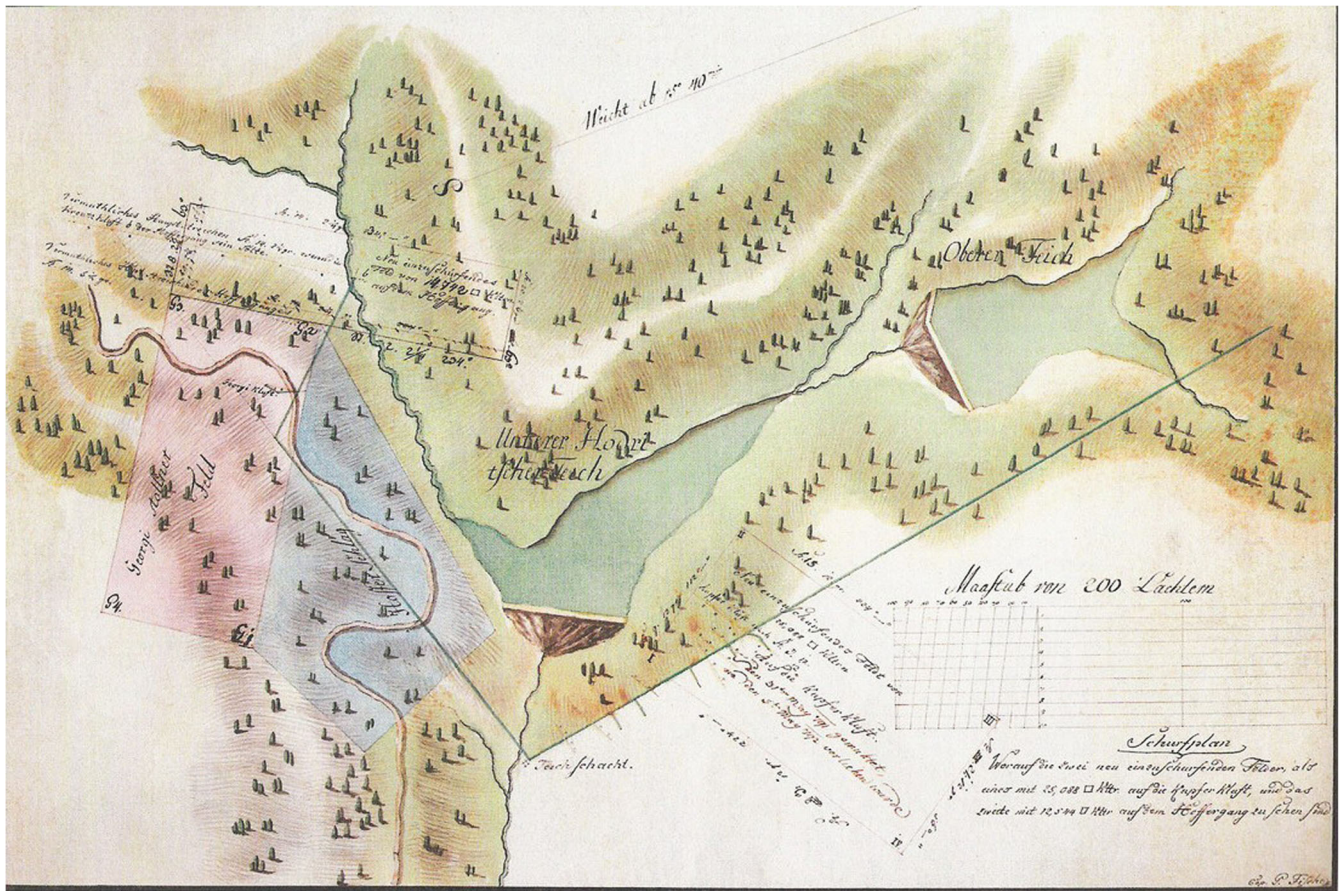
Fig. 3 The Upper and Lower Hodruša reservoirs on a map of new prospecting fields in the 1790s (copy by P. Fischer) (source: www.slovenskiwynalezcovia.webz.cz/tajchy.htm)

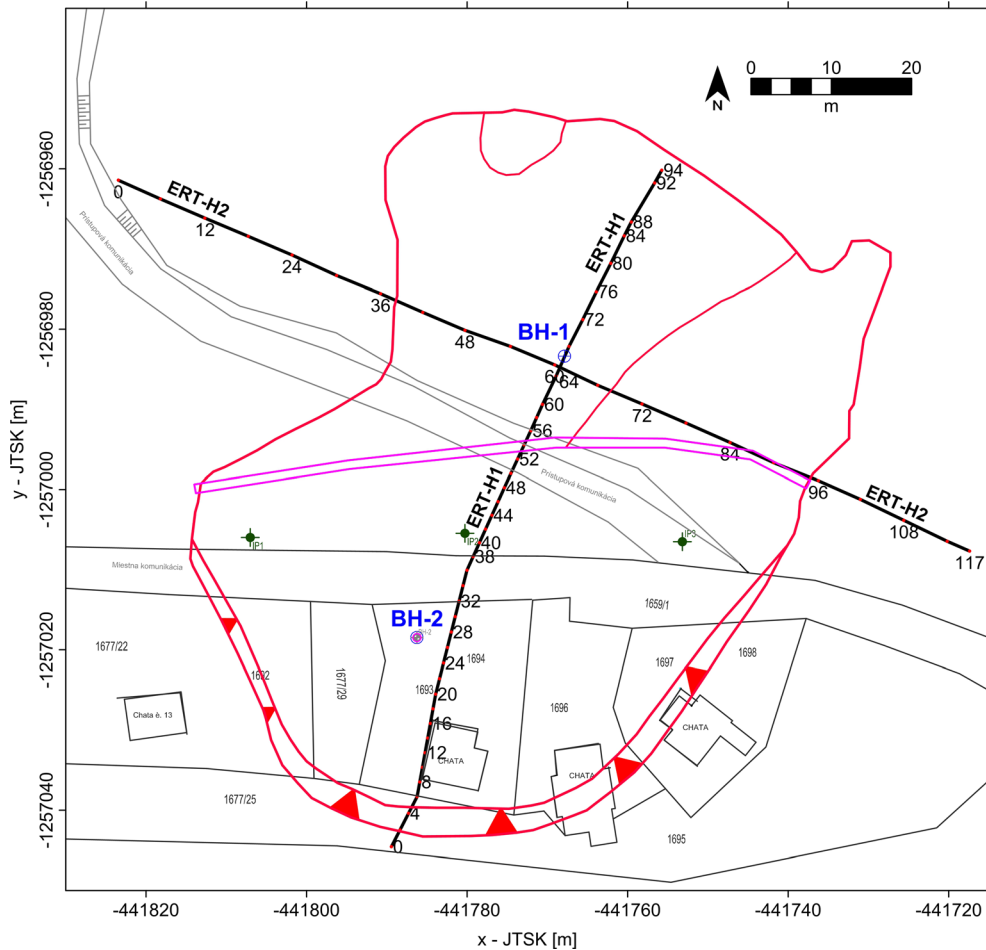
Geophysical measurements were made on two profiles. Profile ERT-H1 followed the direction of movement of the slope deformation from the separation zone through the transportation zone to the toe of the landslide (Fig. 6) over a distance of 94 m with 2 m between electrodes. Profile ERT-H2 was laid out at right angles to profile ERT-H1 in the reservoir area. It is 117 m with electrodes at 3-m intervals.

Fig. 6 Locations of geophysical profiles
