Landslides (2019) 16:1003–1020
 DOI 10.1007/s10346-019-01159-x
 Received: 3 January 2019
 Accepted: 20 February 2019
 Published online: 5 March 2019
 © Springer-Verlag GmbH Germany
 part of Springer Nature 2019

Successive landsliding and damming of the Jinsha River in eastern Tibet, China: prime investigation, early warning, and emergency response

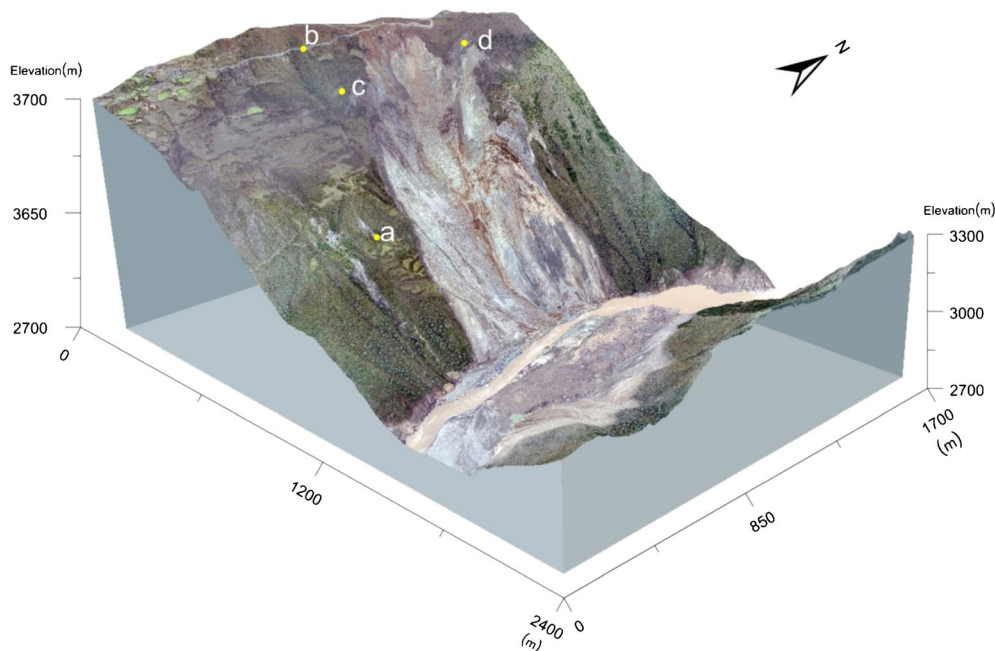
The landslide developed along a ridge at the west bank of the Jinsha River striking 10° N– 15° E with a dip direction of 80° – 100° over a “V”-shaped valley, from an elevation of 3720 m a.s.l. down to 2880 m a.s.l. A three-dimensional view of the site is shown in Fig. 1. Strong neotectonism has been observed accompanied by various geologic hazards along the Jinsha River, which runs across the Hengduanshan north-south tectonic zone (Wang et al. 2000). The monsoonal climate of the Eastern Tibetan Plateau influences the microclimate of the area, which shows an annual precipitation and temperature of 627 mm/year and 8.0° C, respectively, including 3 to 4 months of freezing.

Fig. 1 Three-dimensional view of the October 11, 2018, landslide. The points shown a, b, c and d are locations of the photographs taken during field investigation (see Fig. 2)

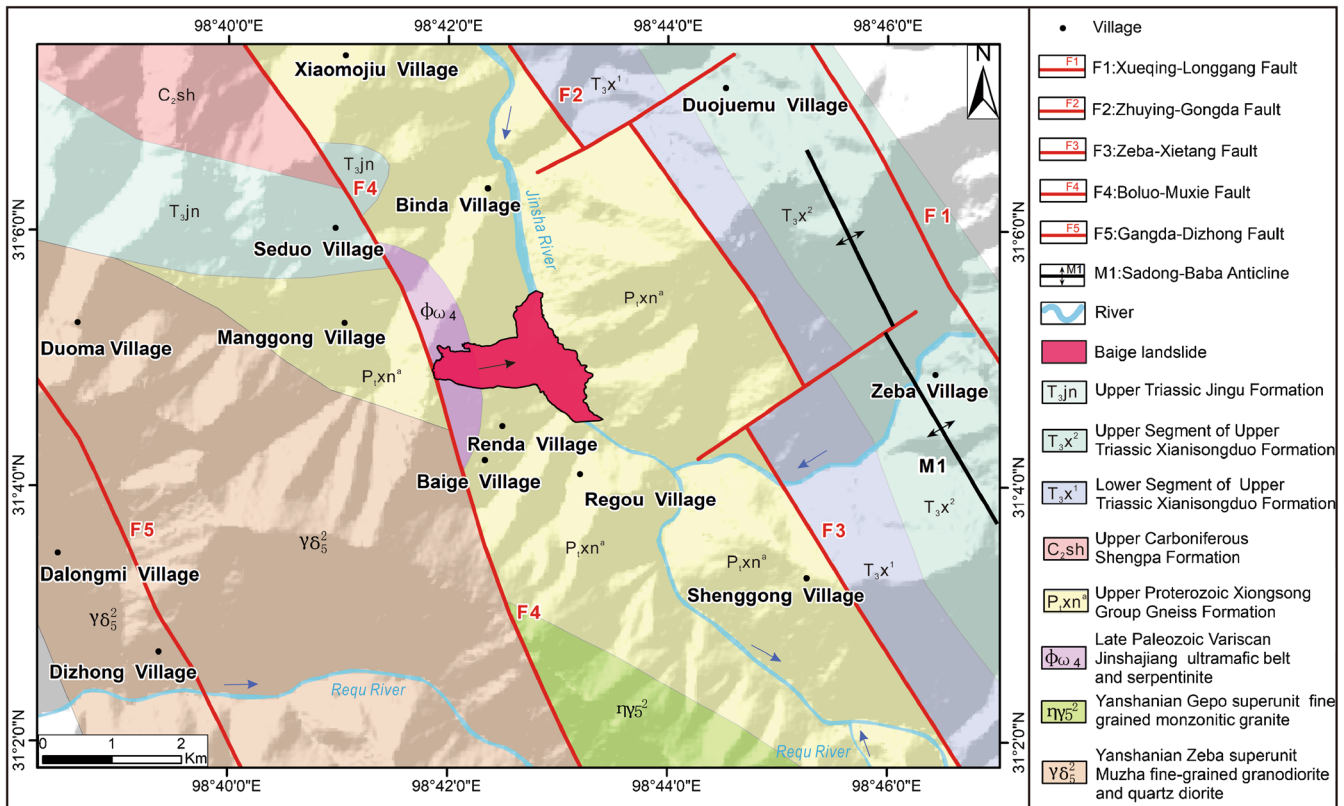
Fig. 3 Geological map of the investigated area

The strata outcropping in the area belong to the Jingu (Ji), Xianisongduo (Xi1), Shengpa (Sh), and Xionsong (Xi2) formations of Upper Triassic, Upper Carboniferous, and Upper Ordovician periods (Fig. 3). They mainly consist of gneiss (P_{gneiss}), granite ($\gamma\delta_5^{2d}$), limestone (T_3jn), and serpentinite (ϕ_{w4}). The landslide headscarp was developed within the serpentinite from Variscan orogeny. The landslide body is mainly composed of gneiss and serpentinite (Fig. 2). The attitude of the gneiss strata is $235^{\circ}\angle 40^{\circ}$. They are crossed by two groups of structural planes dipping 60° – $80^{\circ}\angle 75^{\circ}$ – 85° and 100° – $115^{\circ}\angle 80^{\circ}$, respectively.

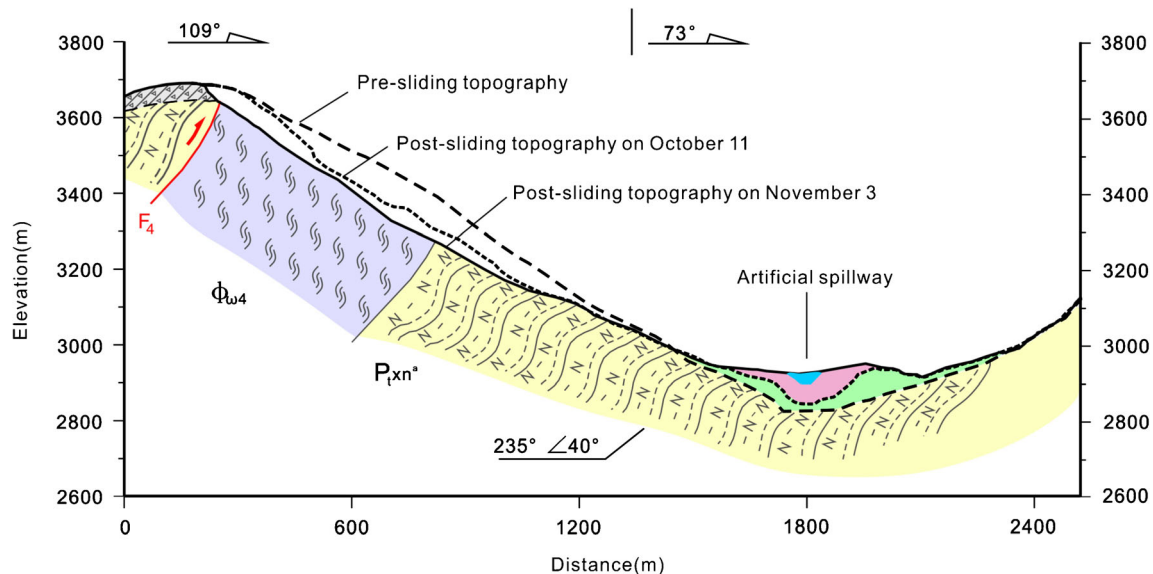
Landslide material from the November 3 event rushed to settle over the natural discharge channel of the Jinsha River, damming it again. Total volume of the landslide deposits reached 9.3 million m³ increasing the height of the dam by 50 m, making it 135 m at the maximal. Thus, a 31 million m³ landslide dam was generated as the consequence of combined actions of both landslides.

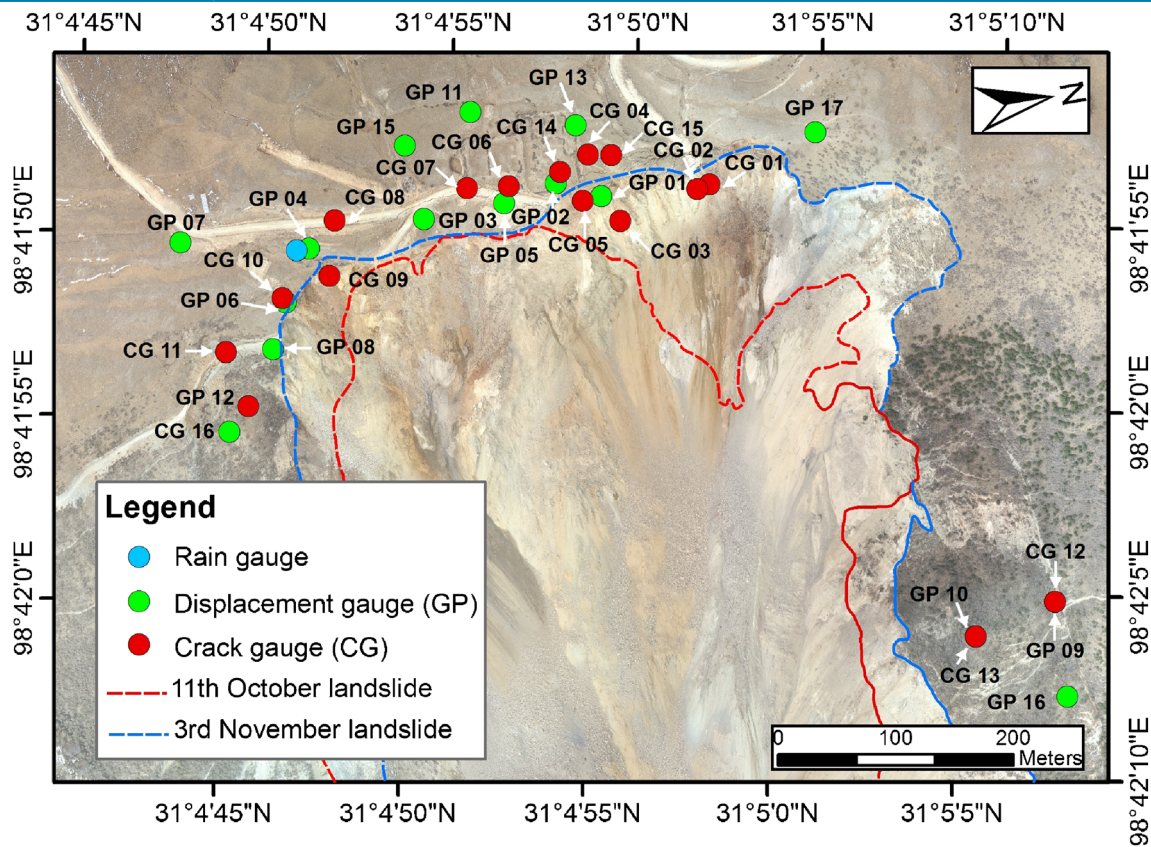
After the October 11, 2018, event, we installed 16 GNSS receivers, 16 crack gauges, and 1 rainfall gauge over the pre-found potential failure zones (see the “Characteristics of first slope collapse” and “Characteristics of the second landslide damming river incident on November 3” sections). A part of deployed equipment was damaged when the second landslide occurred. The layout of the installed monitoring equipment is shown in Fig. 12.

Fig. 12 Location map of installed monitoring instruments. GP refers to the GNSS displacement sensors and CG refers to crack gauges

other six were on a steep ridge in K2 that is strongly affected by the small collapses of unstable rocks. Displacement trends at other stations (GP 3, 4, 5, and 7) were lower as they were located further away from the sliding surface.

The crack gauges were placed on tensile cracks behind the source area (I) of October 11 landslide. Measured time histories are presented in Fig. 13b. Gauges CGo1, CGo2, CGo3, and CGo5 broke before the November 3 event. CGo4 is located 20 m behind the A1 area and spans along a crack oriented in the north-south direction. Sudden increases were observed three times, and they are consistent with the increase in recorded displacement time histories. First increase occurred at 18:00 local time on November 3, 2018, during the slope failure. The other two were observed at 8:00 on November 11 and at 11:00 on November 21. On both occasions small rockfalls were observed around the exposed scarp. Agreement between GNSS logs and crack gauge monitoring show how they reflect the deformation process of the whole slope, making GNSS data and CG data particularly well suited for compiling landslide early warning models.
